## **AIRCRAFT ACCIDENT REPORT**

STRIBLING-PUCKETT, INC.,

BEECHCRAFT A100, N700SP

REPORT NUMBER: NTSB-AAR-76-2

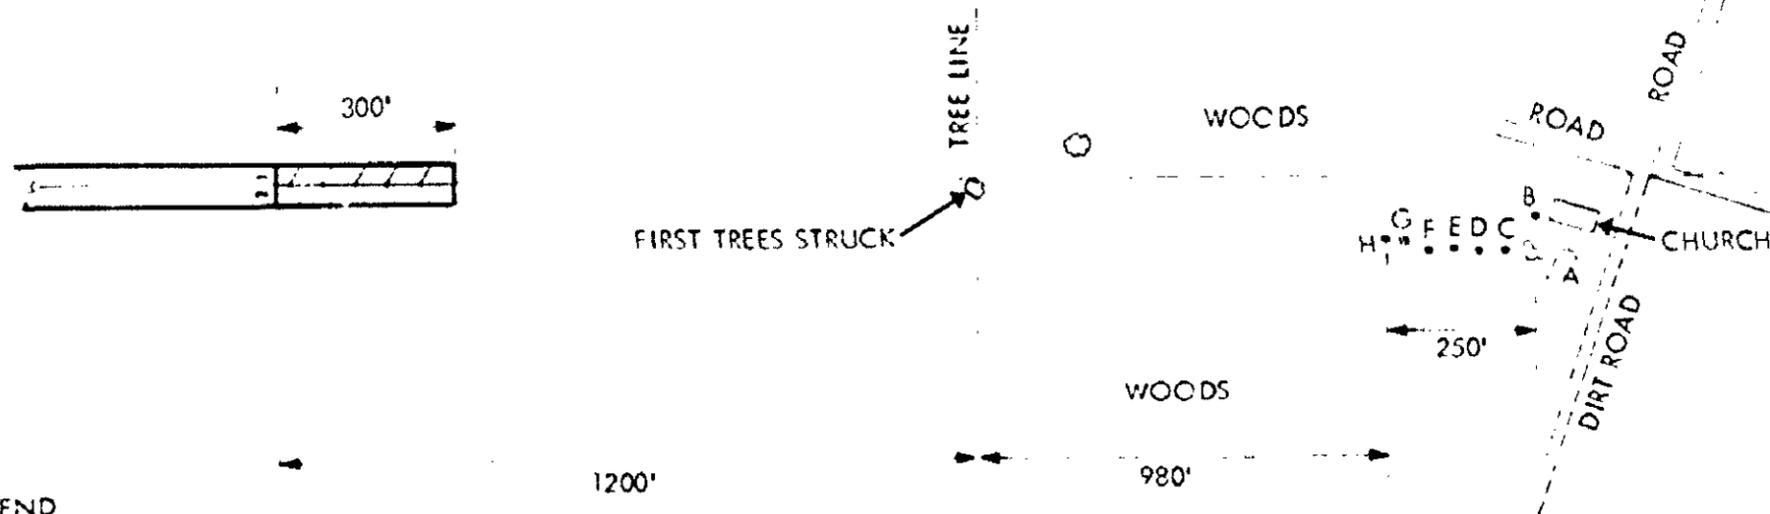
The fuselage came to rest upright on a magnetic heading of 035<sup>o</sup>; the top half was destroyed by fire and impact. The cockpit was damaged by impact and fire which destroyed most of its contents. (See Appendix D.)
