AIRCRAFT ACCIDENT REPORT

NEAR MIDAIR COLLISION

AMERICAN AIRLINES, INC.,
DOUGLAS DC-10, N124 AND

TRANS WORLD AIRLINES, INC.,
LOCKHEED L-1011, N11002

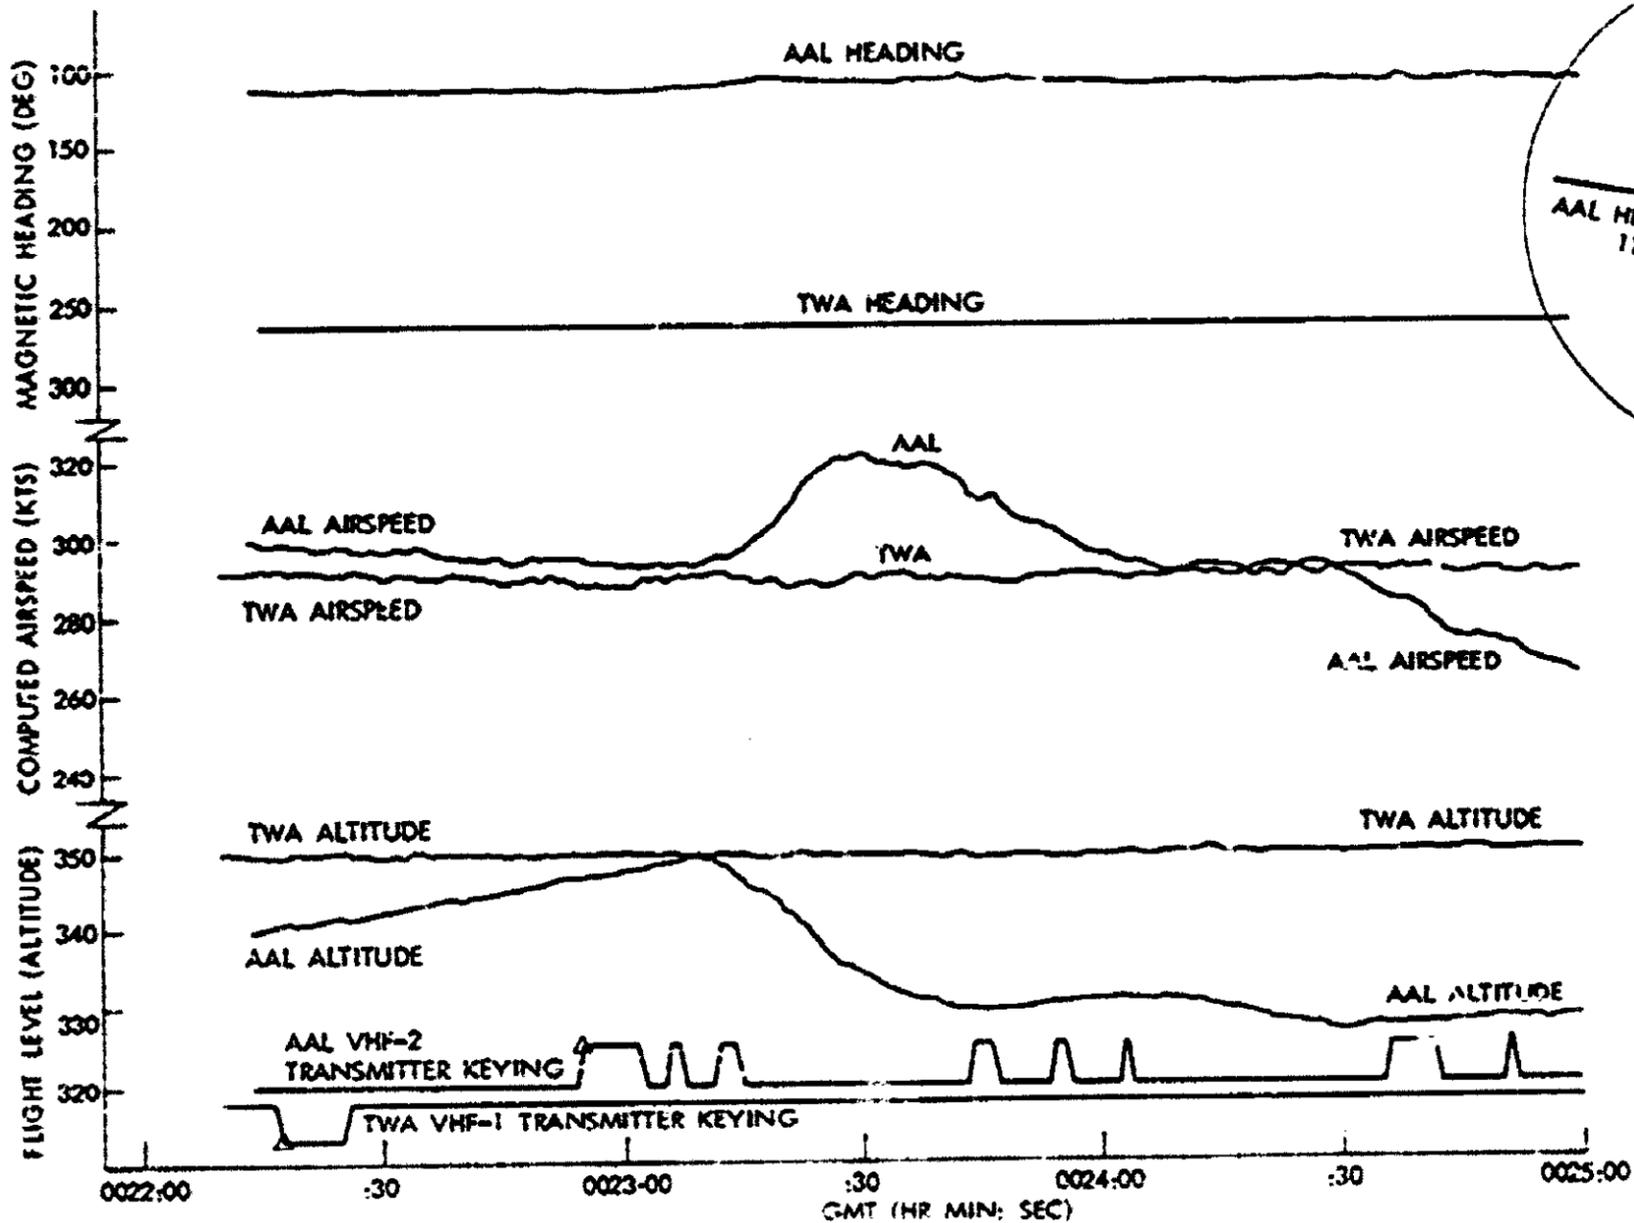
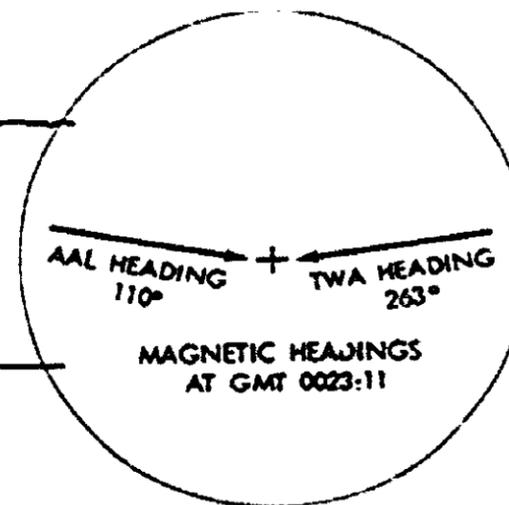
APPENDIX C

Thirty seconds after the evasive maneuver was started, the aircraft had reached FL 330. A maximum pressure altitude of 34,953 ft. was reached 4 seconds after the downward pitch movement began. At this time (1923:11) TWA 37's pressure altitude was 34,965 ft. (See Appendix C.)

- 1) NORMAL ALTITUDE ERROR FOR L-1011 AT 35,000 FT = ± 70 FT.
- 2) MINIMUM ACCURACY (ALTITUDE) FOR DC-10 AT 50,000 FT = ± 80 FT (LESS THAN ± 80 AT LOWER ALTITUDE)

△ REFERENCE POINTS FOR GMT (FROM ATC TRANSCRIPT)
