AIRCRAFT ACCIDENT REPORT

CAMPBELL-EWALD ADVERTISING COMPANY, ROCKWELL

TURBO COMMANDER 690A, N847CE, NEMACOLIN,

PENNSYLVANIA, SEPTEMBER 12, 1975

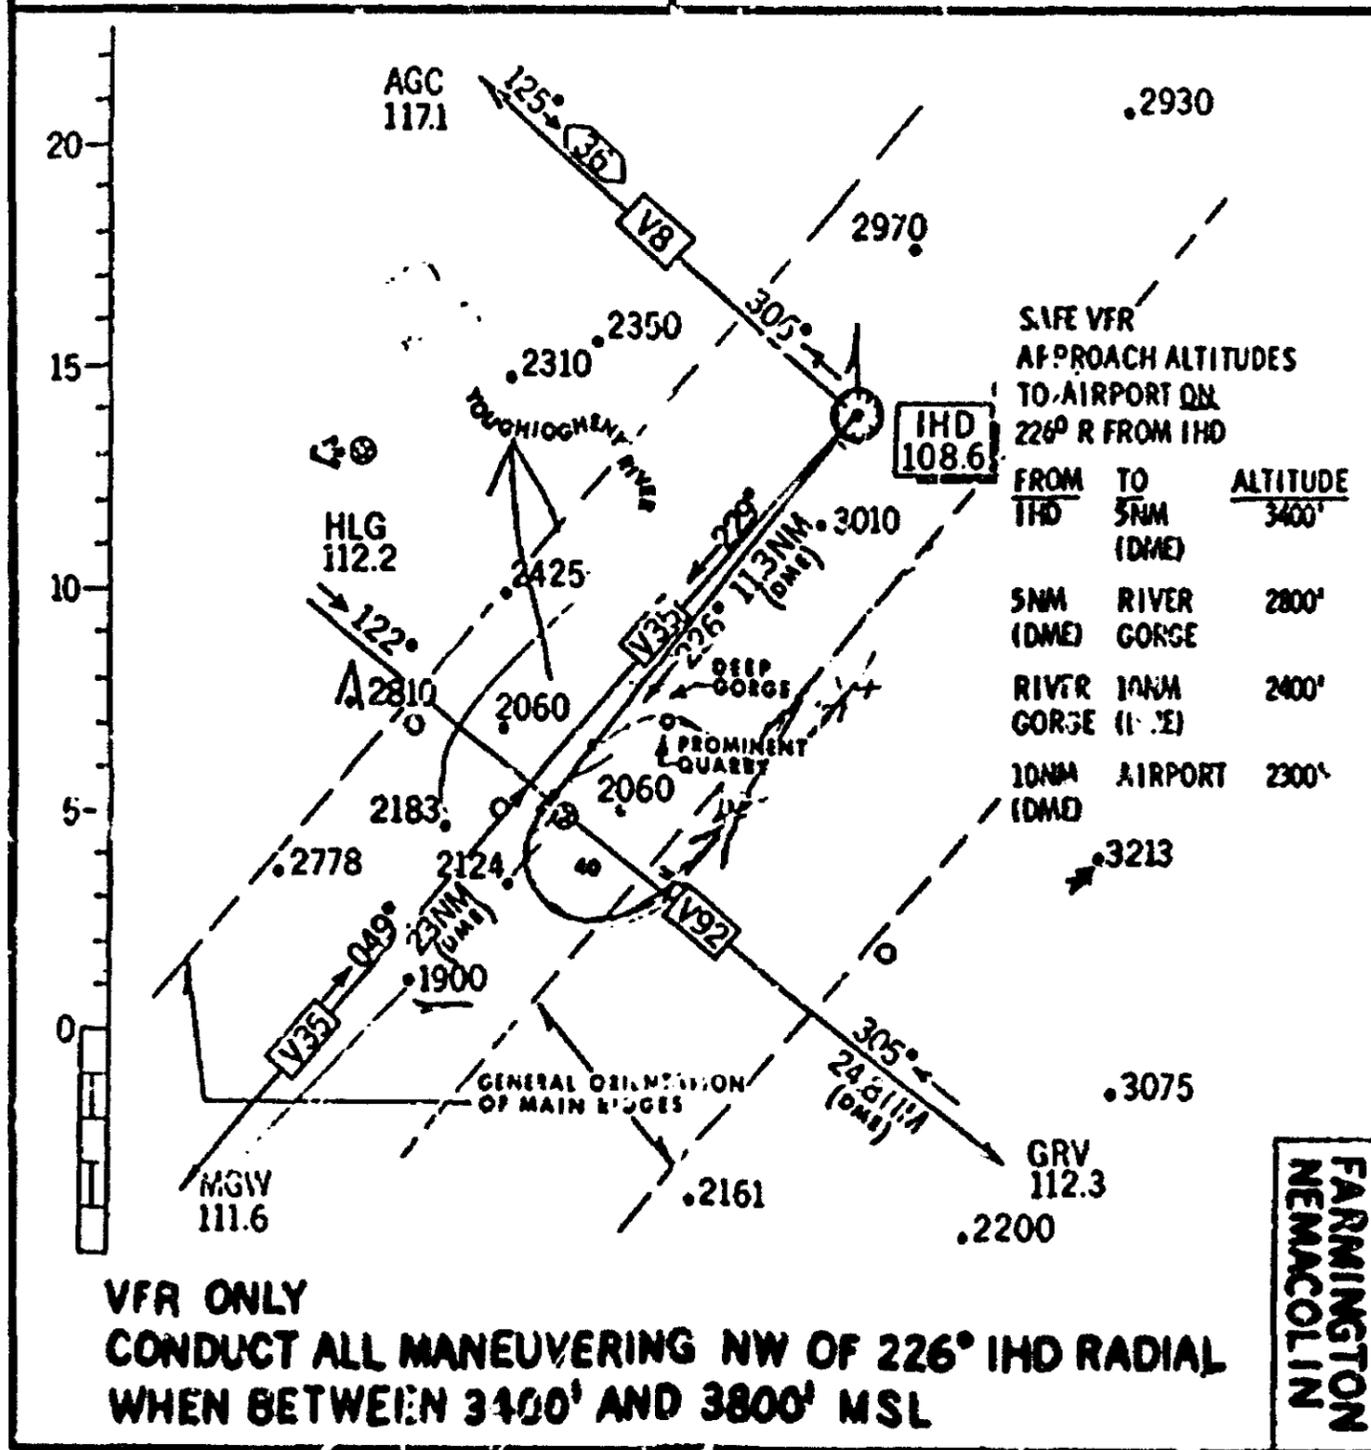
"VFR Safe Altitude Approach Plate"

During the investigation, the Safety Board obtained a copy of an unofficial and unapproved approach procedure for the Nemaquin Airport entitled, "VFR safe altitude approach plate." The Safety Board could not determine who prepared the plate, but the investigation disclosed that aviation personnel of the Campbell-Ewald Company had access to the approach plate. Another pilot for the company stated that he was reasonably sure that a copy of the approach plate was aboard N847CE when it crashed.

The approach plate is constructed, using the Indian Head VORTAC and its distance measuring equipment to establish minimum safe altitudes below 5,000 feet between the VORTAC and Nemaquin Airport. The approach plate depicts a 226° radial from the Indian Head VORTAC; the instructions on the approach plate read as follows: "Conduct all maneuvering NW of 226 IHD Radial when between 3400' and 3800' m. s. l." Additionally, the instructions state that it should be used only in visual flight conditions.

The approach plate was not authorized by the FAA; there are no authorized instrument approaches to the Nemaquin Airport. (See Appendix D.)

The unofficial VFR approach plate, which was reportedly on board the aircraft, showed the Nemaocolin Airport located on the 226° radial of the Indian Head VORTAC. The flight instruments recovered from the aircraft wreckage showed a probable final heading of about 226°. The aircraft wreckage was strewn along a path which was oriented about 230°. Also, altitudes recorded by Cleveland Center during the aircraft's descent from Indian Head VORTAC correspond closely, in time and distance, to the "safe" altitudes depicted on the VFR approach plate. The Safety Board believes that these factors indicate that the flightcrew was using the VFR approach chart for navigation.
