Aerotransportes Entre Rios S. R. L.
Canadair CL-44-6, LV-JSY, Miami, FL,
International Airport, Sep 27, 1975

1. Report No. NTSB-AAR-76-9		2. Government Accession No.		3. Recipient's Catalog No.	
4. Title and Subtitle Aircraft Accident Report - Aerotransportes Entre Rios S.R.L. Canadair CL-44-6, LV-JSY, Miami International Airport, Miami, Florida, September 27, 1975				5. Report Date March 10, 1976

AIRCRAFT ACCIDENT REPORT

AEROTRANSPORTES ENTRE RIOS S.R.L.
CANADAIR CL-44-6, LV-JSY
MIAMI INTERNATIONAL AIRPORT
MIAMI, FLORIDA
SEPTEMBER 27, 1975

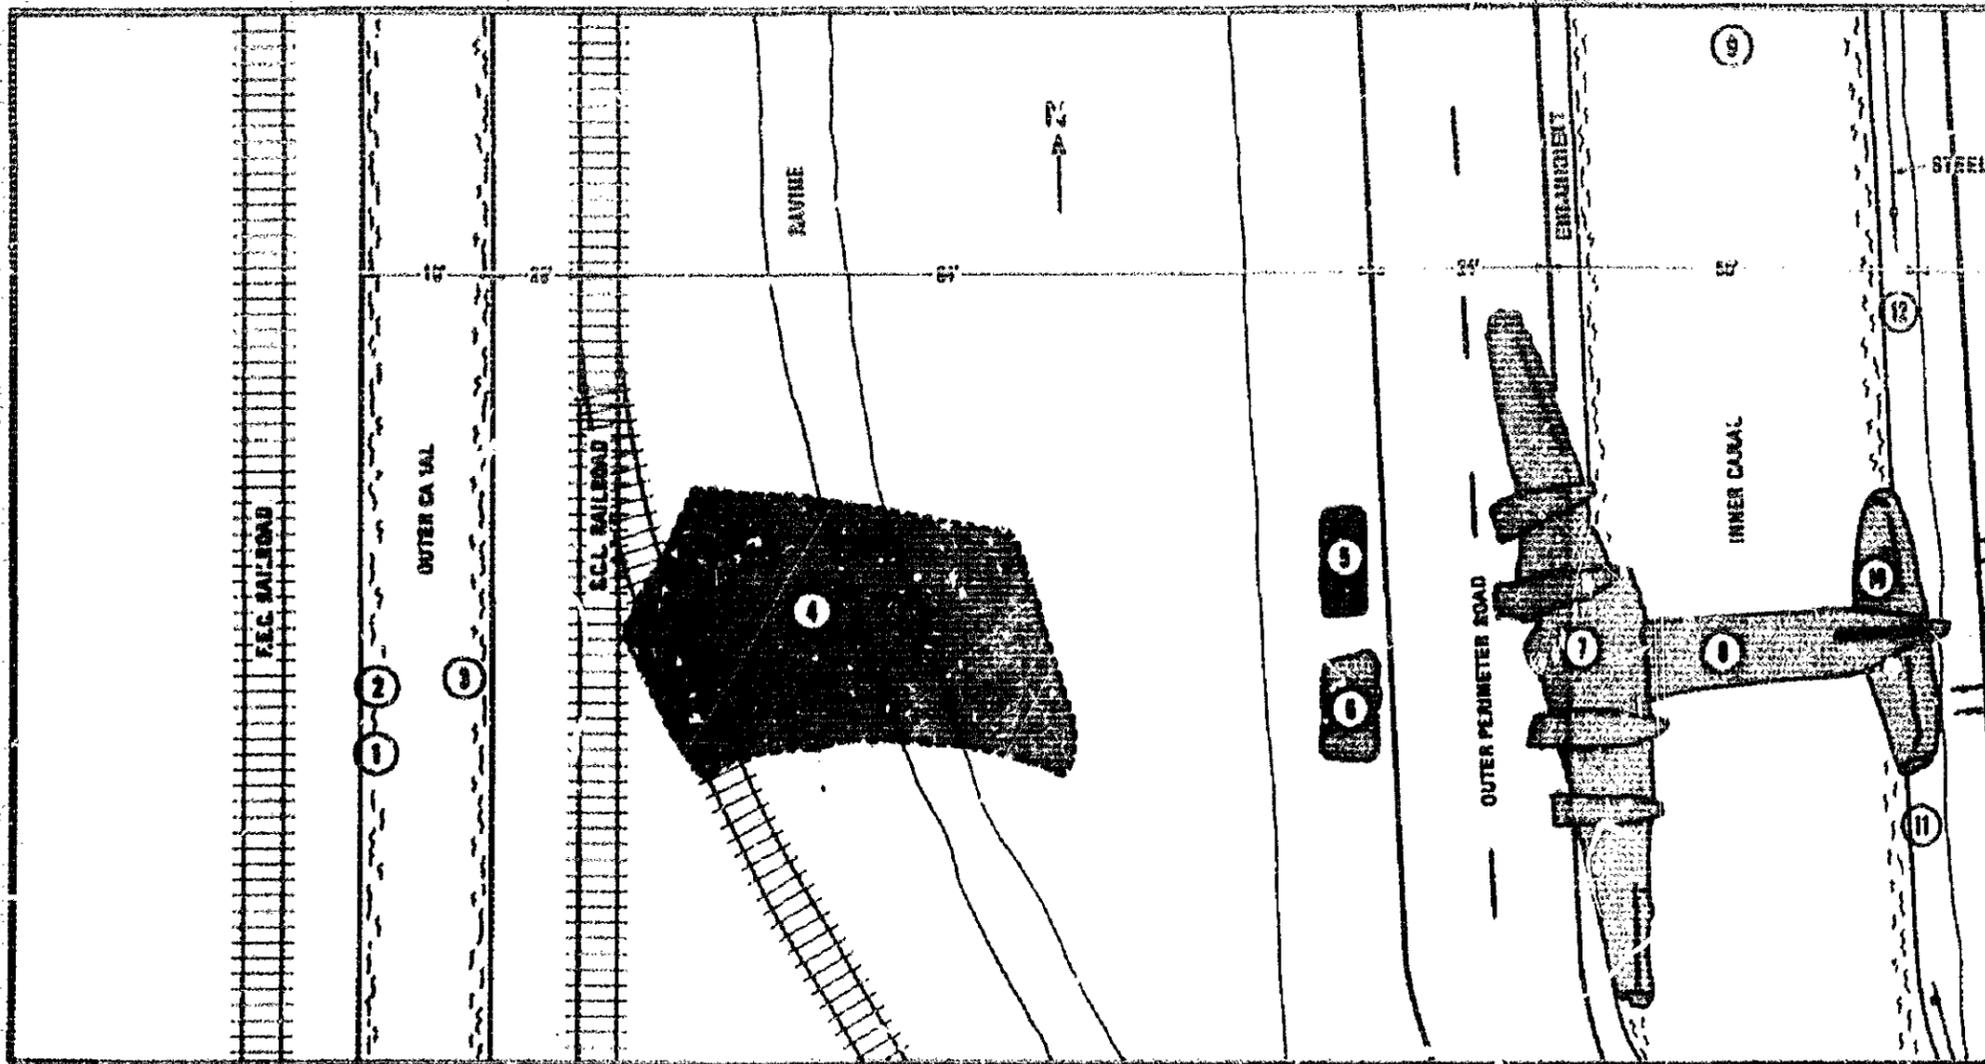
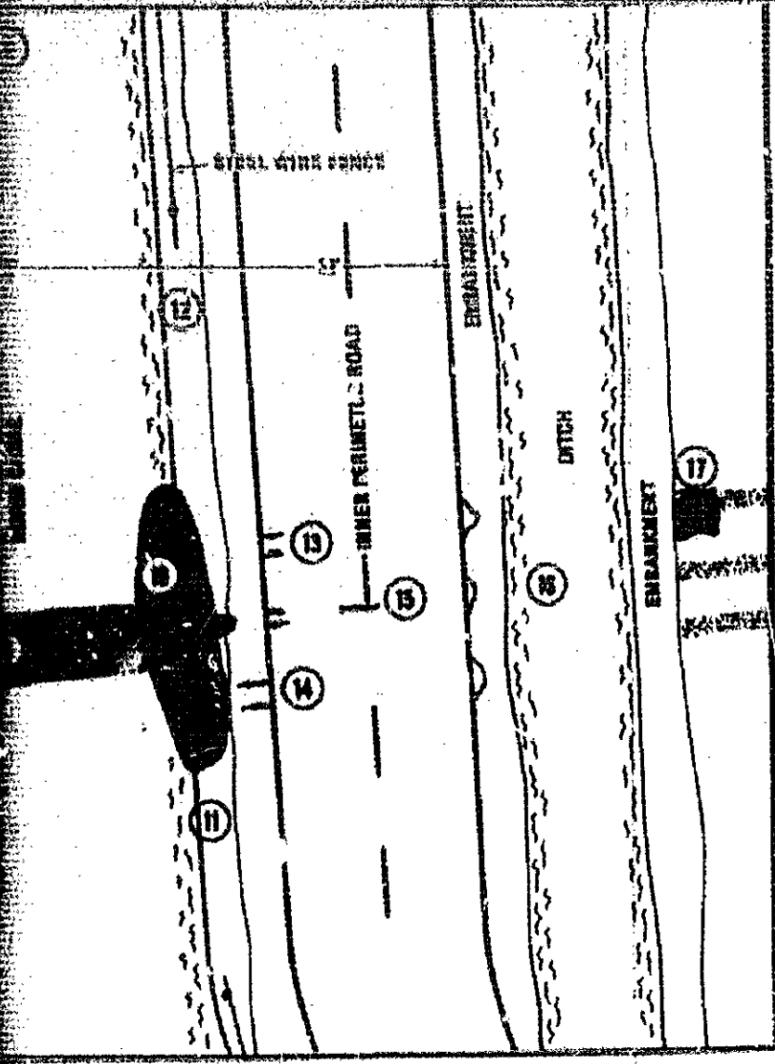
WRECKAGE DISTRIBUTION CHART
AEROTRANSPORTES ENTRE RIOS
CANADAIR CL-44-6, LV-1SY, S/N106925
MIAMI INTERNATIONAL AIRPORT
MIAMI, FLORIDA
SEPTEMBER 27, 1975
DCA 76-AZ-005

The empennage came to rest on the east bank of a canal 961 ft. from the departure end of the runway. The fuselage was across the canal and the center section, wings and engines were on its west bank. The fuselage forward of the wing, the cargo in the cabin, and the occupants were found west of the canal. (See Appendix D.)
