JAPAN AIR LINES COMPANY, LIMITED
BOEING 747-246, JA8122, ANCHORAGE, ALASKA,
DECEMBER 16, 1975

NATIONAL TRANSPORTATION SAFETY BOARD

1. Report No. NTSB-AAR-76-12	2. Government Accession No.	3. Recipient's Catalog No. NTISUB/3/104-76/012	
4. Title and Subtitle Aircraft Accident Report - Japan Air Lines, Co., Ltd. Boeing 747-246, JA8122, Anchorage, Alaska, December 16, 1975		5. Report Date March 31, 1976

AIRCRAFT ACCIDENT REPORT

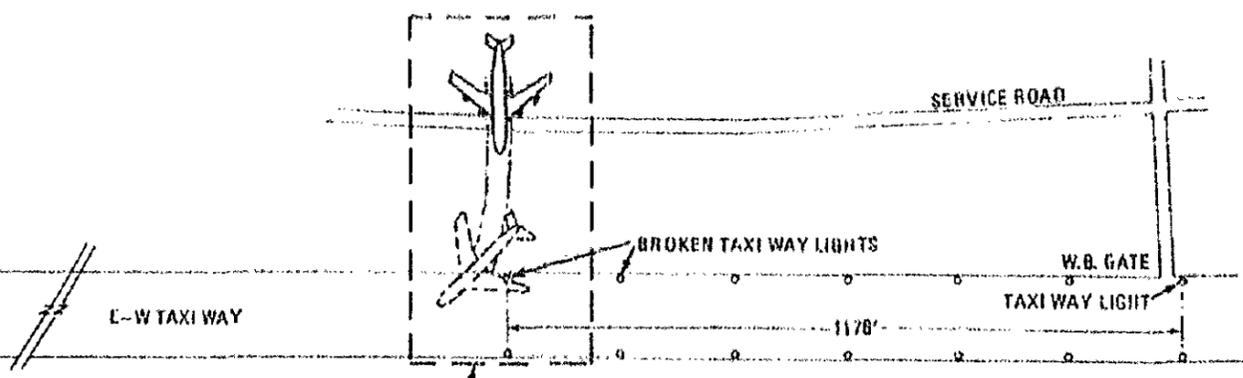
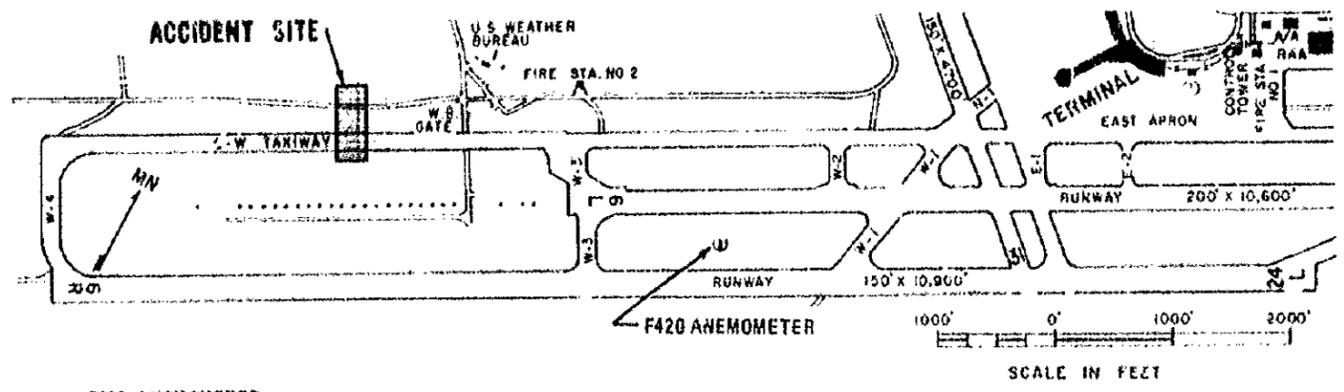
PLAN VIEW - RUNWAY 0R & E-W TAXIWAY

The aircraft then canted to the right and slowly changed its heading (counterclockwise) to about 70° to the taxiway, slid backward down the embankment, and came to rest 90° to the taxiway. The statements by the first officer and flight engineer essentially confirm the captain's account of the accident.

9. The terrain adjacent to the taxiway area where the accident occurred has an incline of about -13° .
10. The captain was aware of the slippery conditions when he began his taxi out, and he was warned about slipperiness while taxiing.

ACCIDENT SITE (SEE DRAWINGS 'A' & 'B')
