AIRCRAFT ACCIDENT REPORT

PUERTO RICO INTERNATIONAL AIRLINES, INCORPORATED
DEHAVILLAND DH-114, N570PR, SAN JUAN, PUERTO RICO,
JULY 11, 1975

NATIONAL TRANSPORTATION SAFETY BOARD

14 APRIL 1976

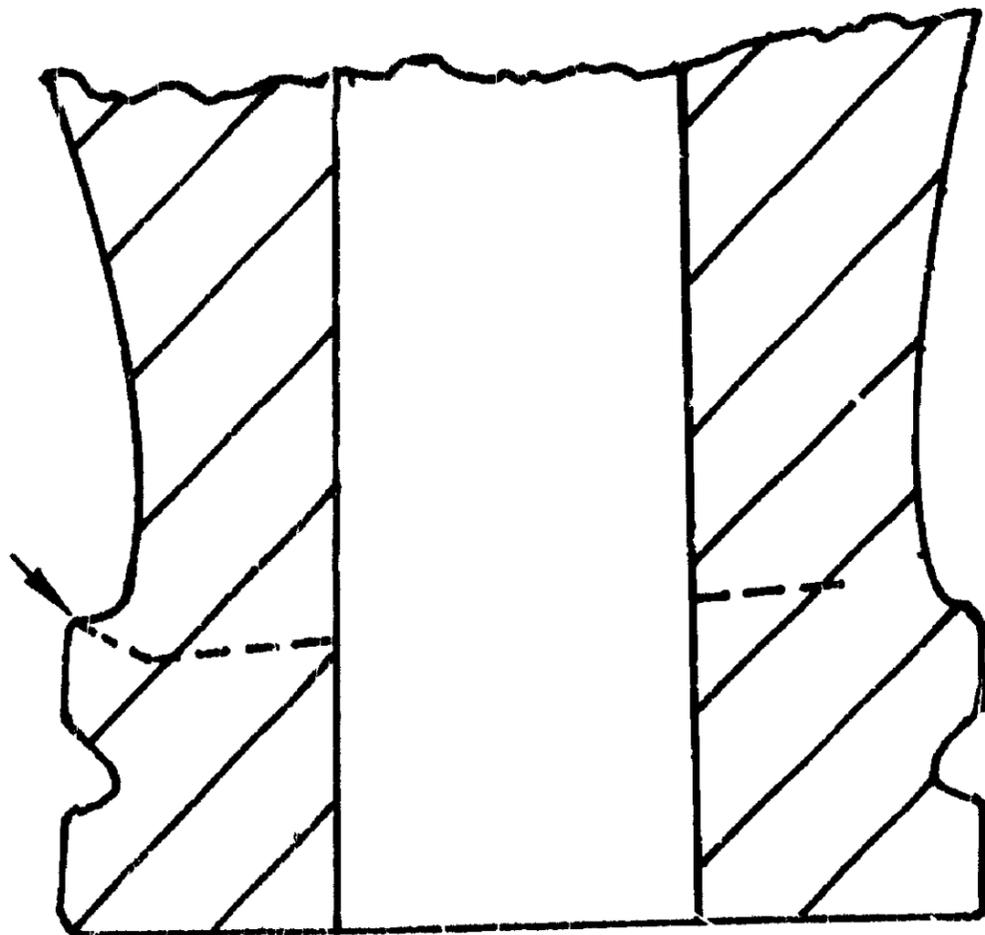
Figure 3. Sketch to illustrate the approximate location of the primary fatigue crack which is indicated by the dashed line. The arrow denotes the approximate origin site.
