CONTINENTAL AIR LINES, INCORPORATED,
BOEING 727-224, N88777, STAPLETON INTERNATIONAL
AIRPORT, DENVER, COLORADO, AUGUST 7, 1975
AIRCRAFT ACCIDENT REPORT

NATIONAL TRANSPORTATION SAFETY BOARD

5 MAY 1976

1. Report No. NTSB-AAR-76-14		2. Government Accession No.		3. Recipient's Catalog No.	
4. Title and Subtitle Aircraft Accident Report - Continental Air Lines, Inc., Boeing 727-224, N88777, Stapleton International Airport, Denver, Colorado, August 7, 1975				5. Report Date May 5, 1976

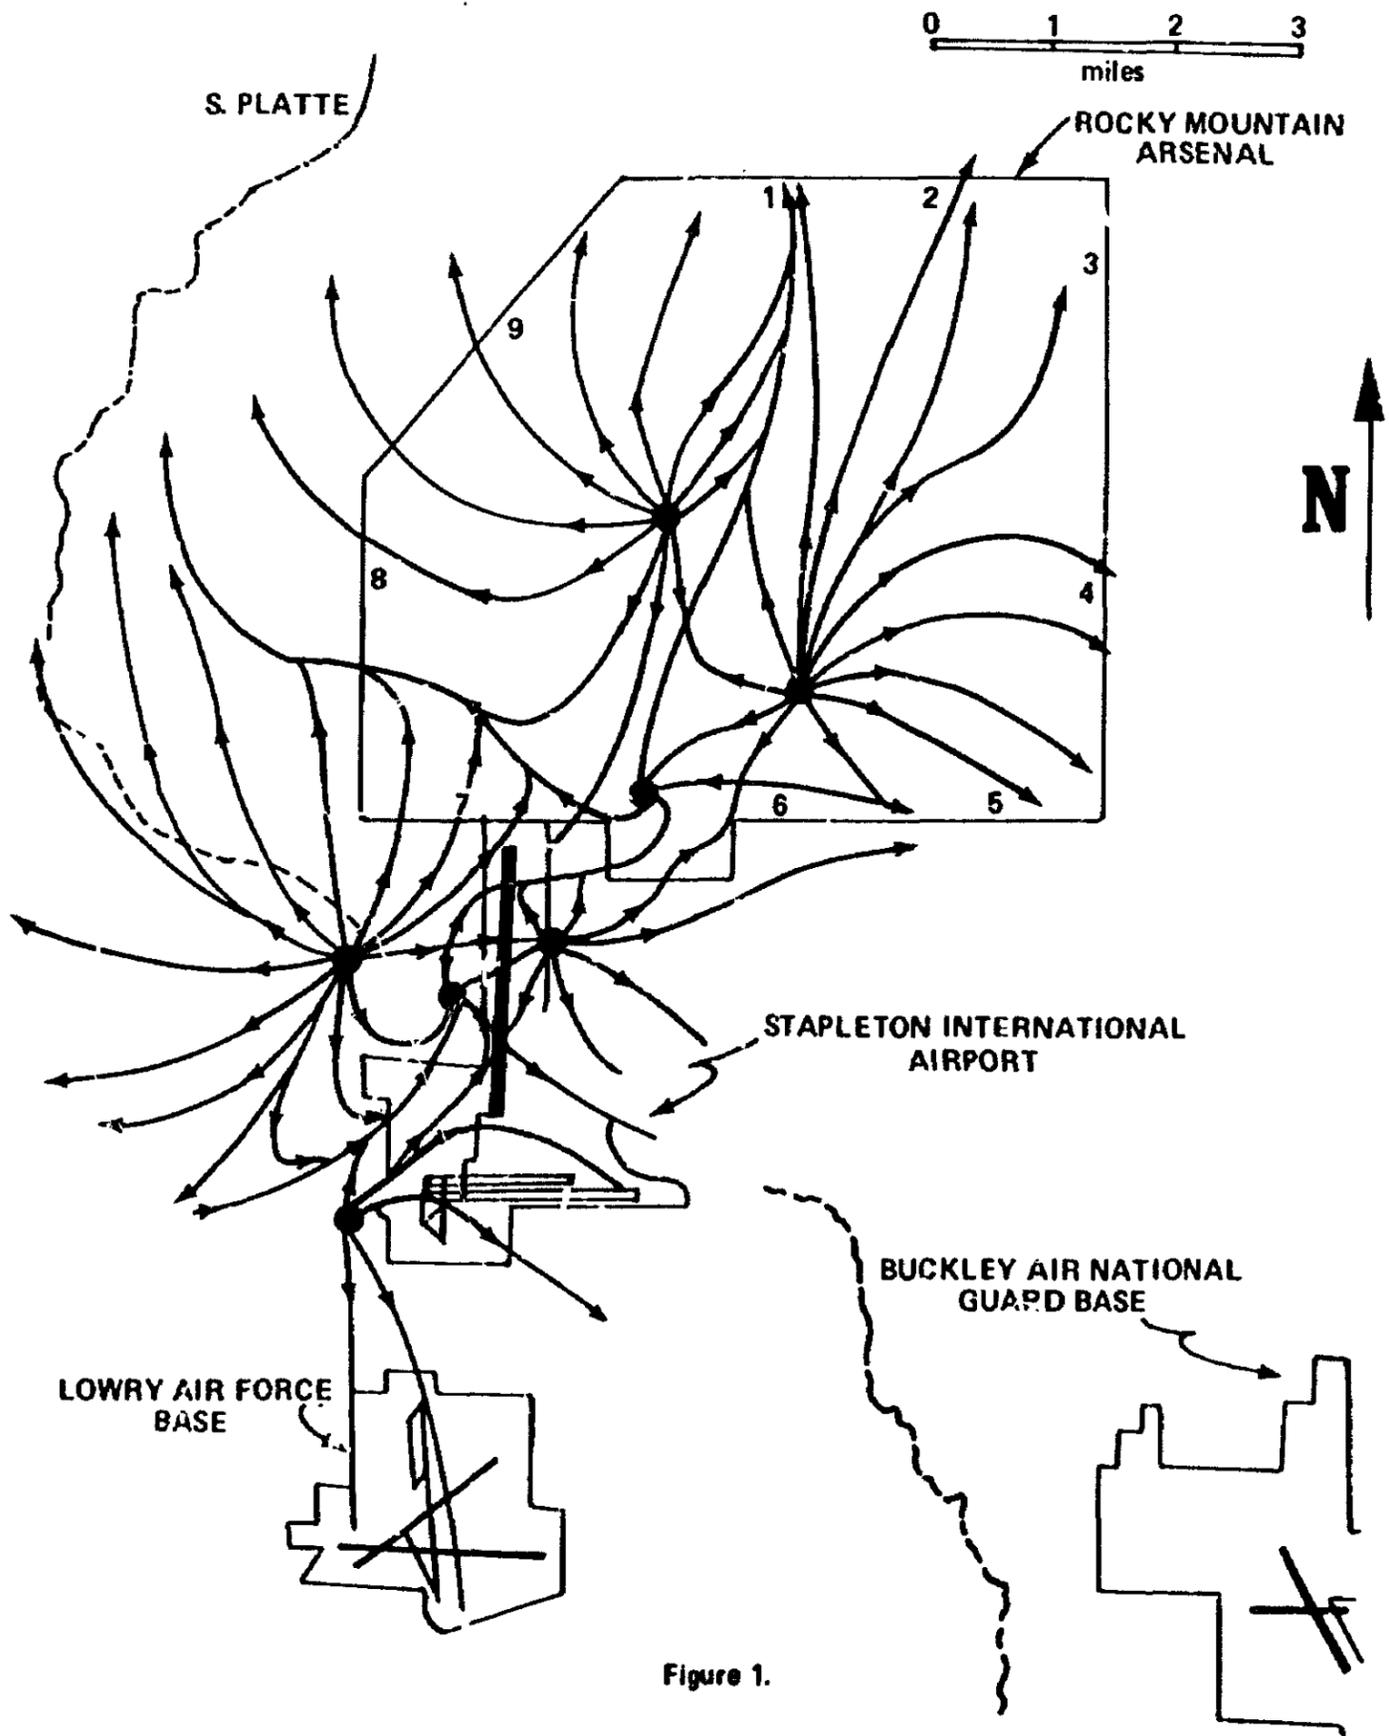
Figure 1.

Streamlines drawn from time-space conversion/isogon analysis superimposed on runway 35L at Stapleton Airport showing the probable runway and surface wind relationship at 1605:30 m.d.t.

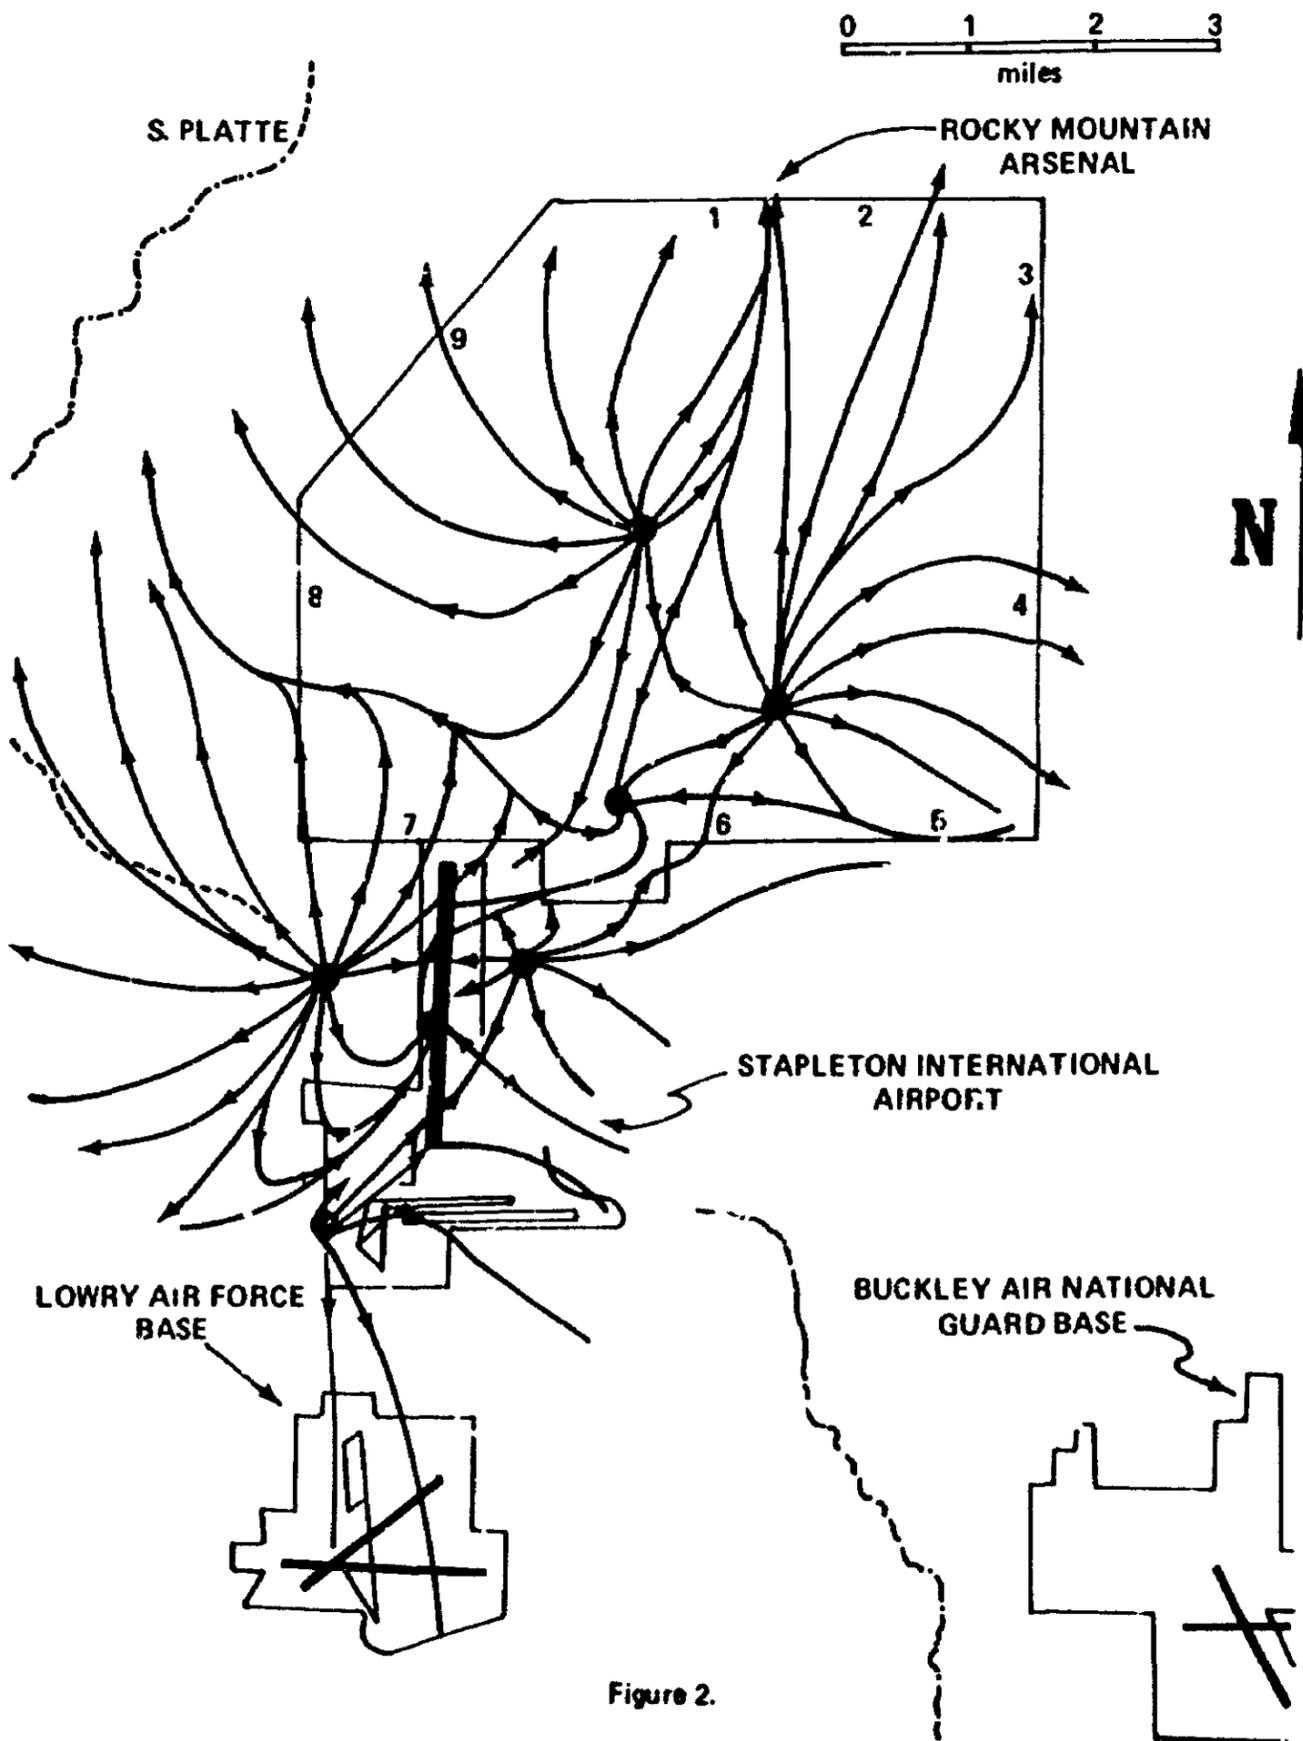
Figure 2.

Streamlines drawn from time-space conversion/isogon analysis superimposed on runway 35L at Stapleton Airport showing the probable runway and surface wind relationship at 1607 m.d.t.

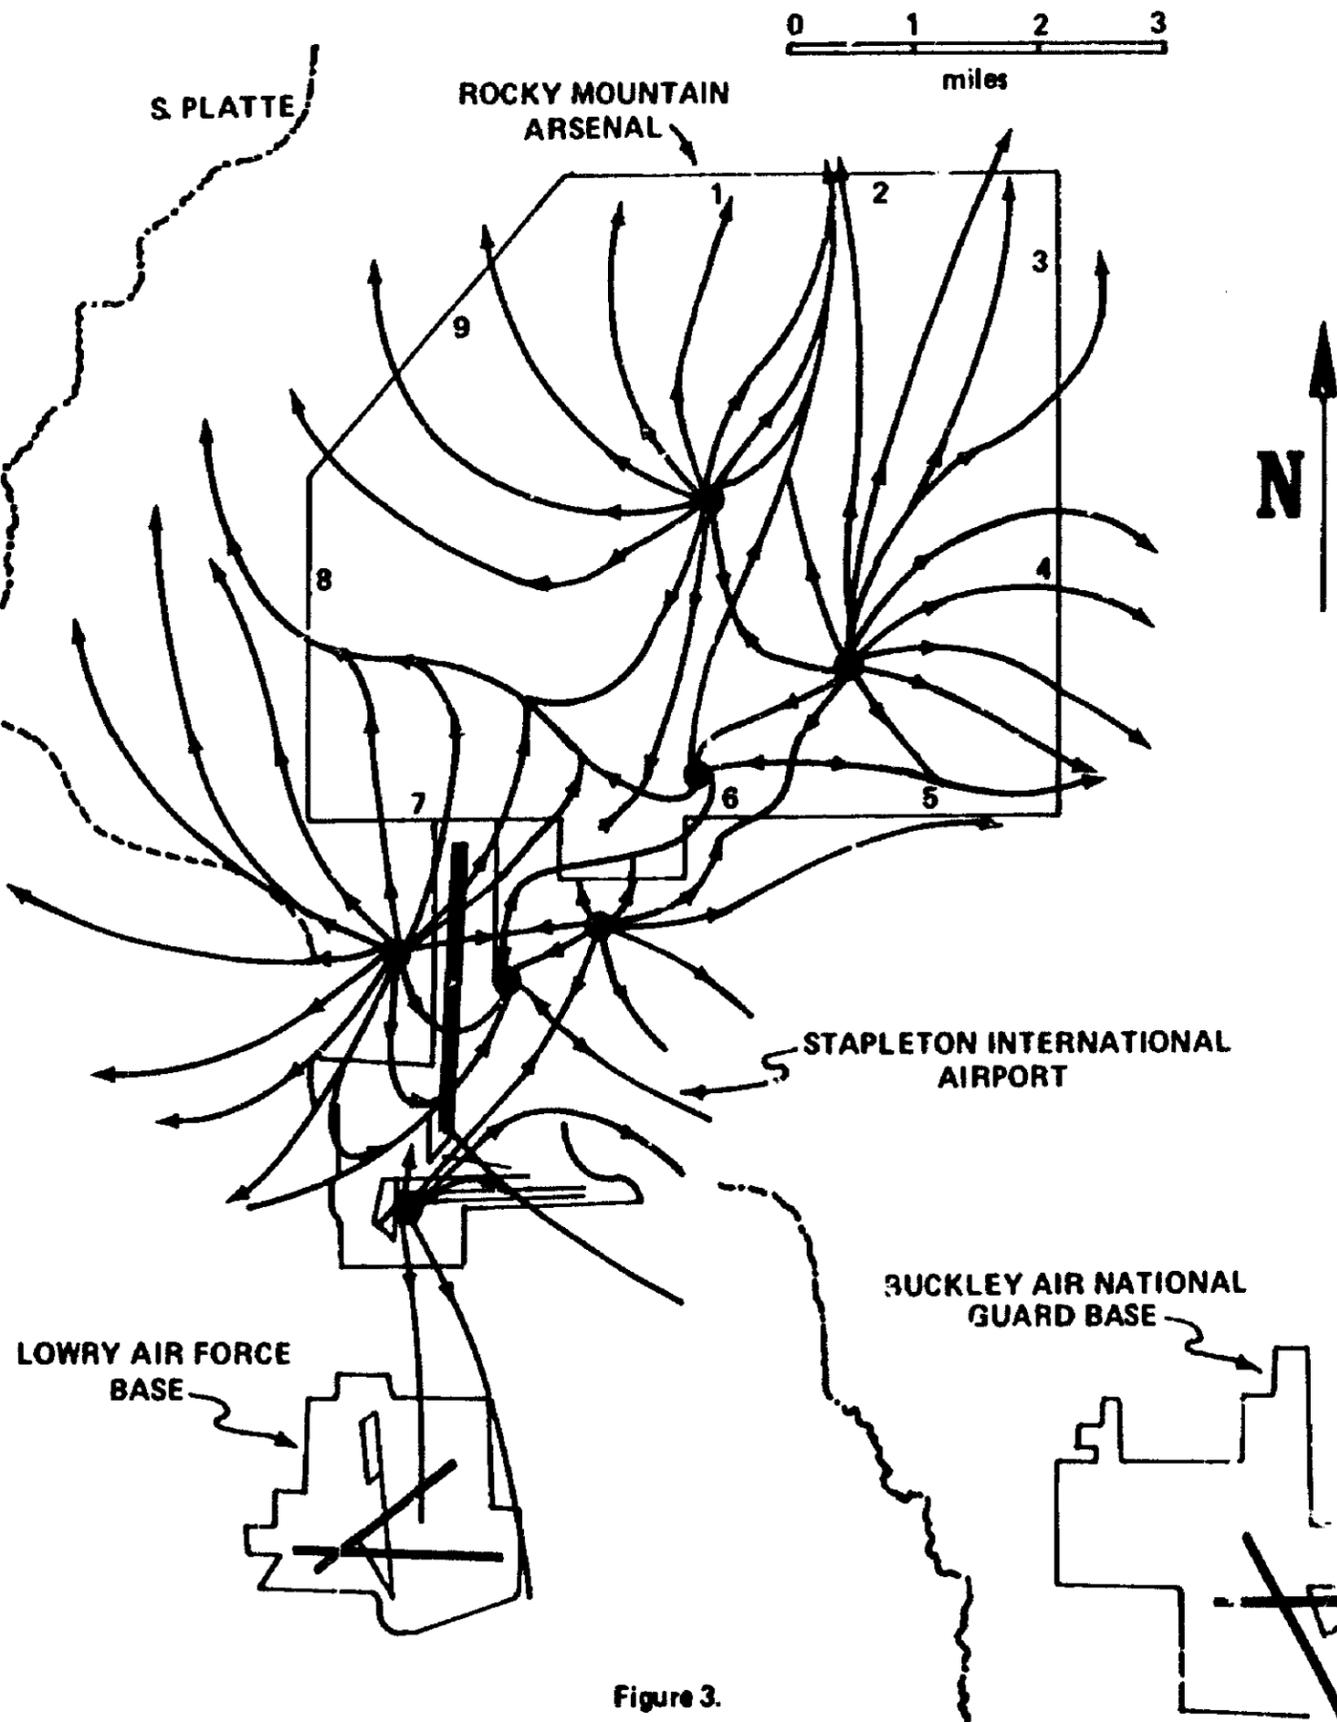
Figure 3.

Streamlines drawn from time-space conversion/isogon analysis superimposed on runway 35L at Stapleton Airport showing the probable runway and surface wind relationship at 1610 m.d.t.

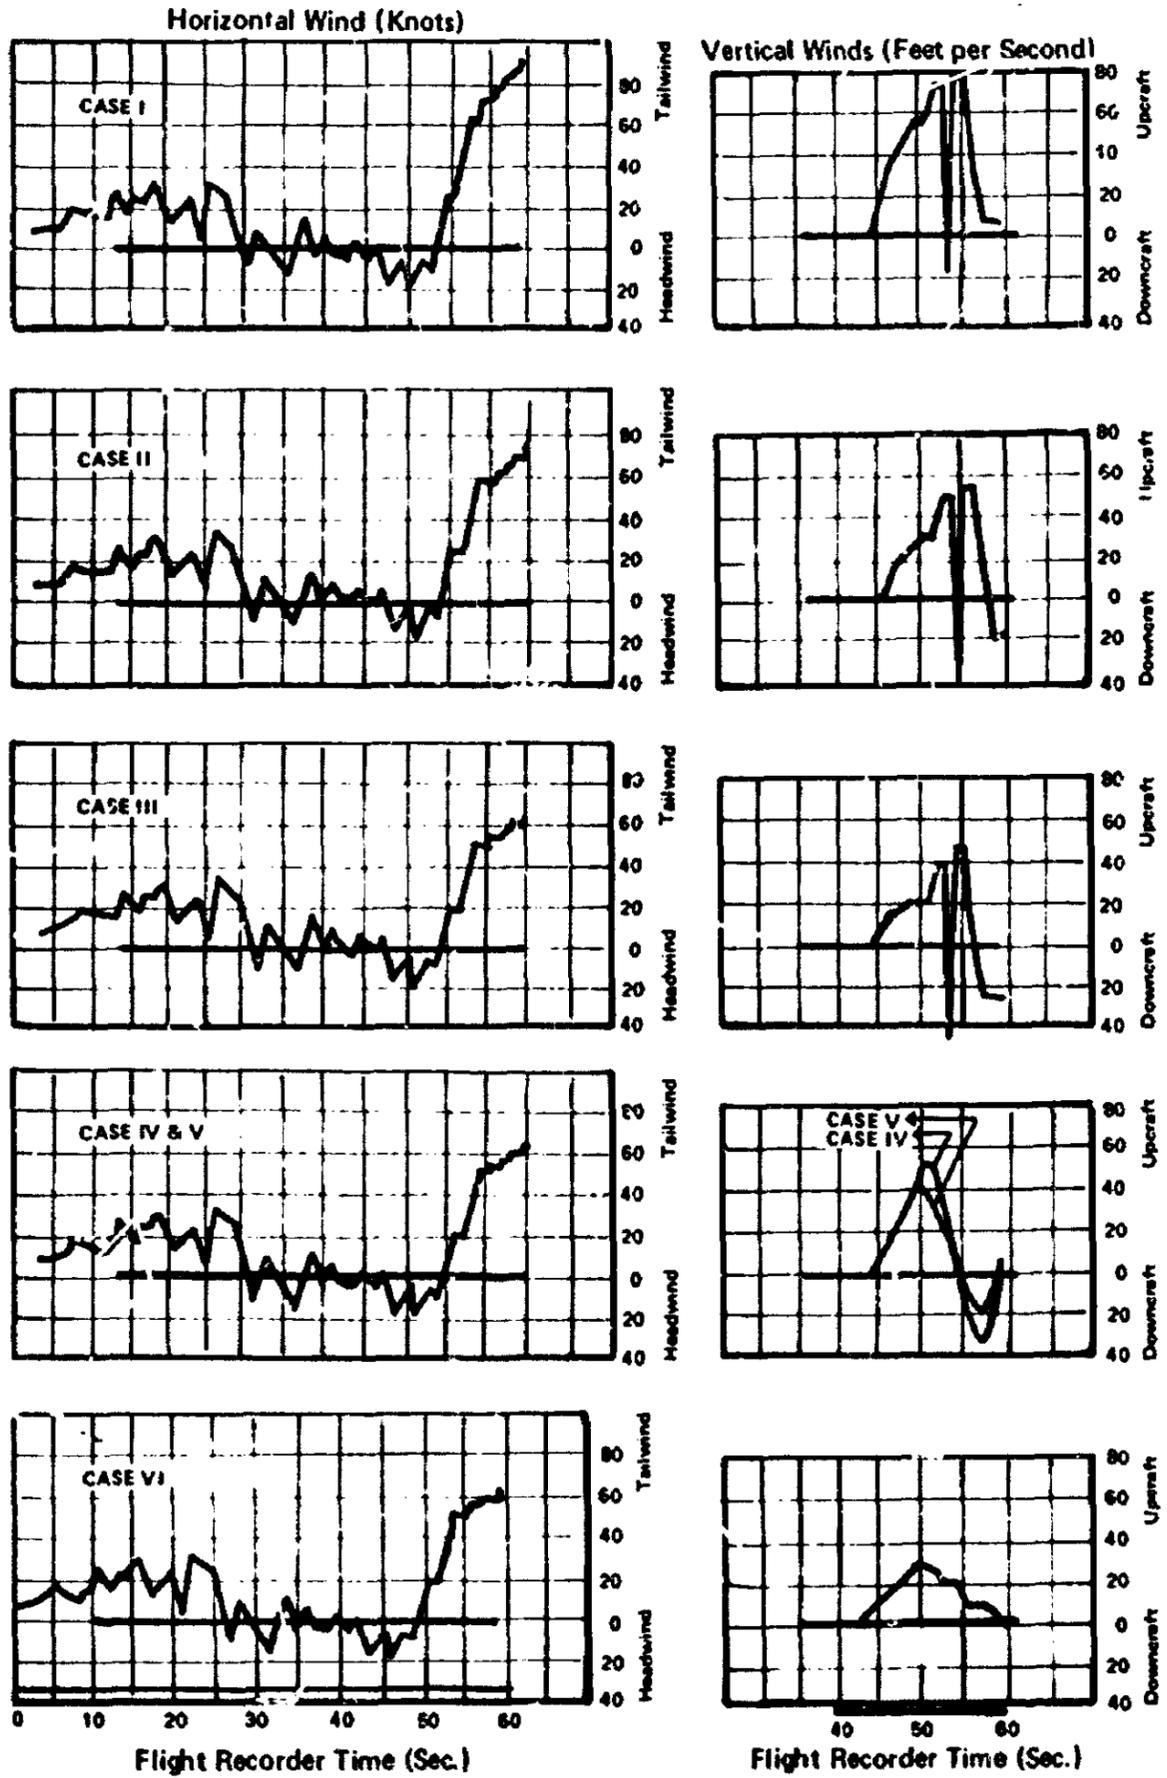
Figure 4.

HORIZONTAL AND VERTICAL WINDS DERIVED FROM AIRCRAFT PERFORMANCE ANALYSIS
