NEAR MIDAIR COLLISION, HUGHES AIRWEST,
DOUGLAS DC-9, N9333 AND NORTHWEST AIRLINES,
INC., DOUGLAS DC-10, N148US, SPOKANE
INTERNATIONAL AIRPORT, SPOKANE, WASHINGTON,
APRIL 1, 1976

NATIONAL TRANSPORTATION SAFETY BOARD,
WASHINGTON, D.C.

18 AUGUST 1976

1. Report No. NTSB-AAR-76-18		2. Government Accession No.		3. Recipient's Catalog No.	
4. Title and Subtitle Aircraft Incident Report -- Near Midair Collision, Hughes Airwest, Douglas DC-9, N9333, and Northwest Airlines, Inc., Douglas DC-10, N148US, Spokane, Washington, April 1, 1976		5. Report Date August 18, 1976		6. Performing Organization Code

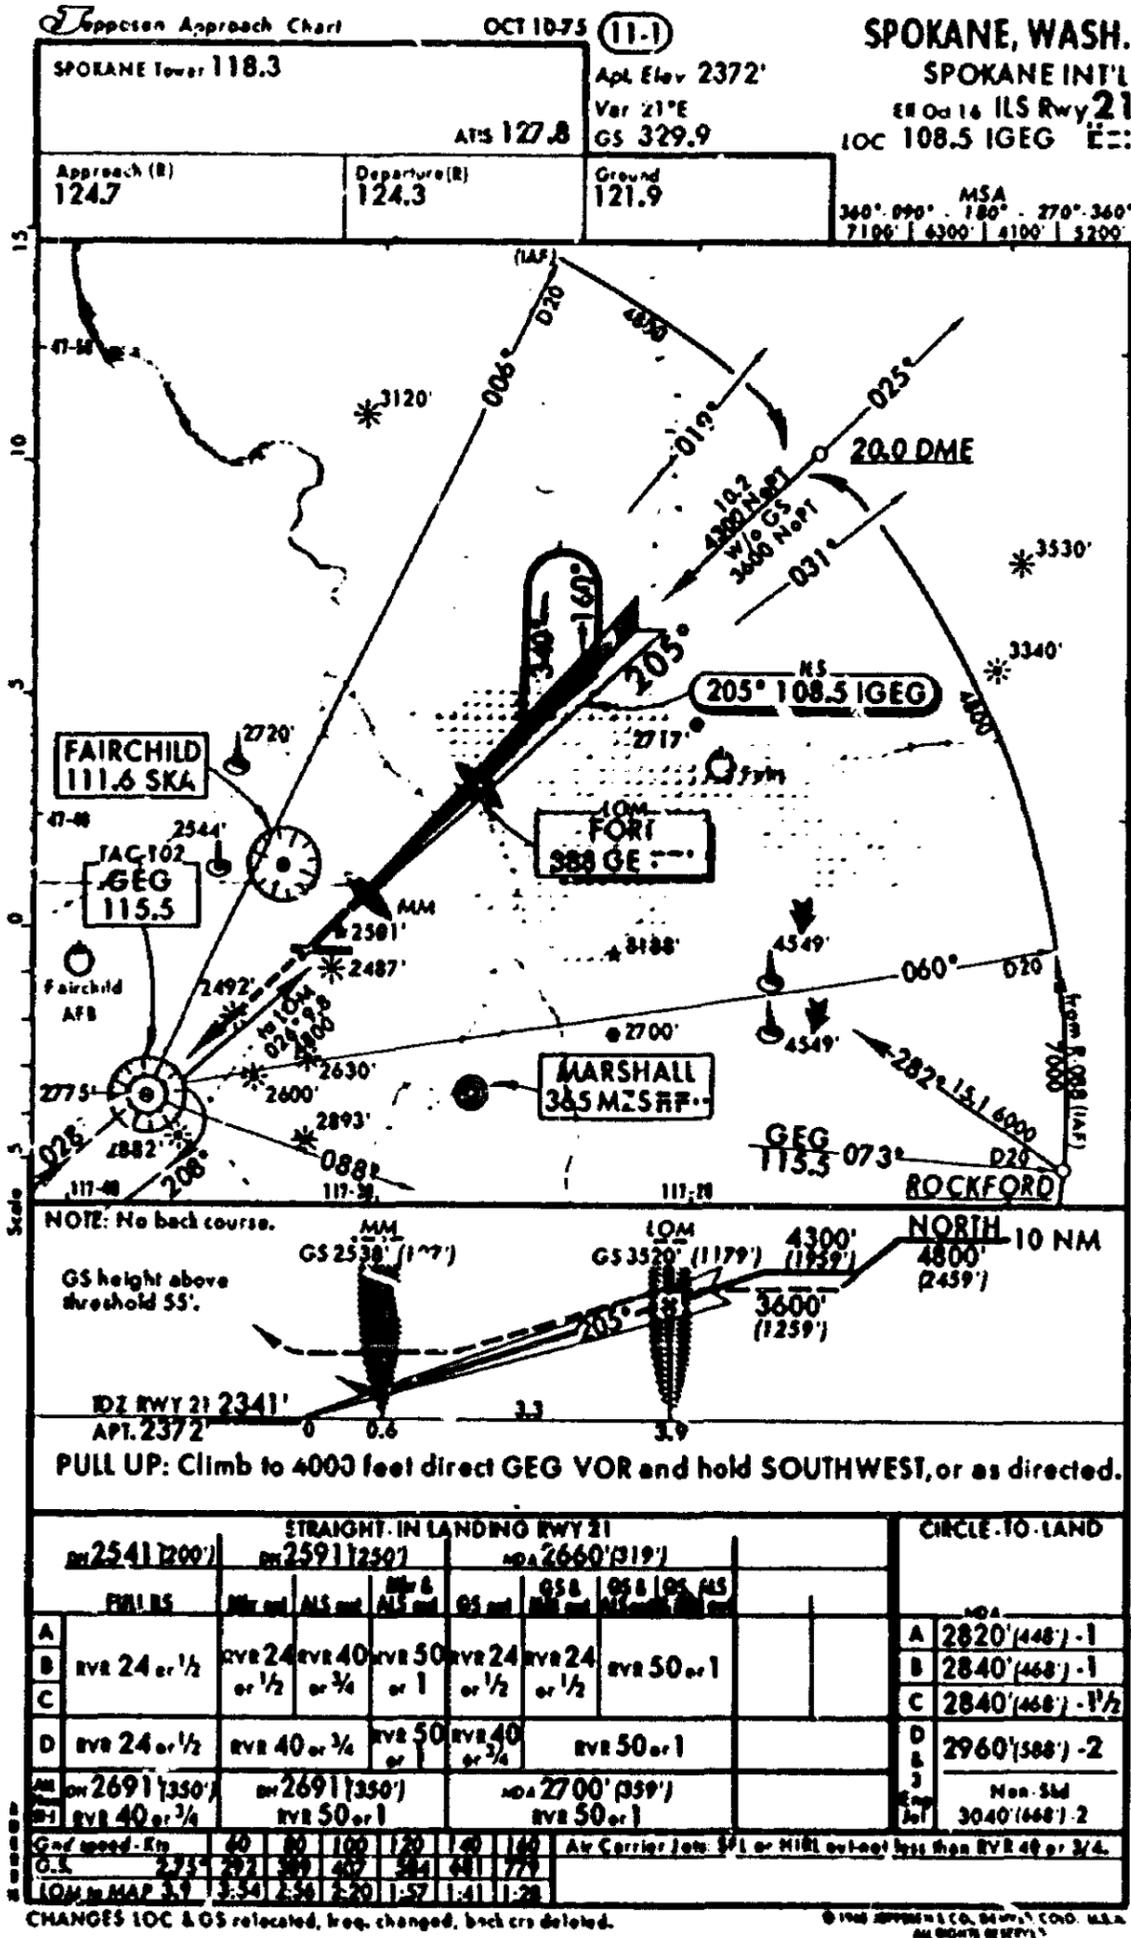
APPENDIX C

The OM (and final approach fix) for the ILS approach to runway 21 at Spokane Airport is located 3.9 miles from the threshold on a magnetic bearing of 025° (inbound localizer course is 205°) from the localizer transmitter. (See Appendix C.)
