Aircraft Accident Report. Midair Collision. Reeds
Aviation, Inc., Piper PA-28R-200, N7941C, and Piper
PA-28-181, N8592C, Near Huntsville, Mo-July 24, 1976

1. Report No. NTSB-AAR-77-2	2. Government Accession No.	3. Recipient's Catalog No.
4. Title and Subtitle Aircraft Accident Report - Midair Collision, Reeds Aviation, Inc., Piper PA-28R-200, N7941C and Piper PA-28-181, N8592C, near Huntsville, Missouri, July 24, 1976		5. Report Date April 14, 1977

MIDAIR COLLISION
REEDS AVIATION, INC., PIPER PA-28R-200, N7941C
AND
PIPER PA-28-181, N8592C
NEAR HUNTSVILLE, MISSOURI
JULY 24, 1976

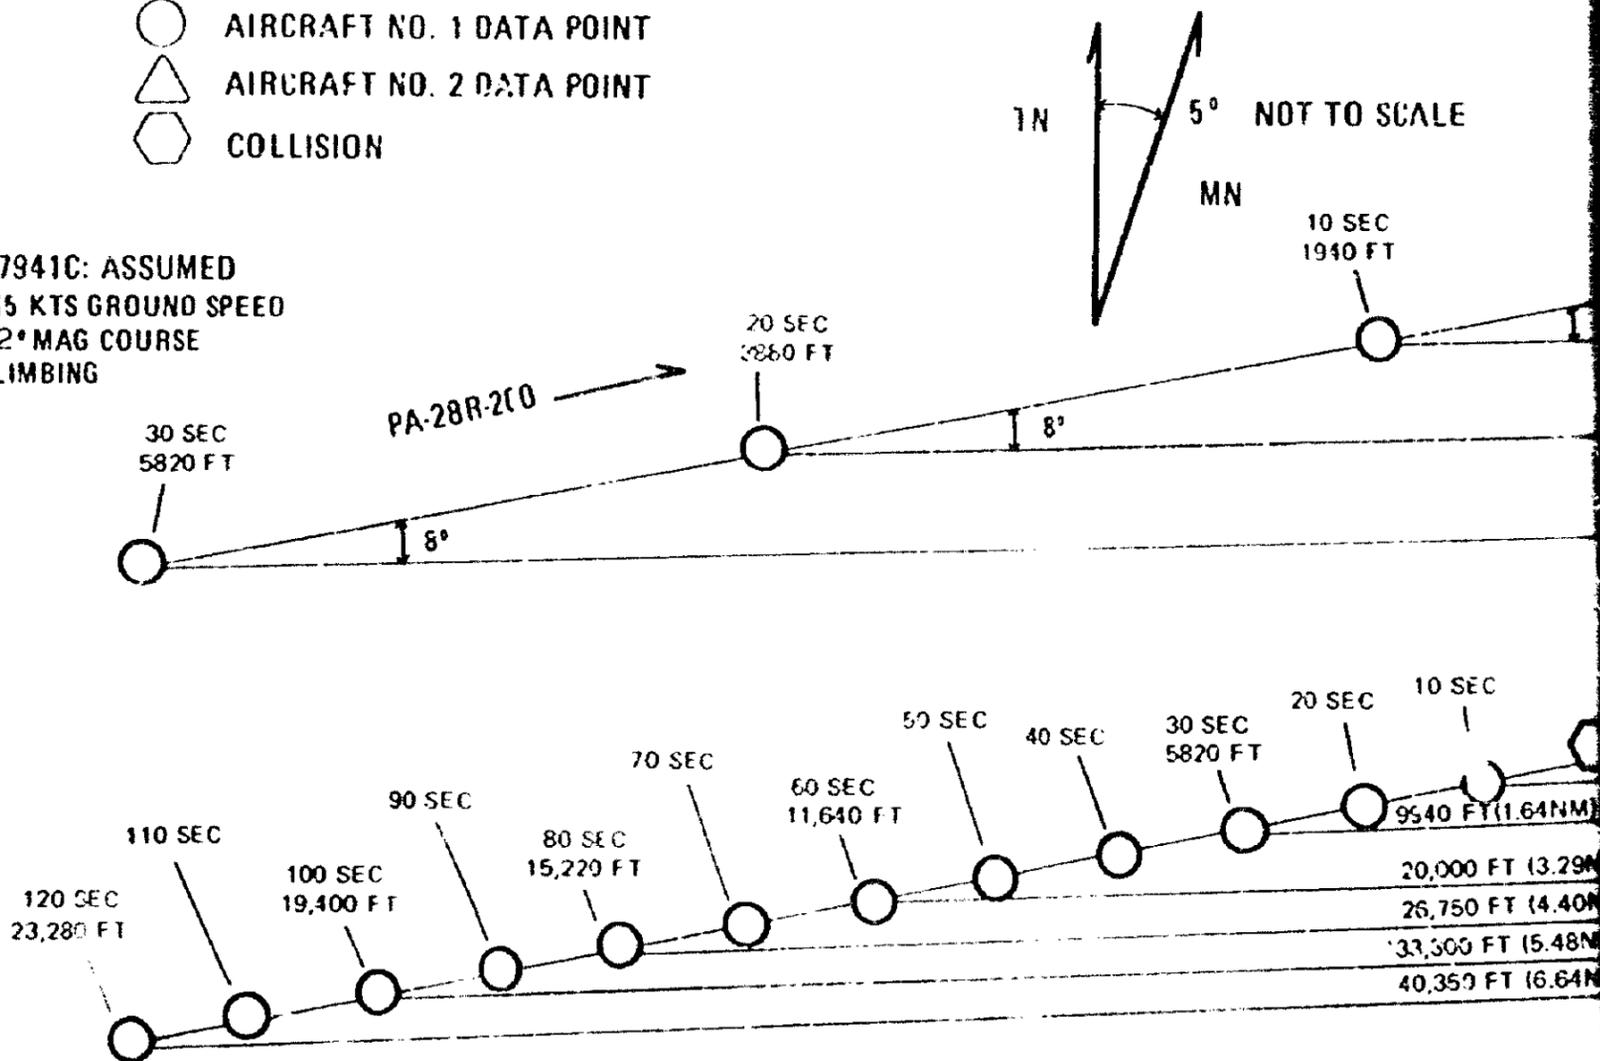
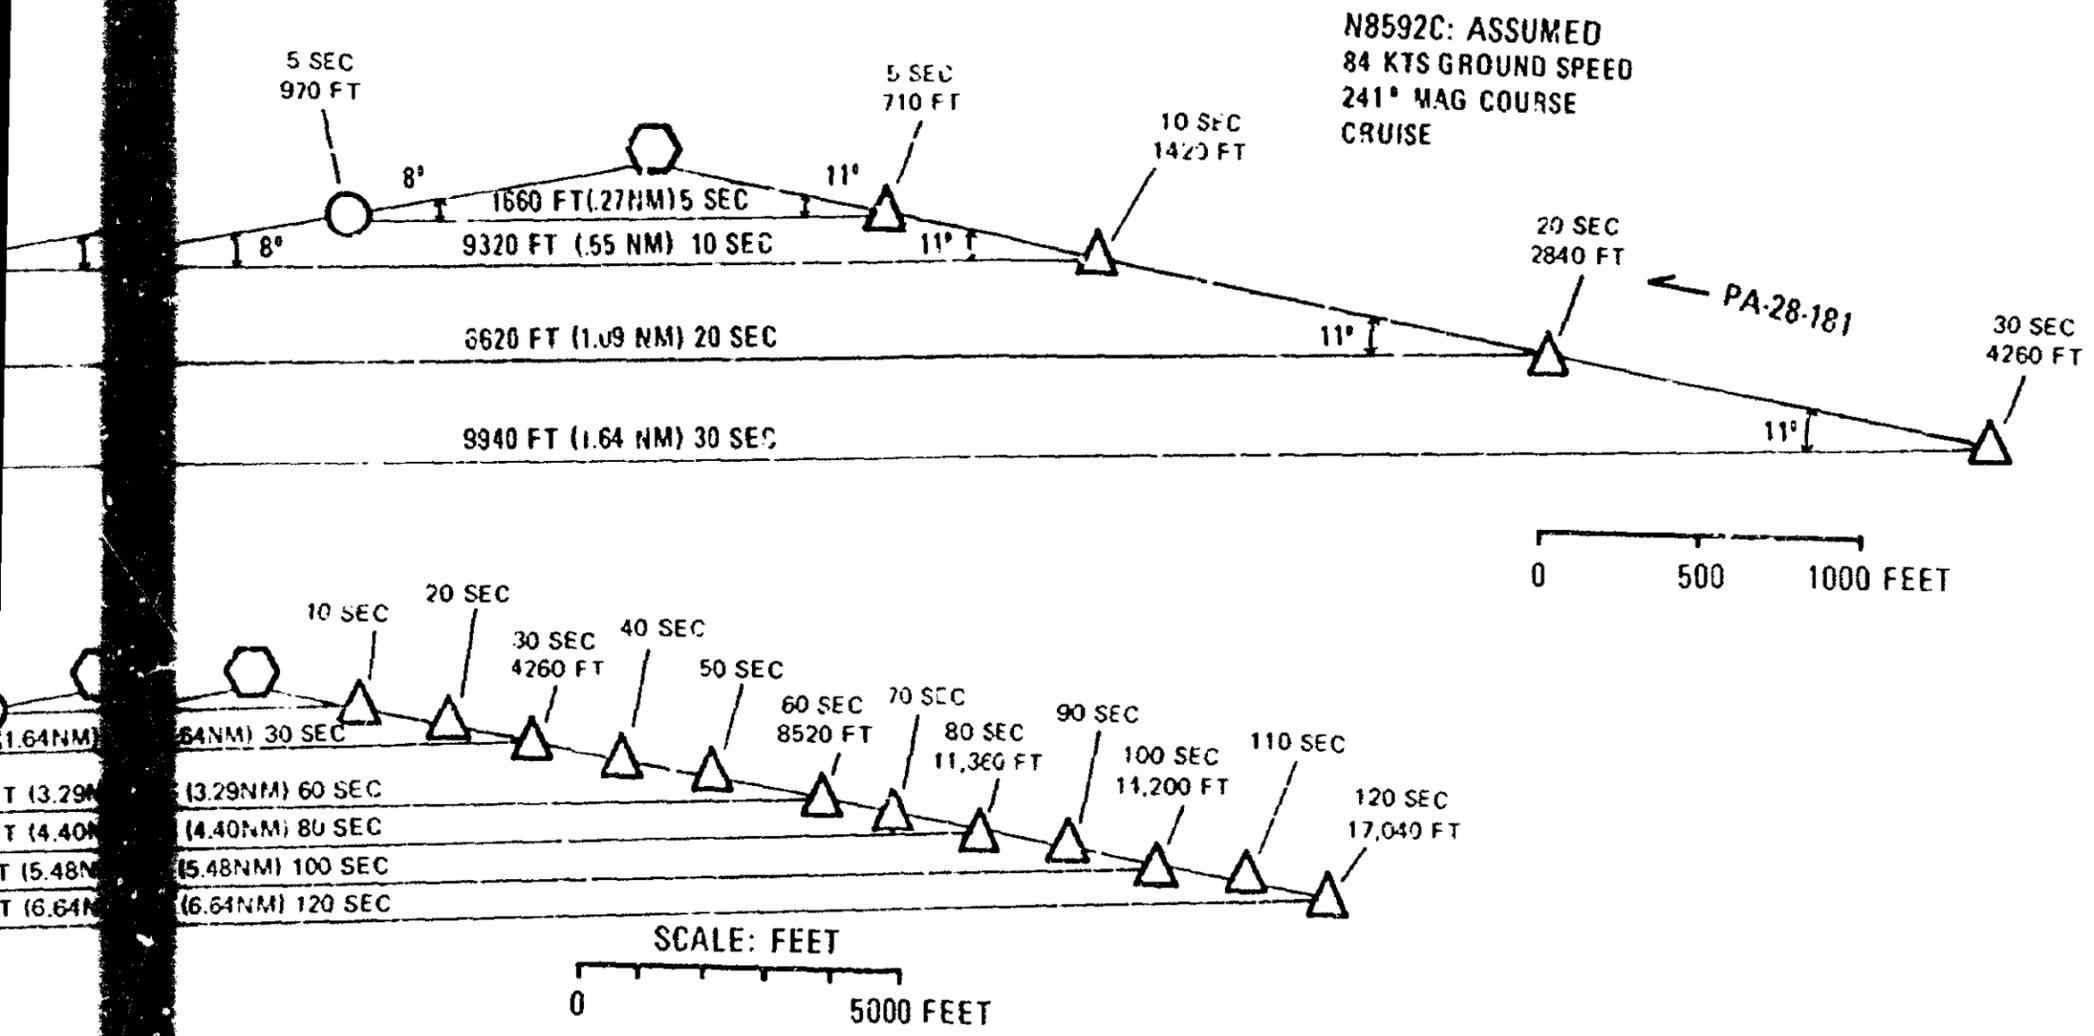
N7941C: ASSUMED
115 KTS GROUND SPEED
42° MAG COURSE
CLIMBING

CALCULATED RATE OF CLOSURE WAS 196 KNOTS
THIS CHART IS BASED UPON ASSUMED HEADINGS,
SPEEDS AND ALTITUDES FOR BOTH AIRCRAFT.
THE PROBABLE COLLISION GEOMETRY AS SHOWN
IS INTENDED TO ILLUSTRATE ONLY THE RELATIVE
PATHS OF BOTH AIRCRAFT AND NOT INTENDED TO
ILLUSTRATE ABSOLUTE DATA FOR EITHER AIRCRAFT.

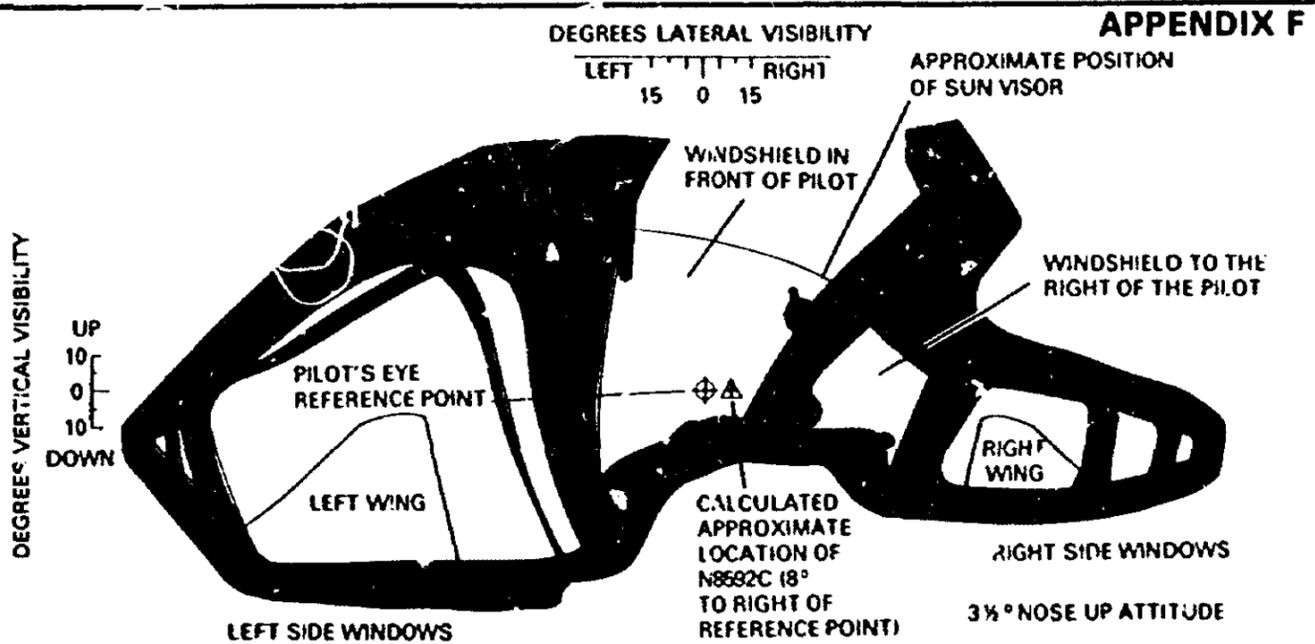
14. Regardless of the deficient distant vision of the pilot of N8592C, he should have been able to detect N7941C in time to avoid the collision.
15. Neither pilot's outside view would have been masked by cockpit structures in the vicinity of the other aircraft's target.

VISIBILITY FROM PA-28R-200 PILOT'S SEAT REPRESENTS POSSIBLE VISIBILITY FROM N7941C

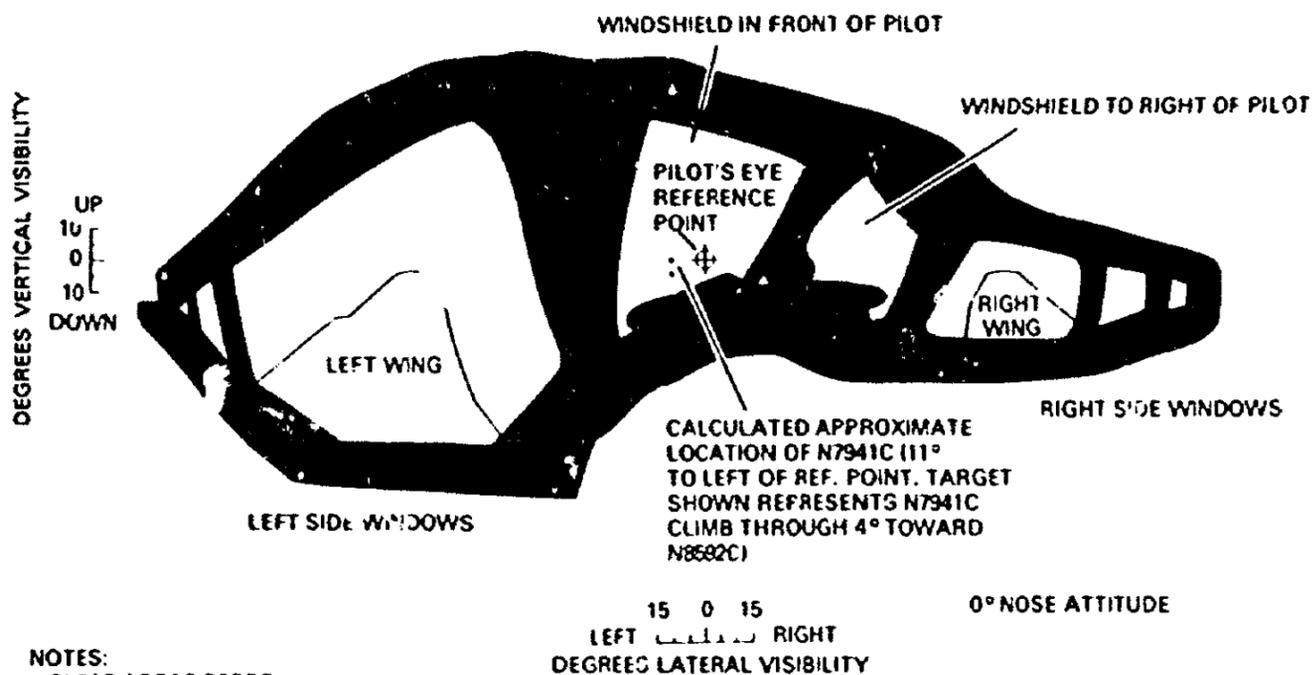
VISIBILITY FROM PA-28-181 PILOT'S SEAT REPRESENTS POSSIBLE VISIBILITY FROM N8592C
