Aircraft Accident Report - Ruel Insurance Corporation  
Cessna 414, N8PR, and U.S. Air Force F-4E, 67-0255,  
Near Brighton, Florida, September 13, 1976

National Transportation Safety Board, Washington, D.C.

1. Report No. NTSB-AAK-77-5	2. Government Accession No.	3. Recipient's Catalog No.	
4. Title and Subtitle Aircraft Accident Report - Ruel Insurance Corporation Cessna 414, N8PR, and U.S. Air Force F-4E, 67-0255, Near Brighton, Florida September 13, 1976		5. Report Date September 16, 1977

RUEL INSURANCE CORPORATION  
CESSNA 414, N8PR,  
and  
U.S. AIR FORCE  
F-4E, 67-0255,  
NEAR BRIGHTON, FLORIDA  
SEPTEMBER 13, 1976

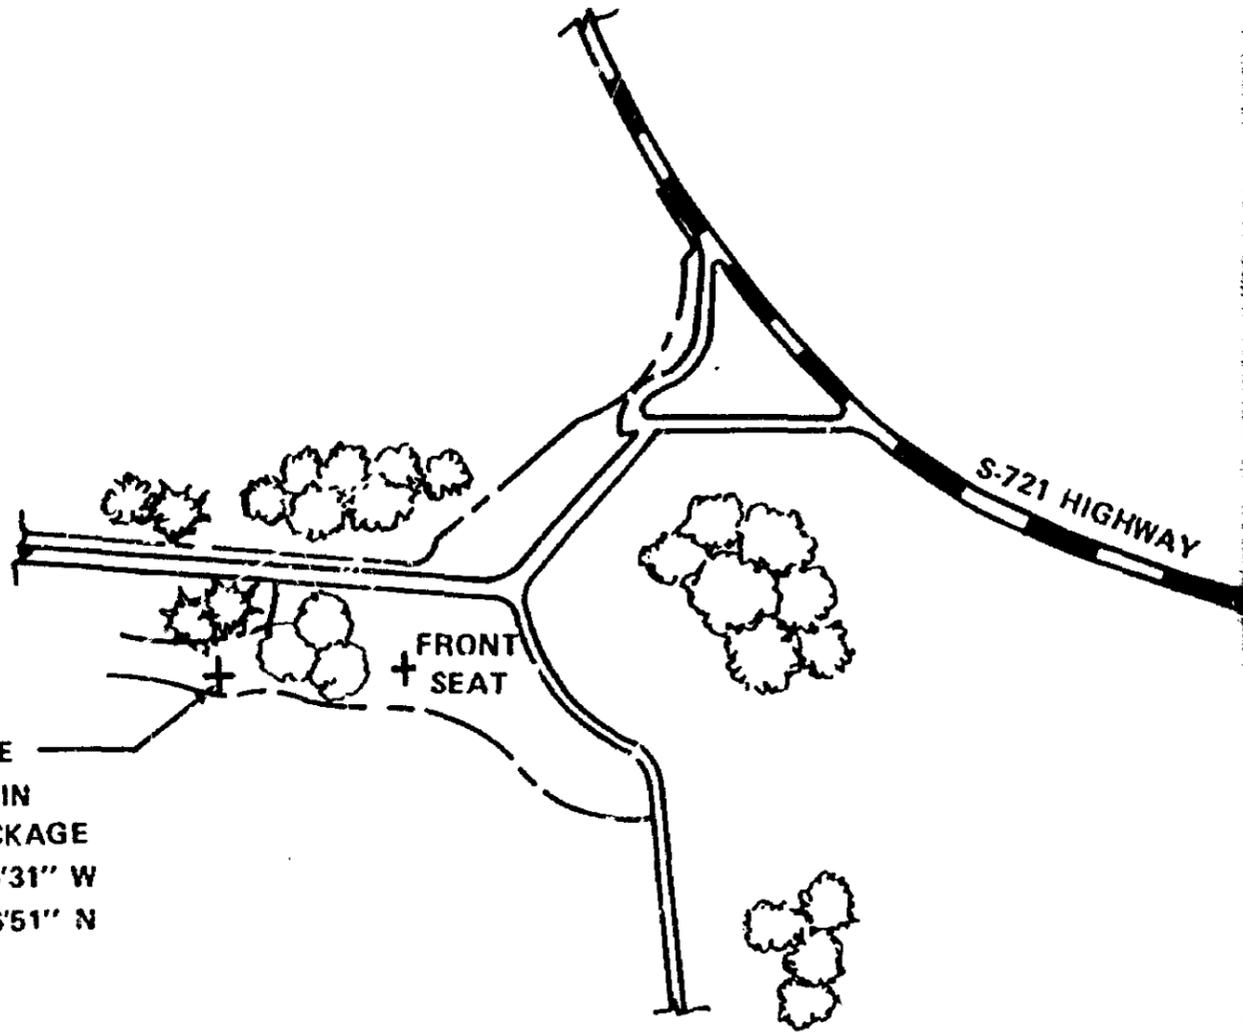
F4E  
MAIN  
WRECKAGE  
81° 05'31" W  
27° 06'51" N

The main wreckage of the F-4E was found in a swampy area in a small pond about 1.5 miles west of the N8PR site. All of the aircraft was in this area except those miscellaneous parts found with the N8PR parts. The only parts from N8PR found in the F-4E main wreckage area were pieces from the left engine cowl. (See Appendix D.)

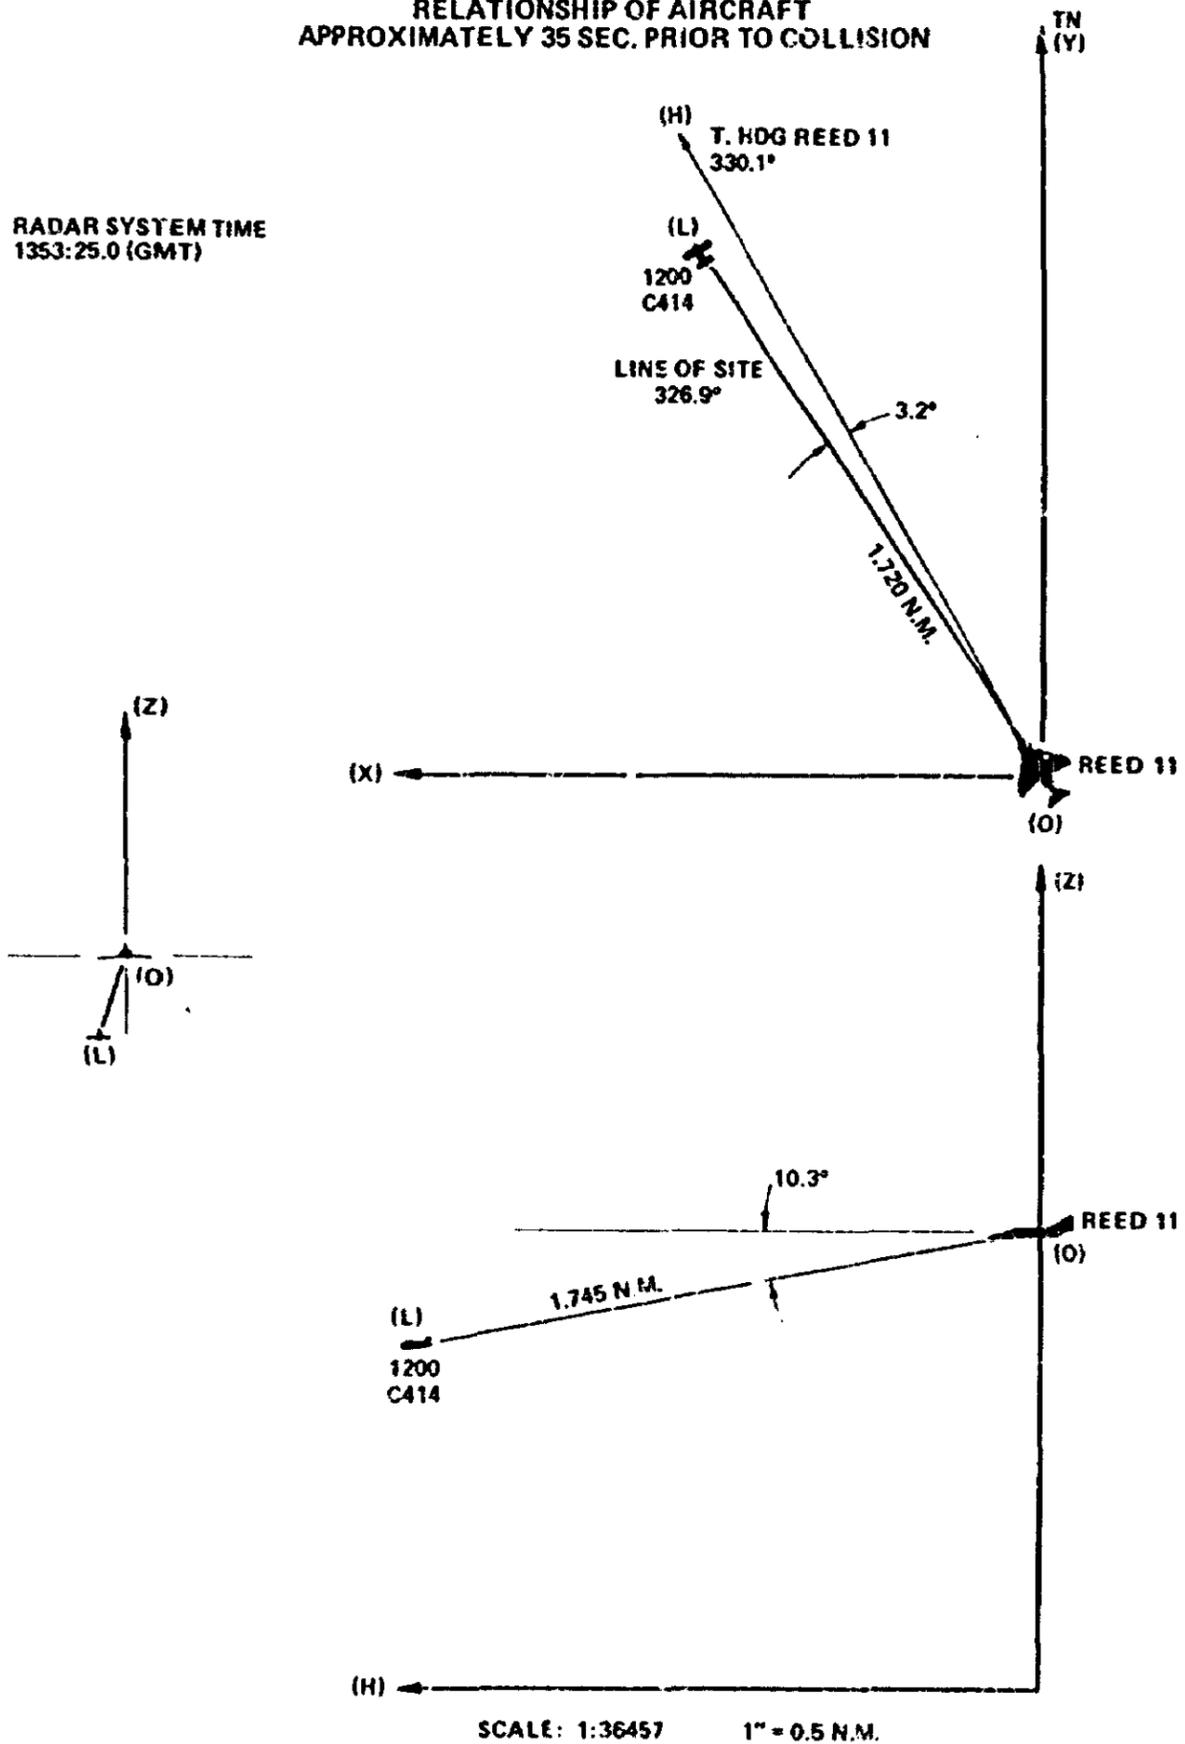
RELATIONSHIP OF AIRCRAFT  
APPROXIMATELY 35 SEC. PRIOR TO COLLISION

The computed data also showed that 55 seconds before the collision, the distance between the lead F-4E and N8PR was 2.8 nmi; 35 seconds before the collision, the distance of separation was 1.7 nmi; and 15 seconds the same distance was .7 nmi. (See Appendix E.)
