**Aircraft Accident Report - Commonwealth of Pennsylvania,  
Piper PA-31T, N631PT, Bressler, Pennsylvania  
February 14, 1977**

## AIRCRAFT ACCIDENT REPORT

NTSB REPORT NUMBER: NTSB/AAR-77-1

COMMONWEALTH OF PENNSYLVANIA  
PIPER PA-31T, N631PT  
BRESSLER, PENNSYLVANIA  
FEBRUARY 24, 1977

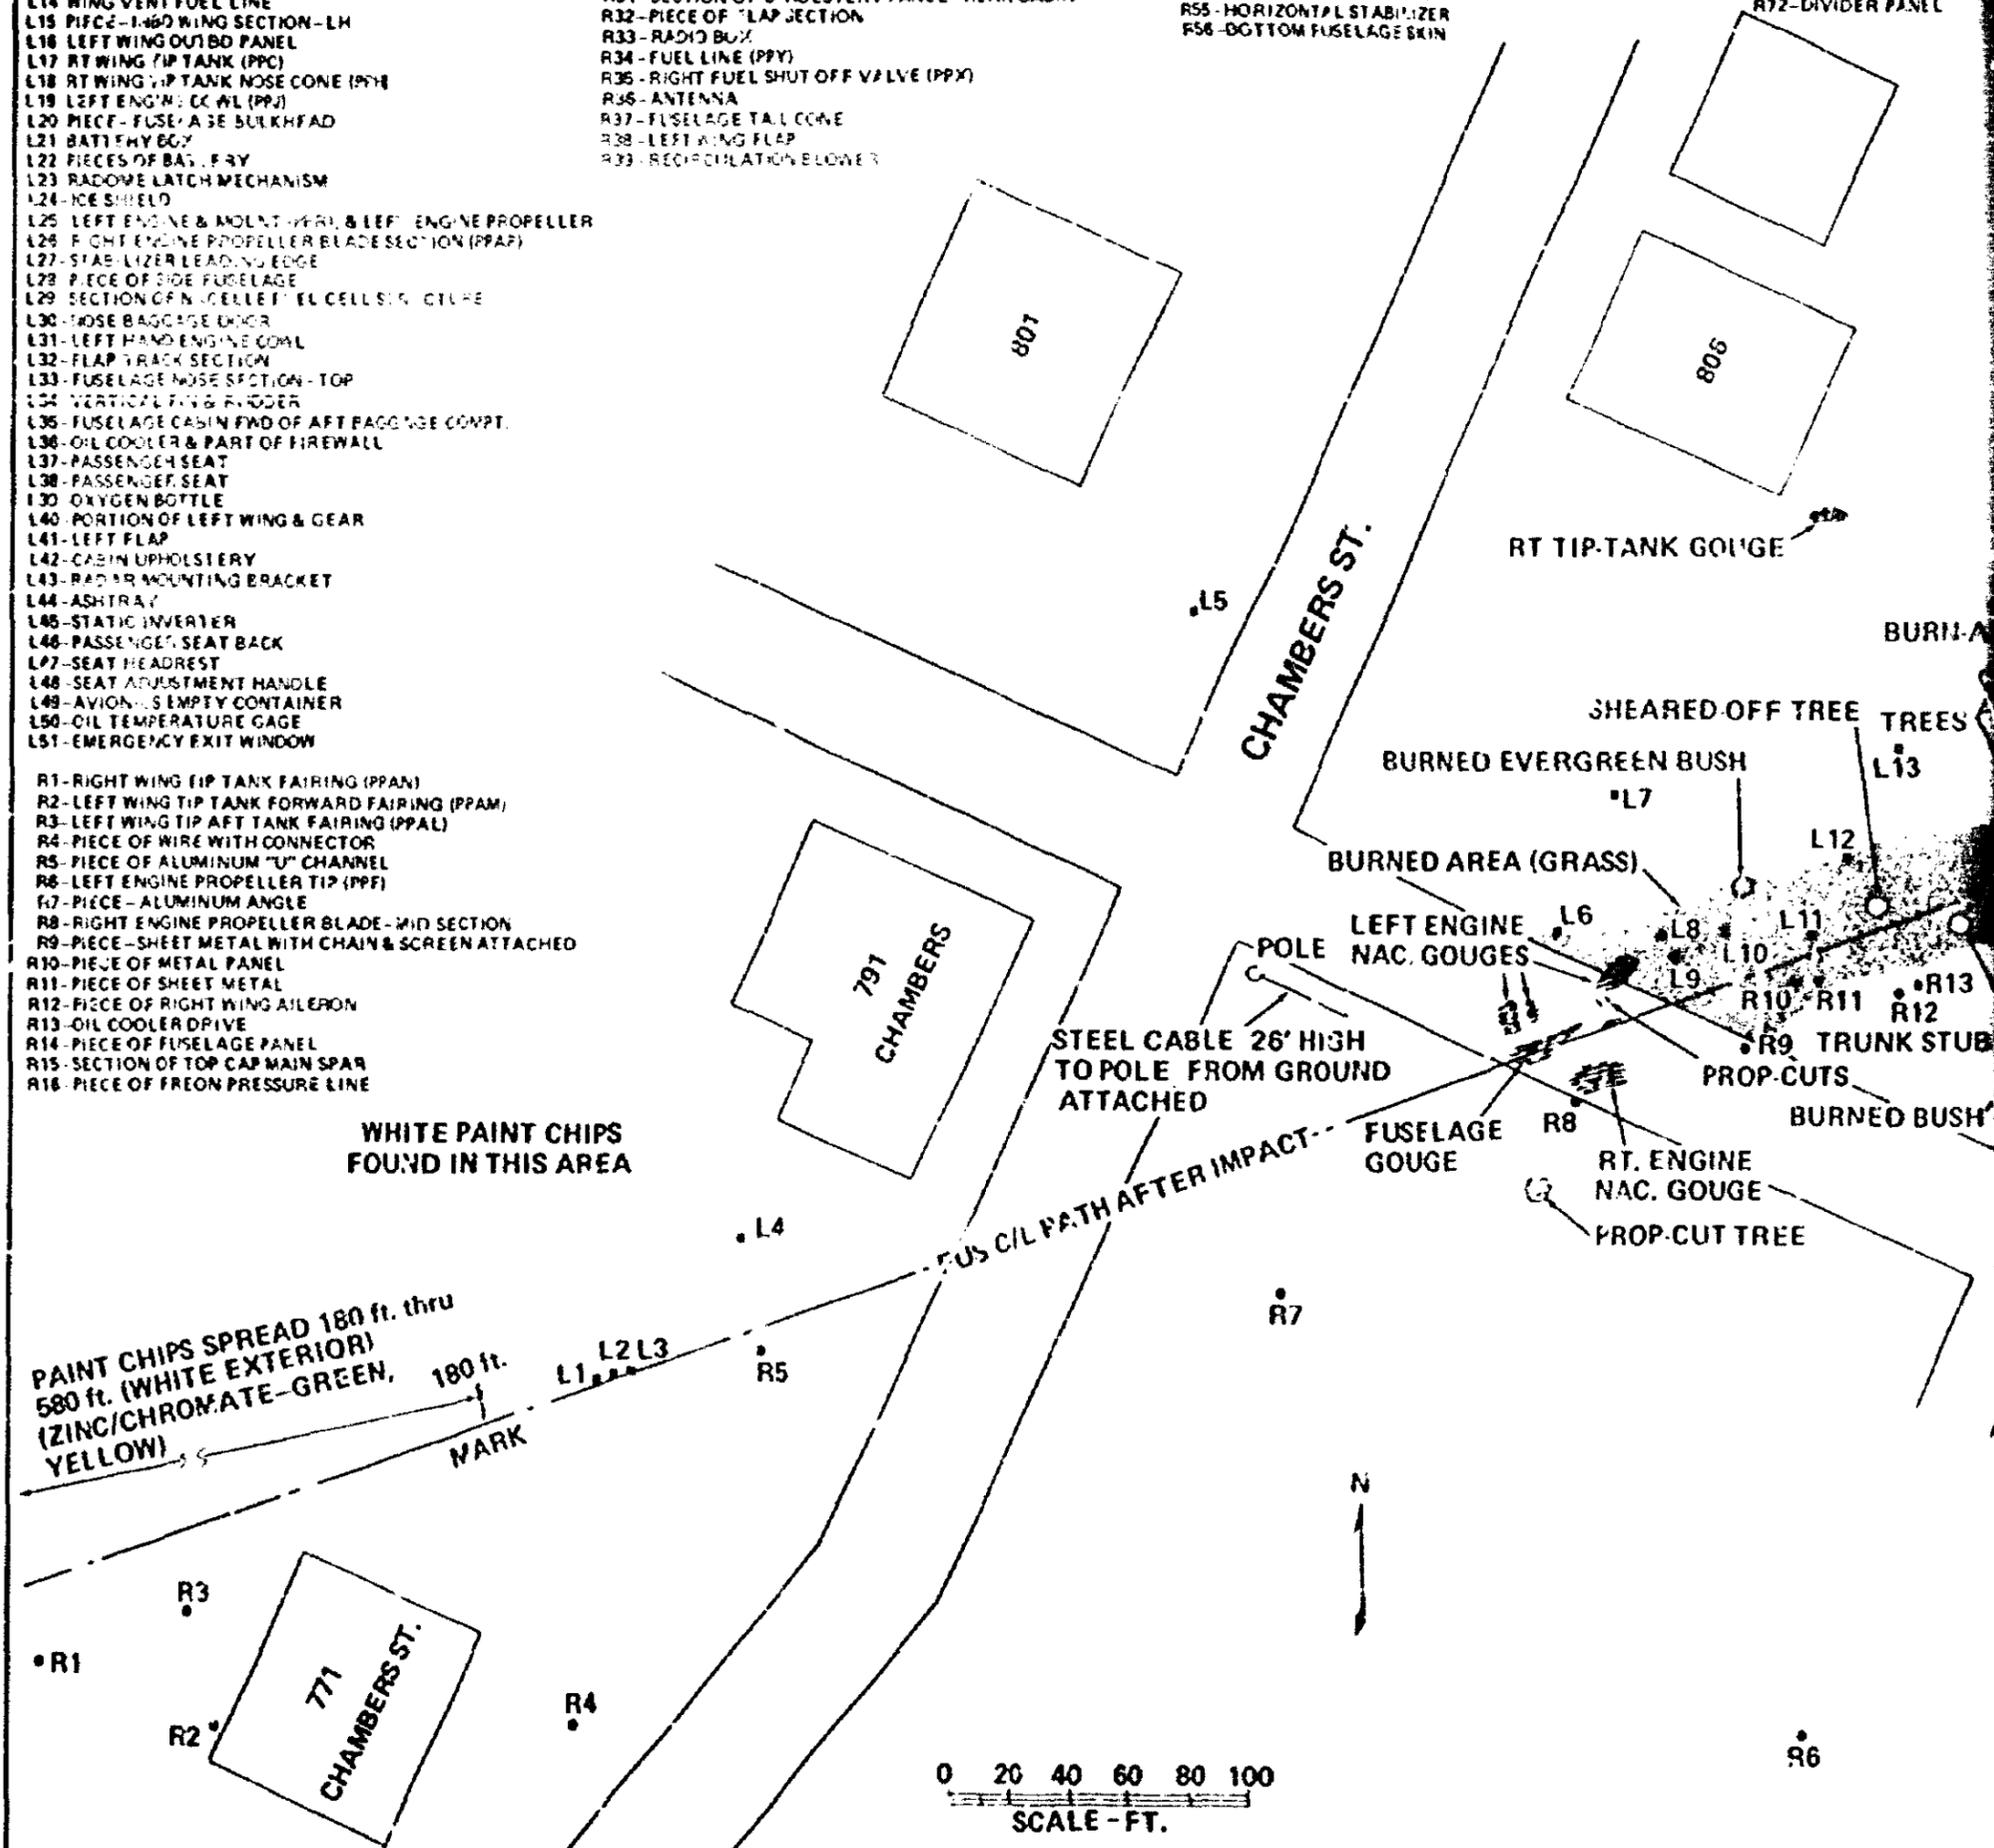
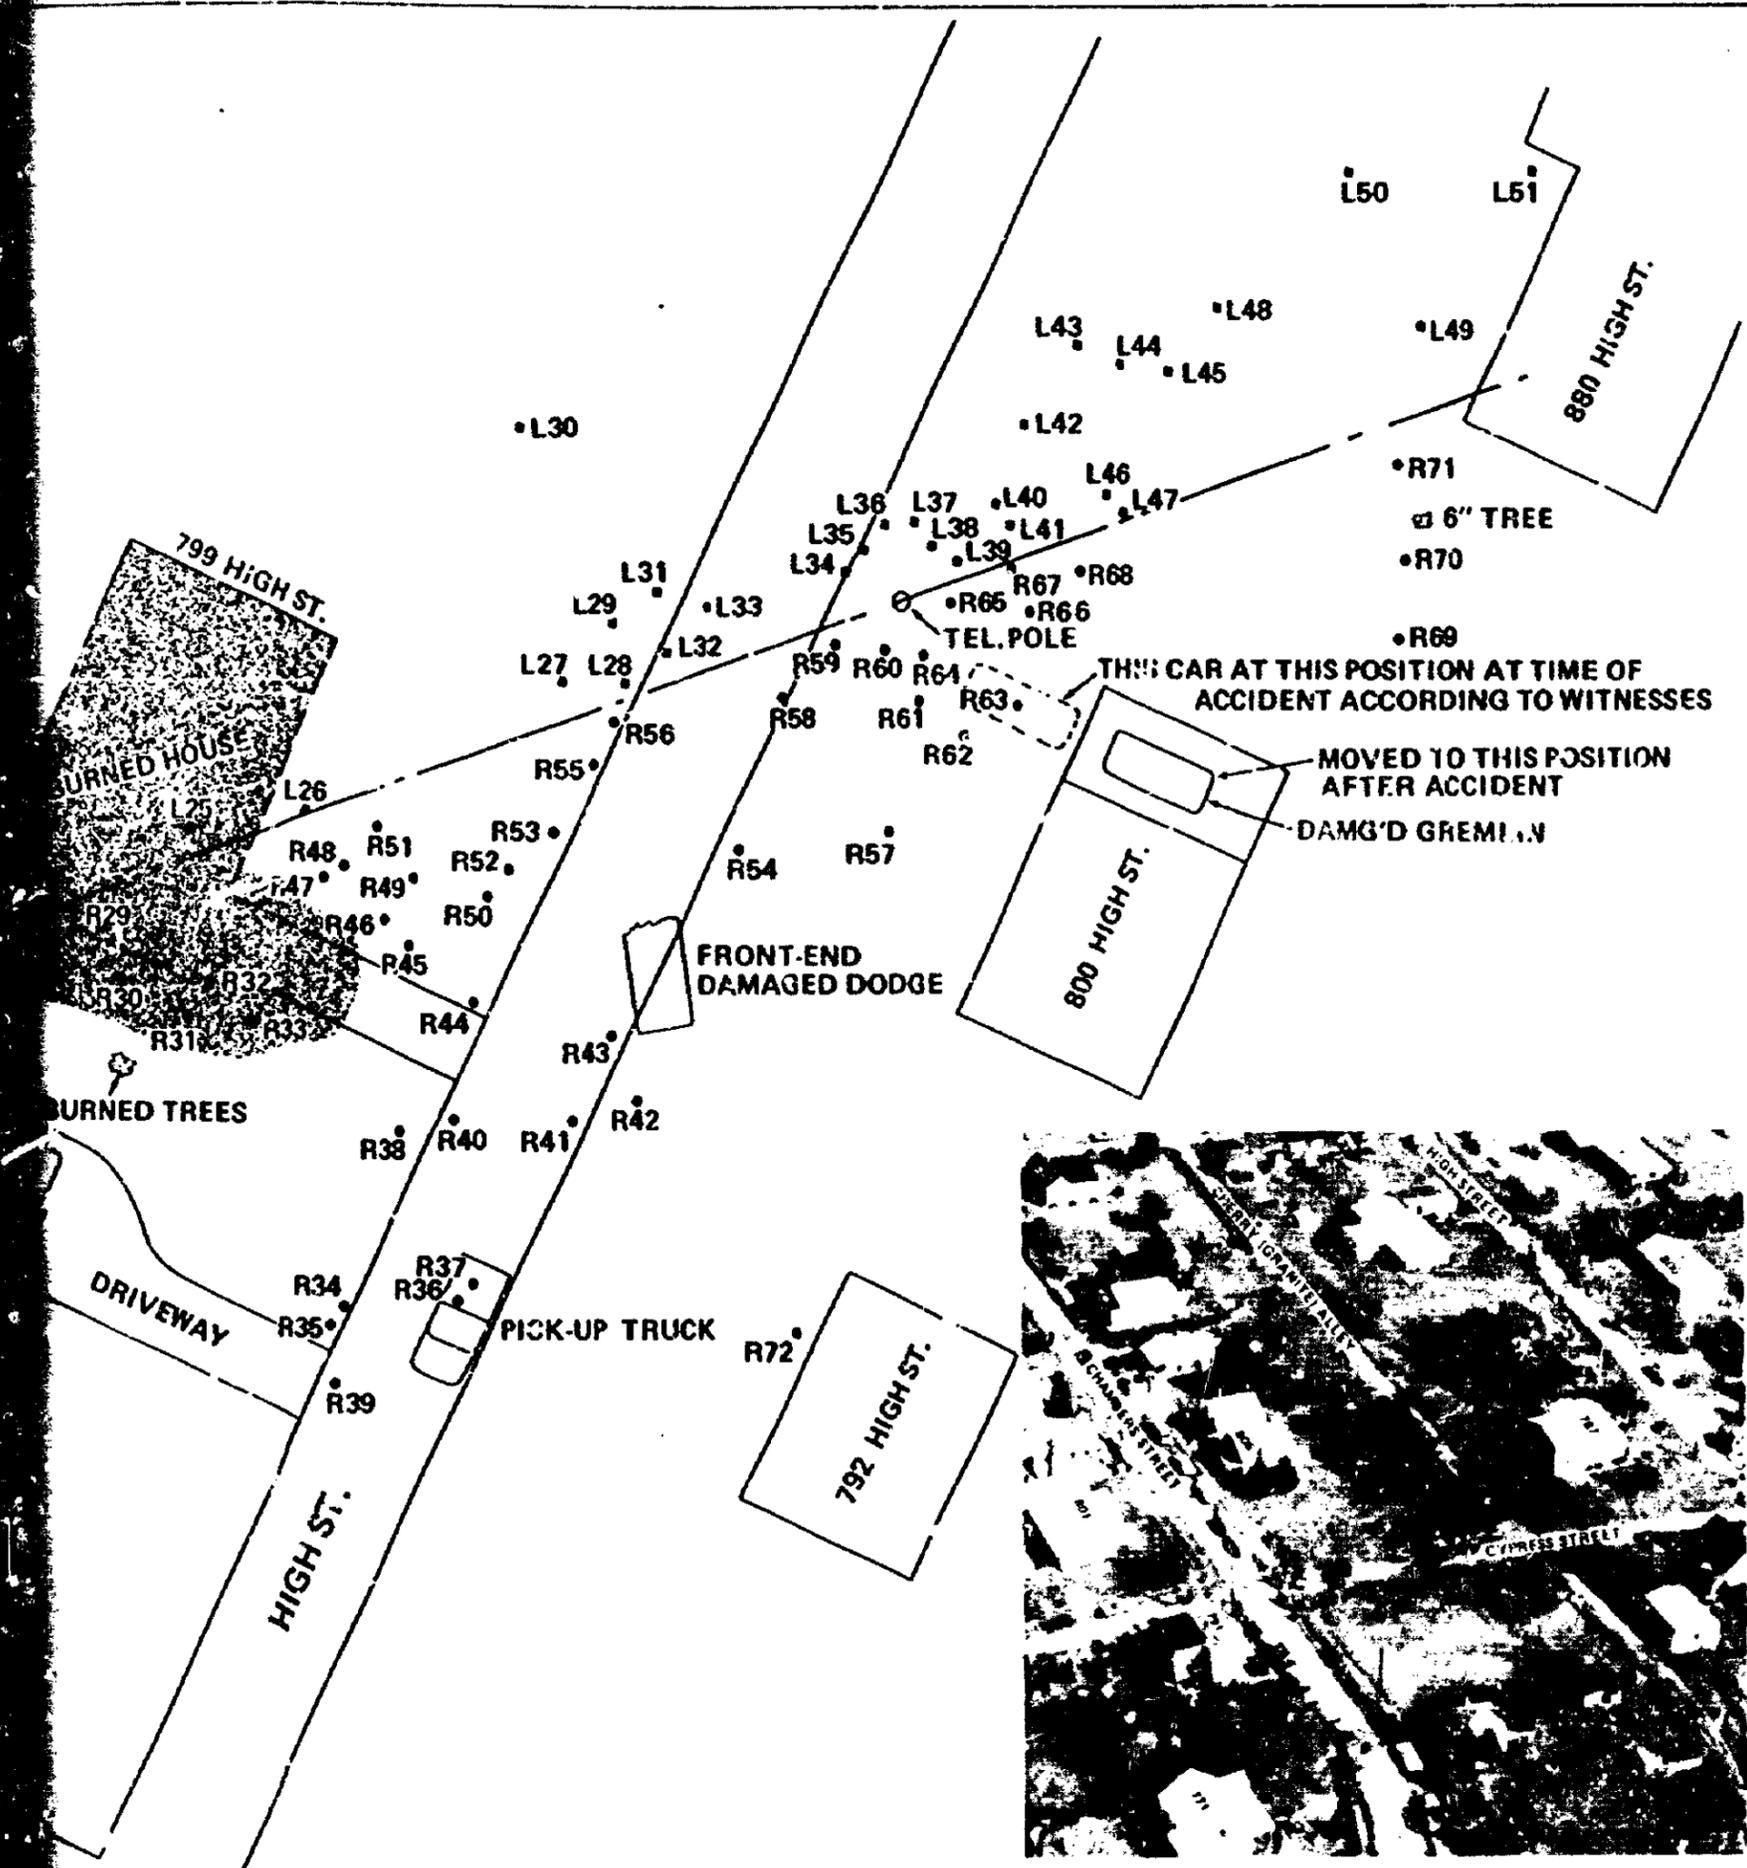
APPENDIX D

The first signs of contact were found 15 ft above the ground on a 23-ft tree. About 20 ft beyond the tree, the aircraft struck the macadam surface of a street. The marks in the street were made by the aircraft's fuselage and engine nacelles. Propeller slash marks were evident in the impact mark made by the left engine nacelle. The aircraft continued to slide on a magnetic heading of 075°. It struck and continued through a house which erupted in flames. The aircraft then struck and displaced an automobile in the driveway and a pickup truck parked in front of the house. The aircraft wreckage continued across another street and came to rest in a driveway against a telephone pole. The total wreckage area was about 755 ft long and about 210 ft wide. (See Appendix D.)
