**Aircraft Accident Report - Allegheny
Airlines, Inc., Douglas DC-9, N994VJ,
Philadelphia, Pennsylvania, June 23, 1976**

National Transportation Safety Board, Washington, D C

19 Jan 78

ALLEGHENY AIRLINES, INC.
DOUGLAS DC-9, N994VJ
PHILADELPHIA INTERNATIONAL AIRPORT
PHILADELPHIA, PENNSYLVANIA
JUNE 23, 1976

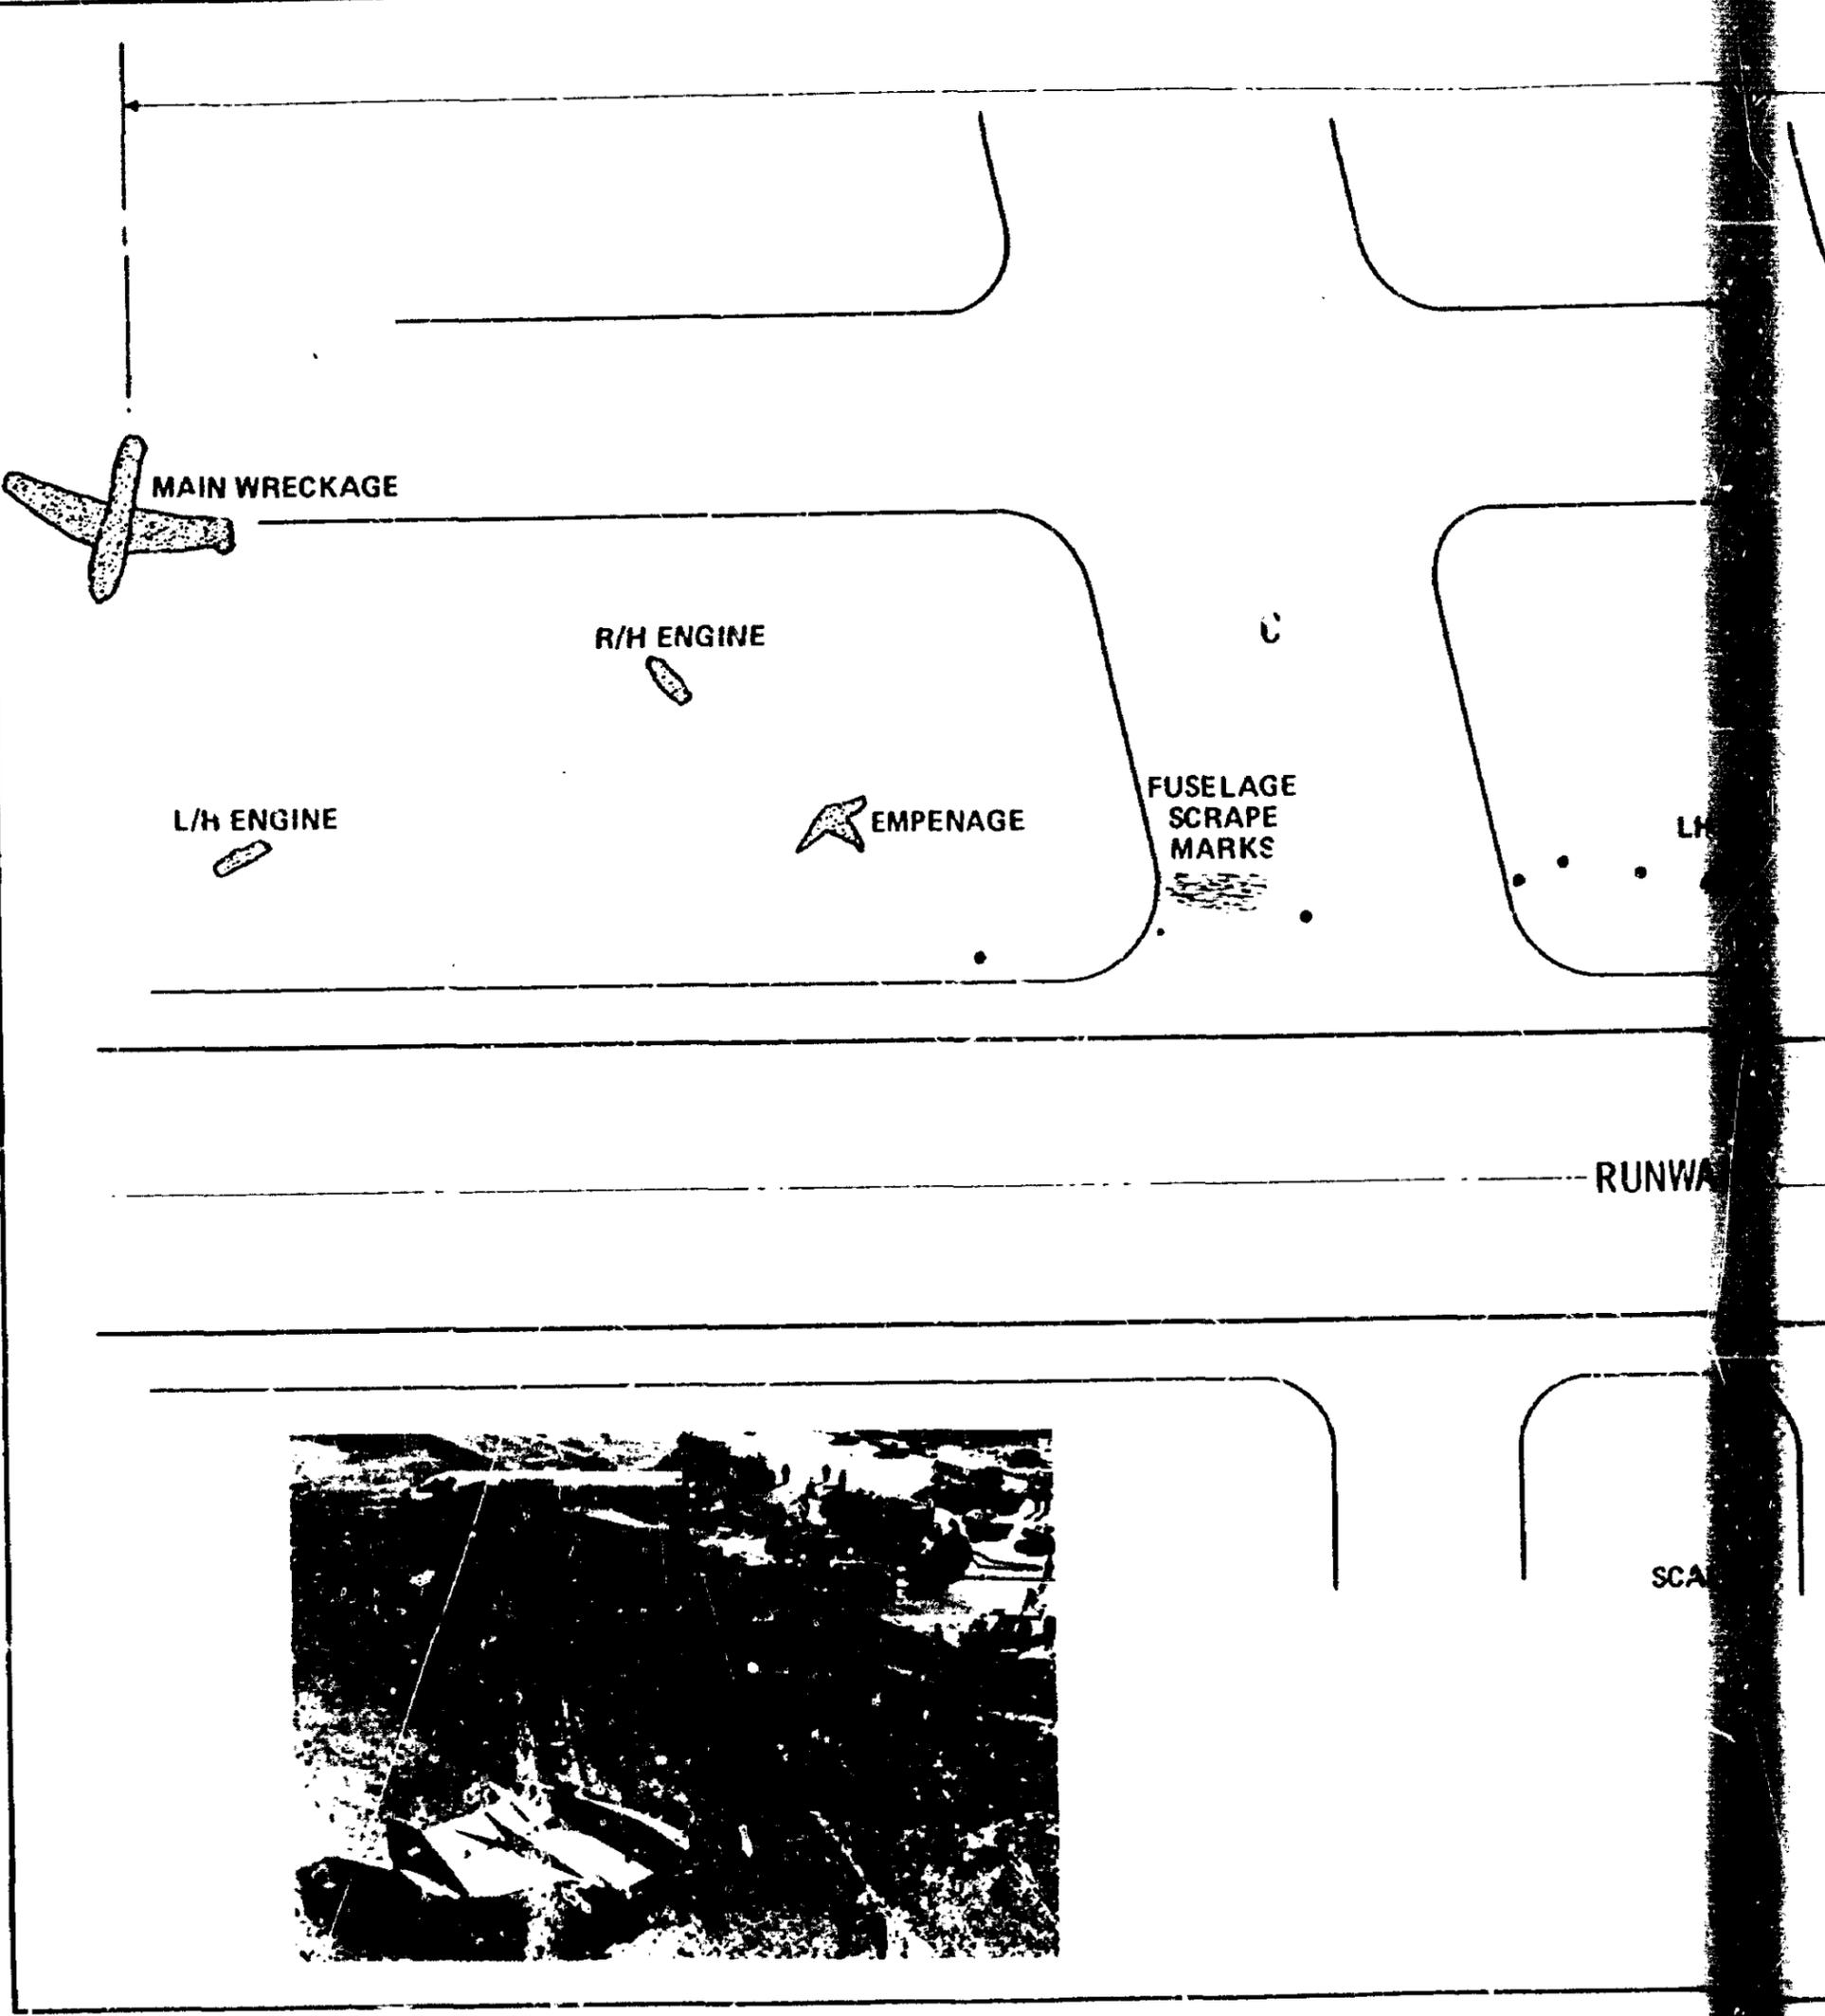
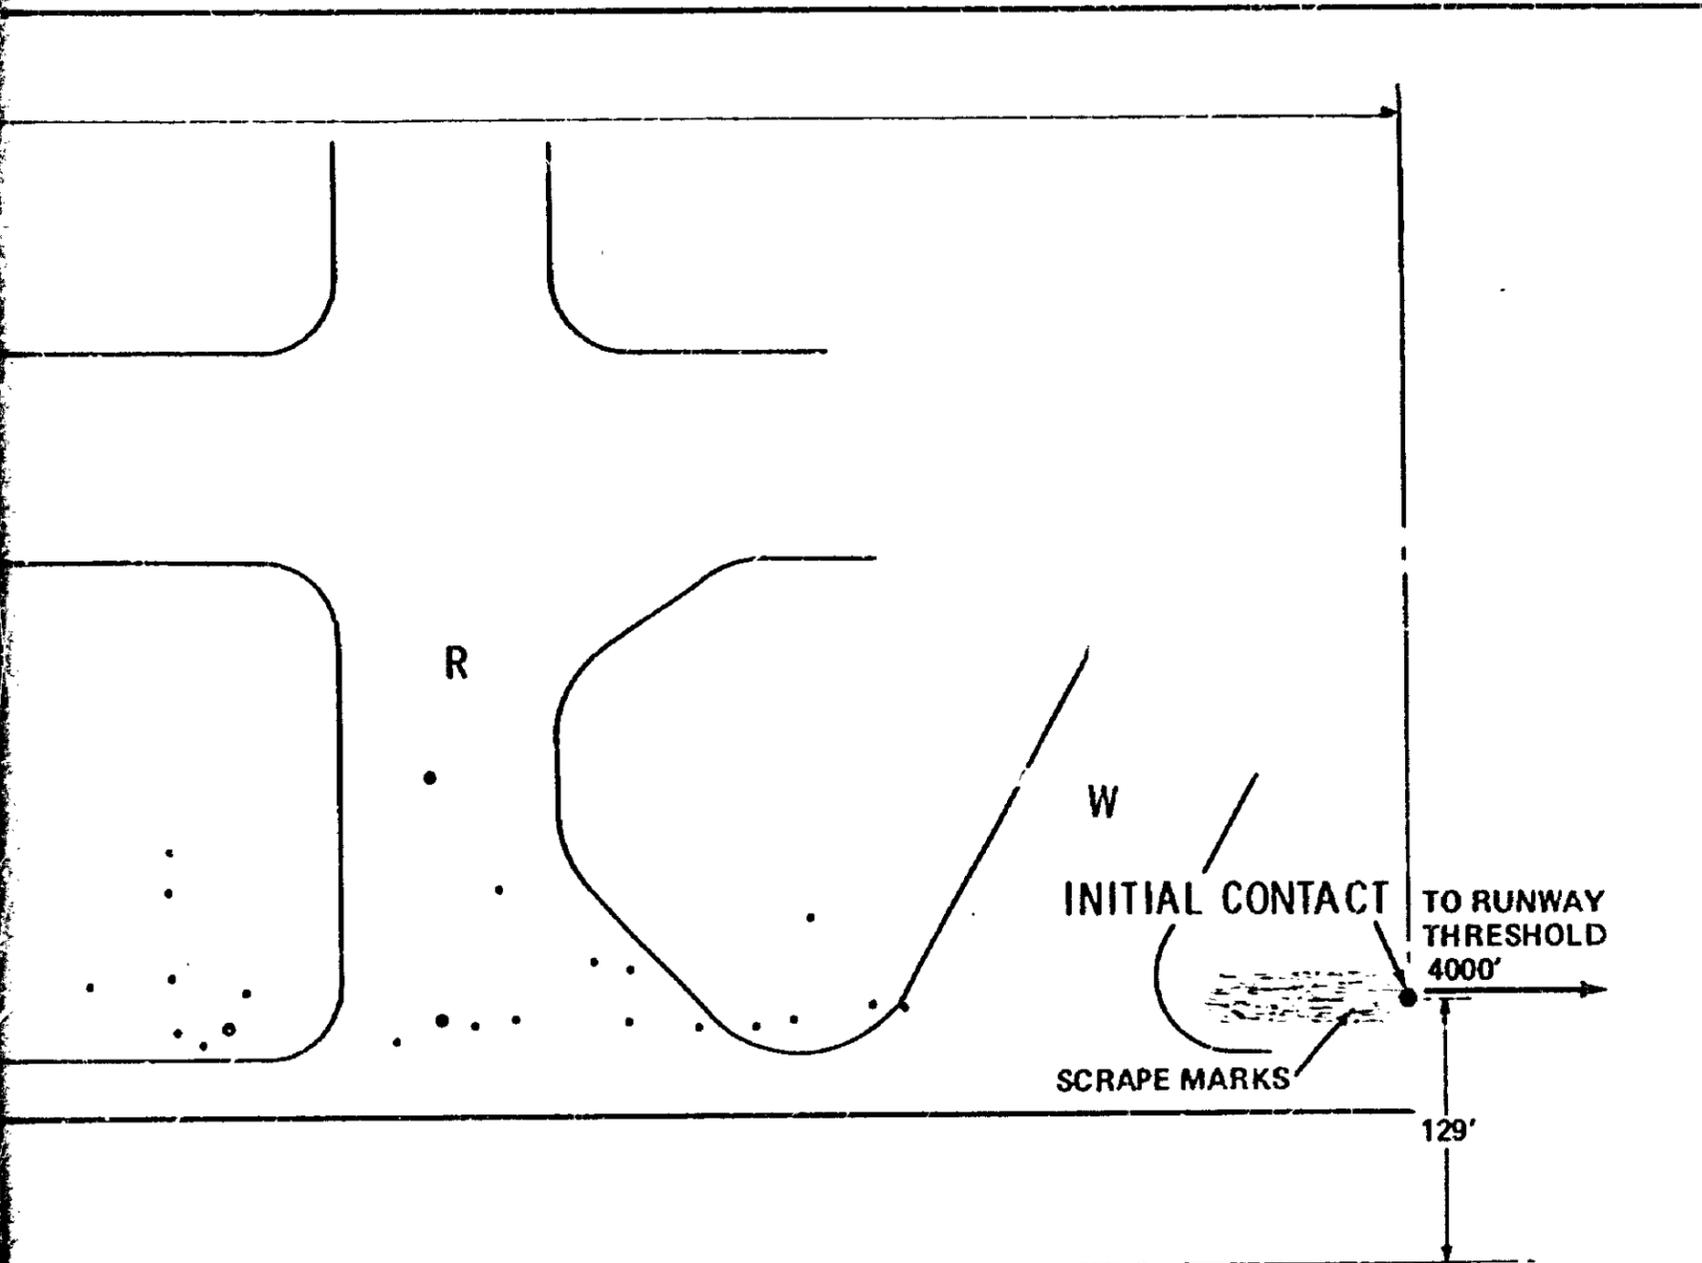
WRECKAGE DISTRIBUTION CHART
ALLEGHENY AIRLINES, INC. DOUGLAS DC-9-30-N994VJ
PHILADELPHIA INTERNATIONAL AIRPORT, PENNSYLVANIA
23 JUNE 1976

The empennage and aft fuselage section had separated from the rest of the fuselage at a point just aft of the pressure bulkhead. The major portion of the fuselage, including the entire cabin and cockpit, was intact with both wings attached. The fuselage was damaged severely below the cusp line, at the rear pressure bulkhead, and at the engine stub wing-to-fuselage attachments. The fuselage lower nose structure was damaged. The lower skin of the fuselage was torn and abraded, the adjacent frames were crushed, and the stringers were damaged for the entire length of the aircraft. The cabin floor was buckled upward above the main landing gears (fuselage stations 699 to 756).

The basic wing structures were intact, but the left wing was damaged more heavily. There were no fuel leaks from the wing tanks. The empennage was attached to the aft fuselage section which had separated from the aircraft. The stabilizer was positioned for 9.8° noseup trim. The landing gear was fully retracted, the leading edge slats were fully extended, and the flaps were partially extended. Measurements taken of the flap extension mechanism revealed that the flaps were in the 15° position.

Both engines and their respective pylon stub wings had separated from the aircraft fuselage and were found 200 ft apart. The engines and the tail section were found between taxiway C and the main wreckage.
