Aircraft Accident Report - Johnson and
Johnson, Inc., Grumman Gulfstream II,
N500J, Hot Springs, Virginia,
September 26, 1976

National Transportation Safety Board, Washington, D C

1. Report No. NTSB-AAR-78-4	2. Government Accession No.	3. Recipient's Catalog No.	
4. Title and Subtitle Aircraft Accident Report - Johnson and Johnson, Inc., Grumman Gulfstream II, N500J, Hot Springs, Virginia, September 26, 1976		5. Report Date February 9, 1978

JOHNSON & JOHNSON, INC.
GRUMMAN GULFSTREAM II, N500J
HOT SPRINGS, VIRGINIA
SEPTEMBER 26, 1976

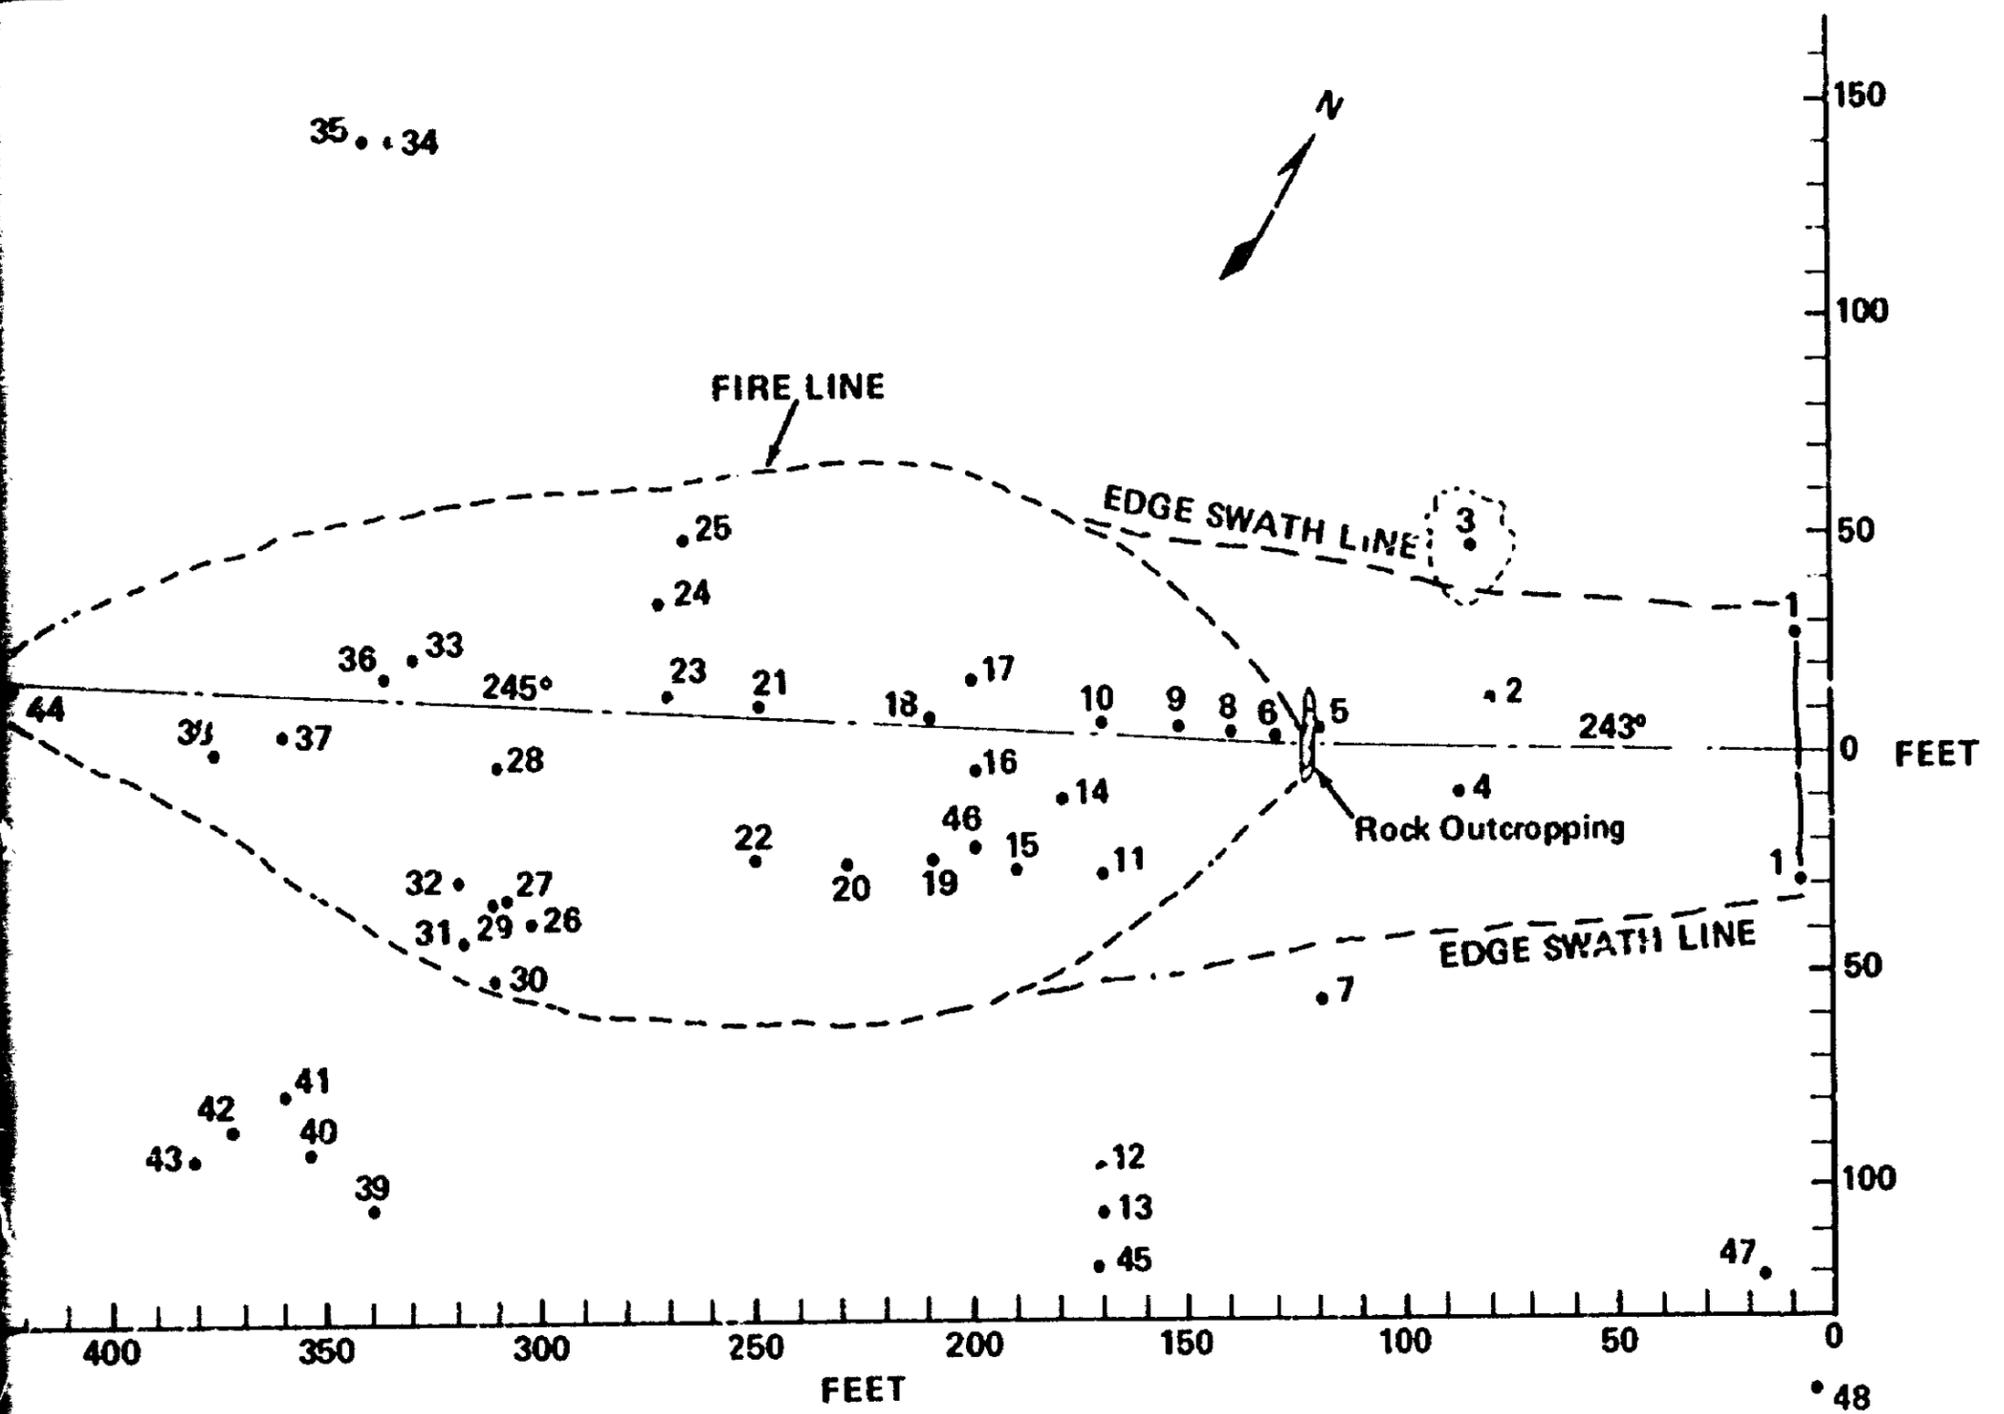
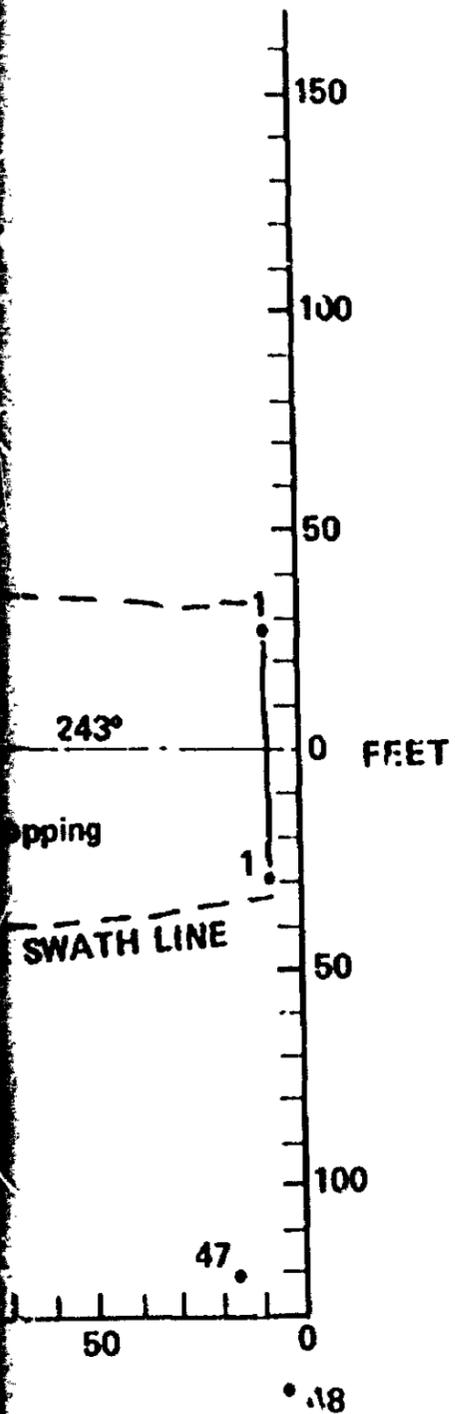
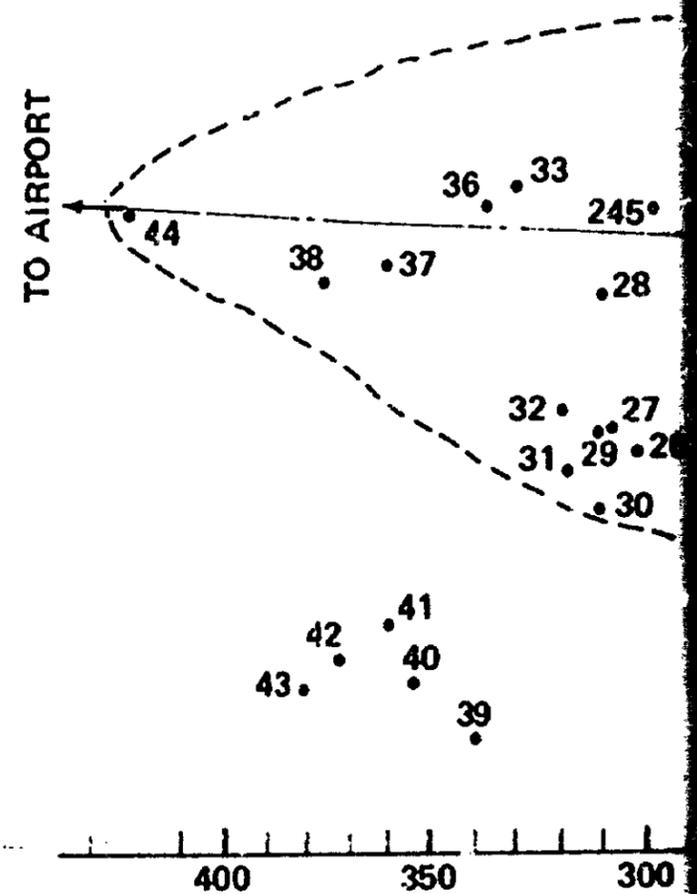
**WRECKAGE DISTRIBUTION CHART
JOHNSON & JOHNSON
GRUMMAN GULFSTREAM II, N500J
INGALLS FIELDS AIRPORT, HOT SPRINGS, VIRGINIA
SEPTEMBER 26, 1978**

The aircraft was destroyed by impact and severe ground fire. The wreckage parts outside the 140- by 300- ft burned area were unburned except for a cabin seat, a food container, a 20- by 20-in. piece of soundproofing, and the left main landing gear's fixed door and outboard tire and wheel rim. However, a ground explosion was evidenced by molten aluminum spattered into trees on the right side of the wreckage path. A piece of sun visor was wrapped around a small tree trunk outside the burned area. Most of the aircraft's structure was melted. Portions of the left and right wing flap structure located near the initial tree impact site, showed no signs of damage due to fire or smoke. Pieces of the right main landing gear found embedded in the rock outcropping were not damaged by fire or smoke.

The aircraft was certificated, maintained, and equipped according to FAA regulations. There was no evidence of structural failure. Although some components of the aircraft were outside the postcrash fire area and were damaged by fire, it is believed that these components were propelled from the main wreckage by the postcrash explosion. The left main landing gear outboard tire probably exploded and broke the wheel rim because of the intense ground fire and the remains were propelled to the locations shown on the wreckage distribution diagram. (See Appendix F.) Since

the main landing gear wheel wells adjoin and are open, any fire or smoke generated in one of those areas should leave evidence of that kind of damage in the other area. Since there was evidence of an explosion and since the right main landing gear and wing flap structure were not damaged by fire or smoke, the Safety Board concludes that an in-flight fire did not occur in the wheel wells. There was no evidence of an in-flight fire on any other structure or component of the wreckage.

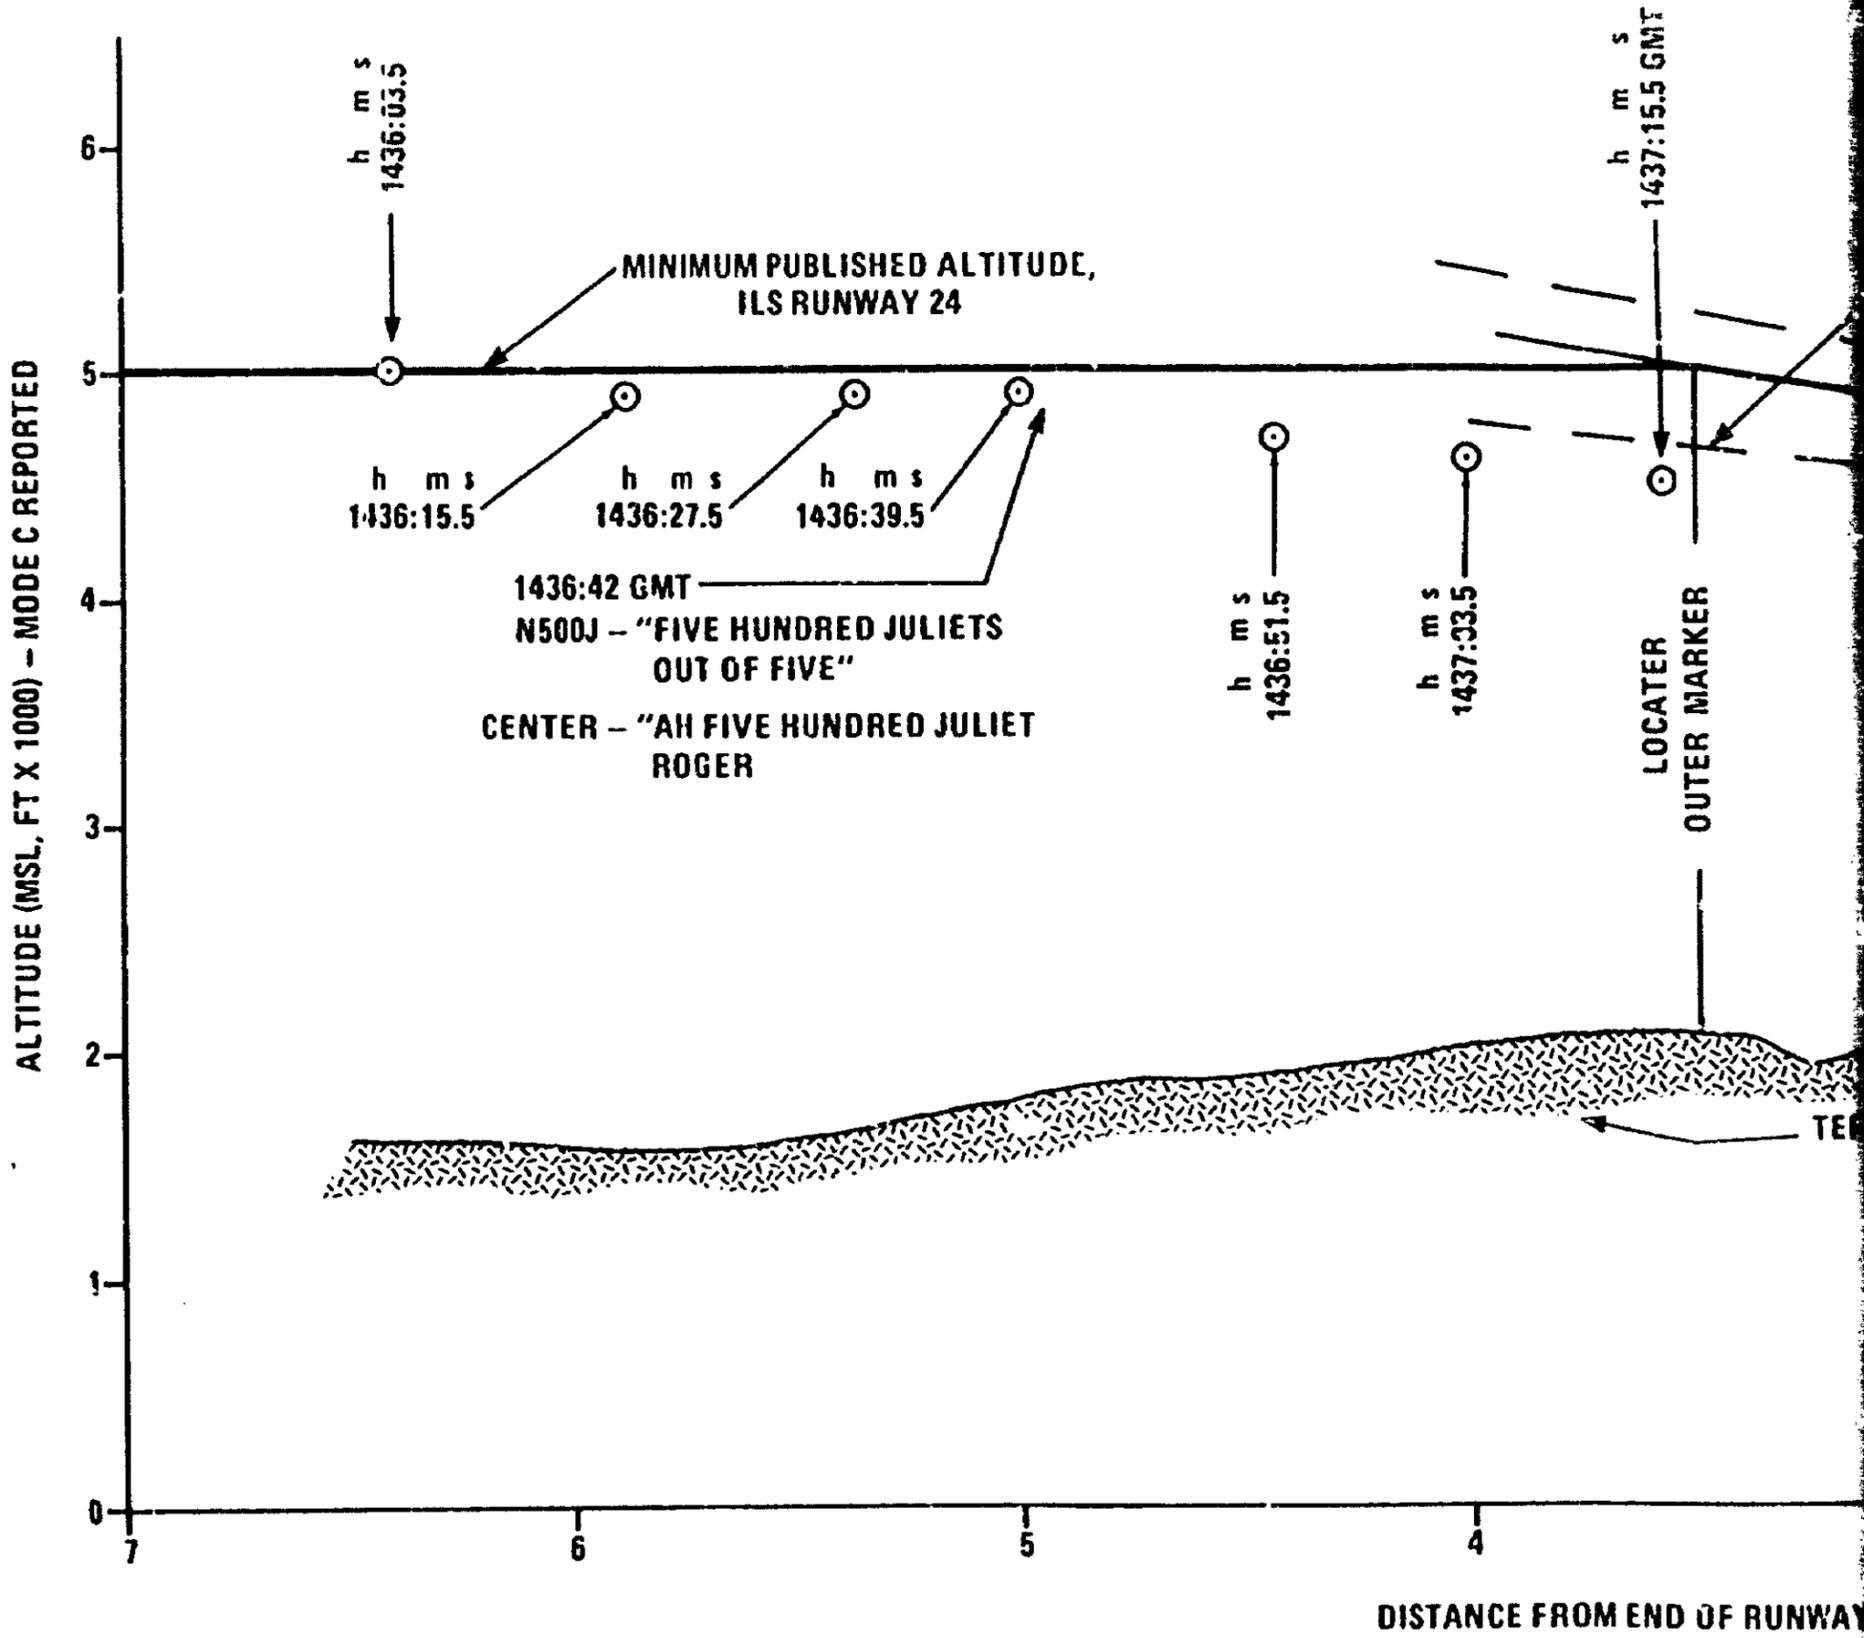
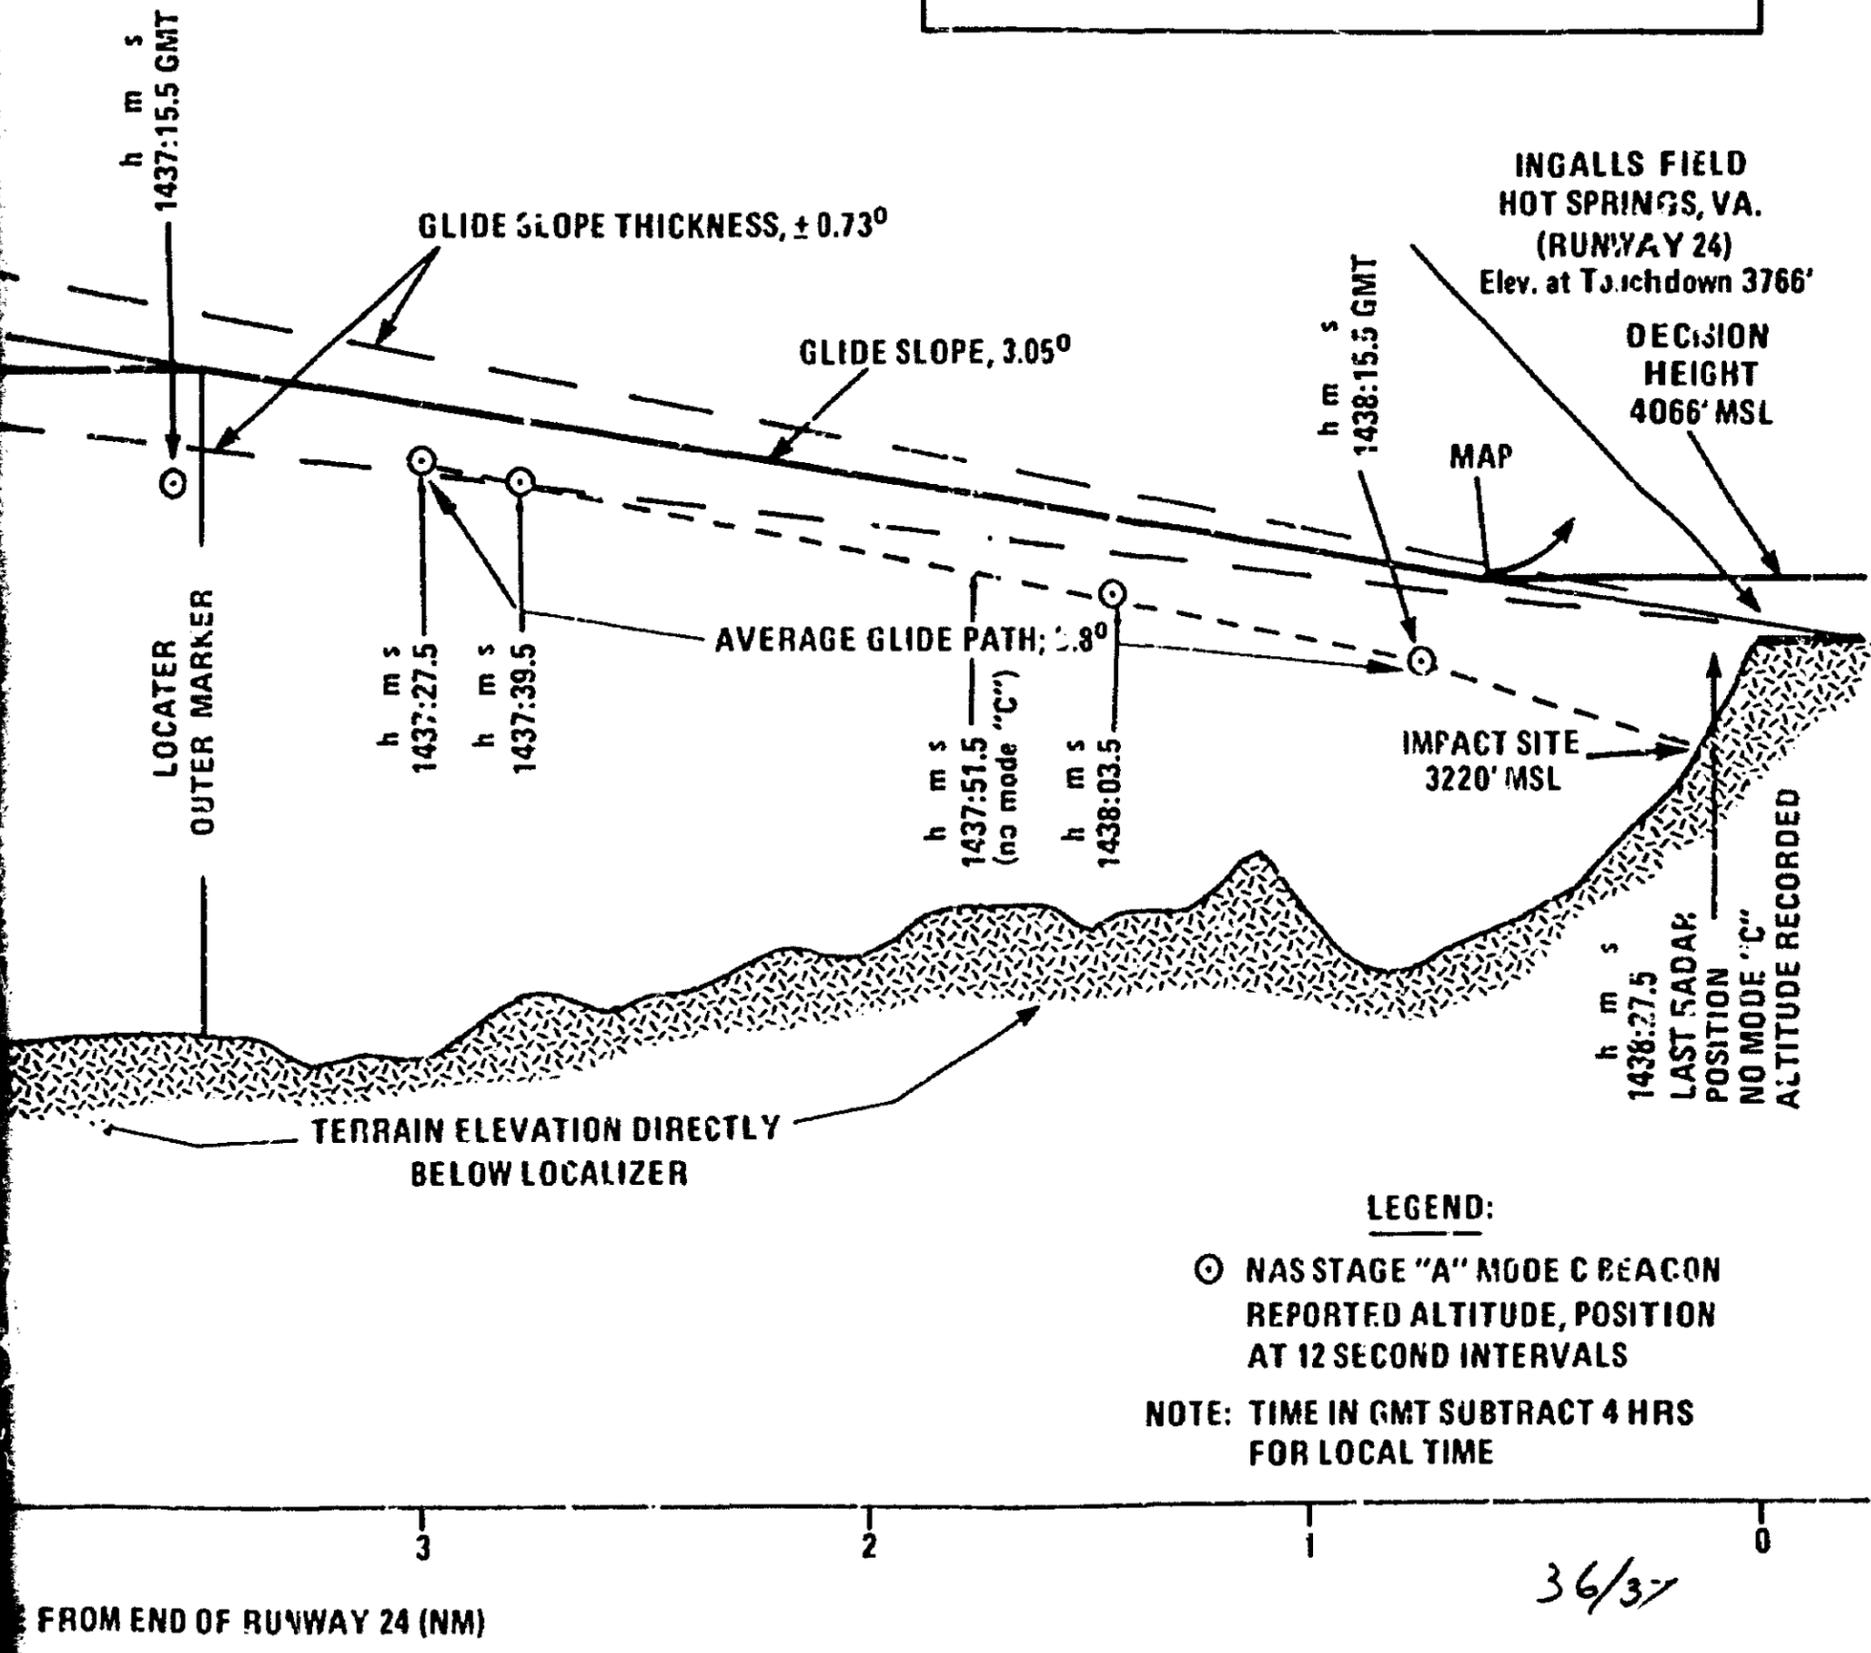
ALTITUDE PROFILE
 (NAS STAGE "A" DERIVED)
 JOHNSON & JOHNSON
 GRUMMAN G-1159, N500J
 INGALLS FIELD, HOT SPRINGS, VA.
 SEPTEMBER 26, 1976

The calculated indicated airspeeds between the LOM and impact approximate the maximum speed for full flap extension and were in excess of the company's recommended approach and landing speeds by about 20 kts. Also, the calculated resultant flightpath angles and rates of descent exceeded those prescribed for the ILS approach. For the calculated groundspeed and prescribed glide slope of 3.0°, the rate of descent should have been 902 ft per minute, or 300 ft per minute less than the minimum calculated rate of descent.
