Aircraft Accident Report - Japan Air Lines Company, Ltd.
McDonnell-Douglas DC-8-62F, JA 8054, Anchorage, Alaska
January 13, 1977

1. Report No. NTSB-AAR-78-7	2. Government Accession No.	3. Recipient's Catalog No.	
4. Title and Subtitle Japan Air Lines Co., Ltd. McDonnell-Douglas DC-8-62F, JA 8054, Anchorage, Alaska, January 13, 1977		5. Report Date January 16, 1979	6. Performing Organization Code

AIRCRAFT ACCIDENT REPORT

JAPAN AIR LINES CO., LTD.
MCDONNELL-DOUGLAS DC-8-62F, JA 8054
ANCHORAGE, ALASKA
JANUARY 13, 1977

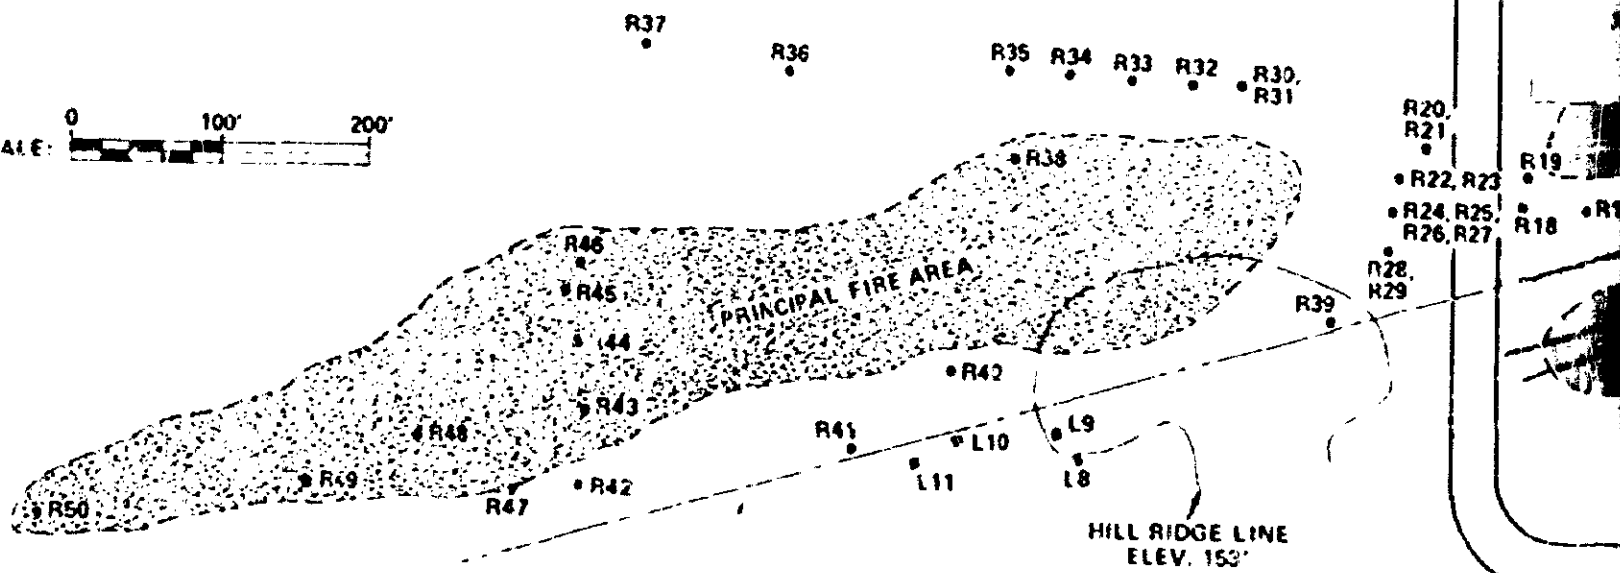
VIEW OF WRECKAGE SITE

The aircraft first struck the ground about 1,031 ft past the departure threshold of runway 24L and about 179 ft left of the extended runway centerline at an elevation of 124 ft. After initial impact, the aircraft continued to travel on a southwesterly heading which diverged to the left of the extended runway centerline. The aircraft crossed the airport access road without marking it and struck rising terrain at an elevation of about 140 ft. The aircraft broke up at that point.

The initial impact mark was V shaped which widened to about 12 ft before it lost definition. A short distance past that point a ground scar had been made by the No. 4 engine. A mark made by the No. 3 engine appeared, followed successively by marks from the No. 1 engine, No. 2 engine and the left wingtip. The magnetic bearing of the centerline

of the ground marks was about 230° . The wreckage area was about 1,670 ft long and 390 ft wide. No aircraft components or wreckage were found outside this area.
