**Aircraft Accident Report - United  
Airlines, Inc., Douglas DC-8-54, N8047U,  
Near Kayville, Utah, December 18, 1977**

**U.S. National Transportation Safety Board, Washington, D C**

1. Report No. NTSB-AAK-78-8		2. Government Accession No.		3. Recipient's Catalog No.	
4. Title and Subtitle Aircraft Accident Report -- United Airlines, Inc., Douglas DC-8-54, N8047U, near Kaysville, Utah, December 18, 1977.				5. Report Date July 27, 1978

UNITED AIRLINES, INC.  
DC-8F-54, N8047U  
NEAR KAYSVILLE, UTAH  
DECEMBER 18, 1977

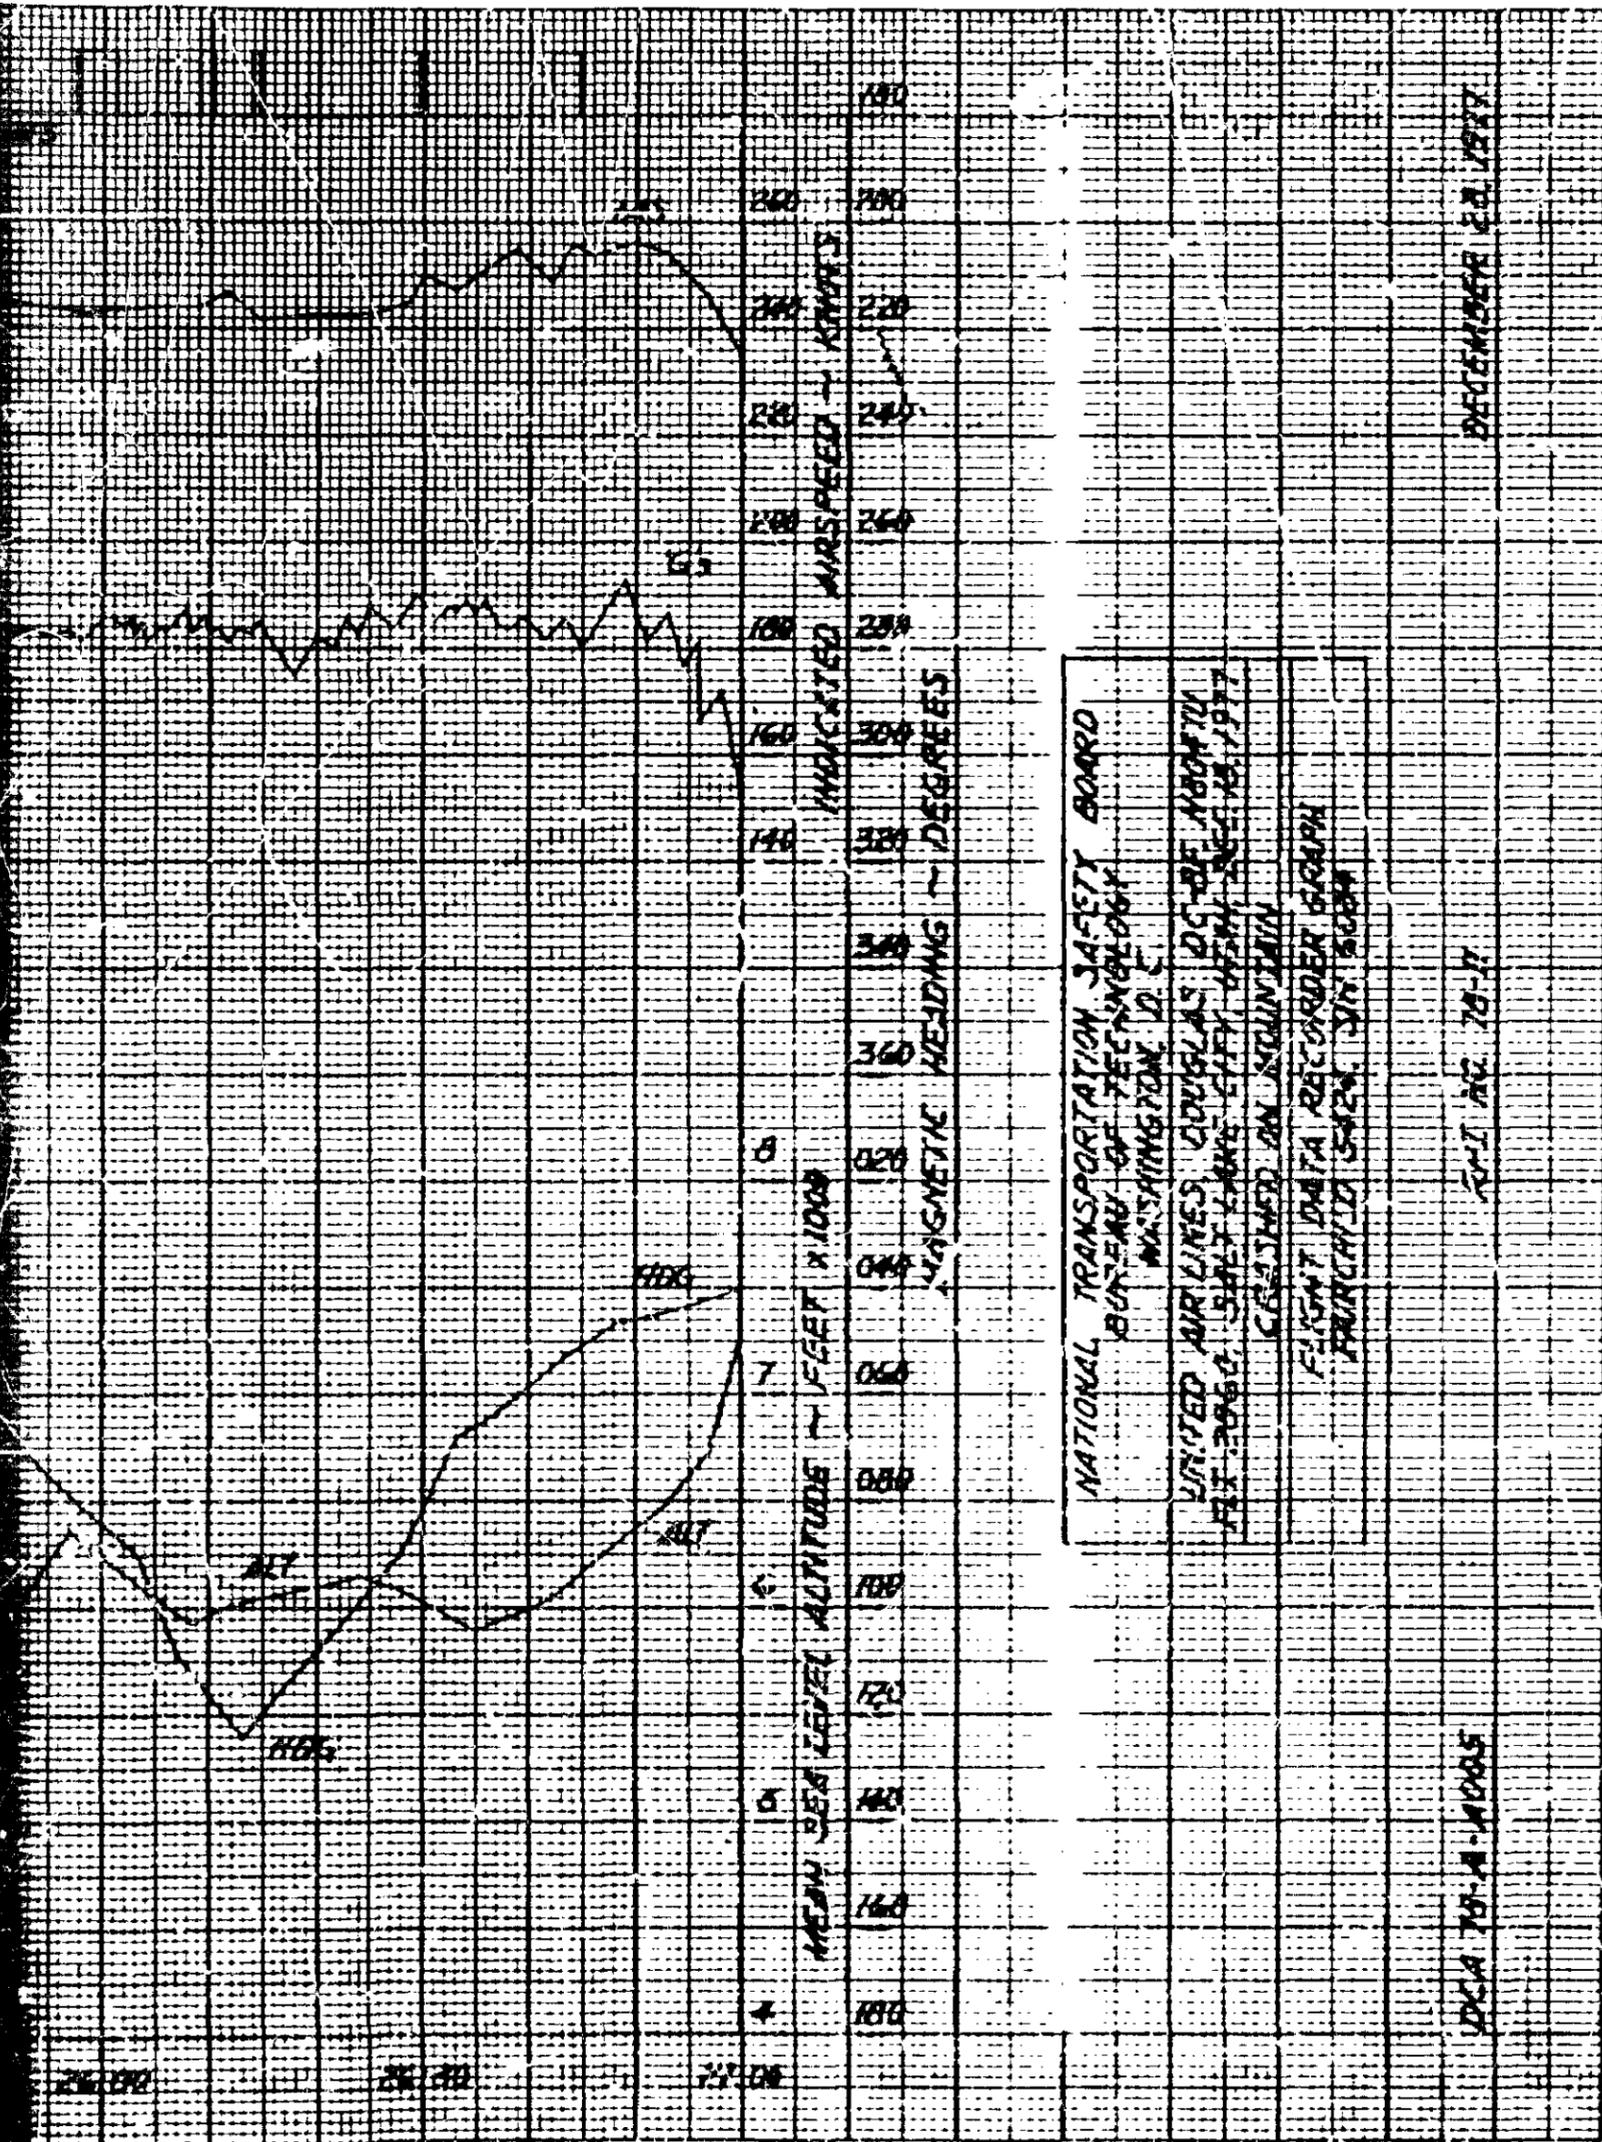
APPENDIX D

UNITED AIRLINES DOUGLAS DC-8F AIRCRAFT  
FLY 2060, SALT LAKE CITY, UTAH, DEC 18, 1977  
CRASHED ON MOUNTAIN  
FLIGHT DATA RECORDER GRAPH  
FRANCHISE 5224, JAN 5, 1978

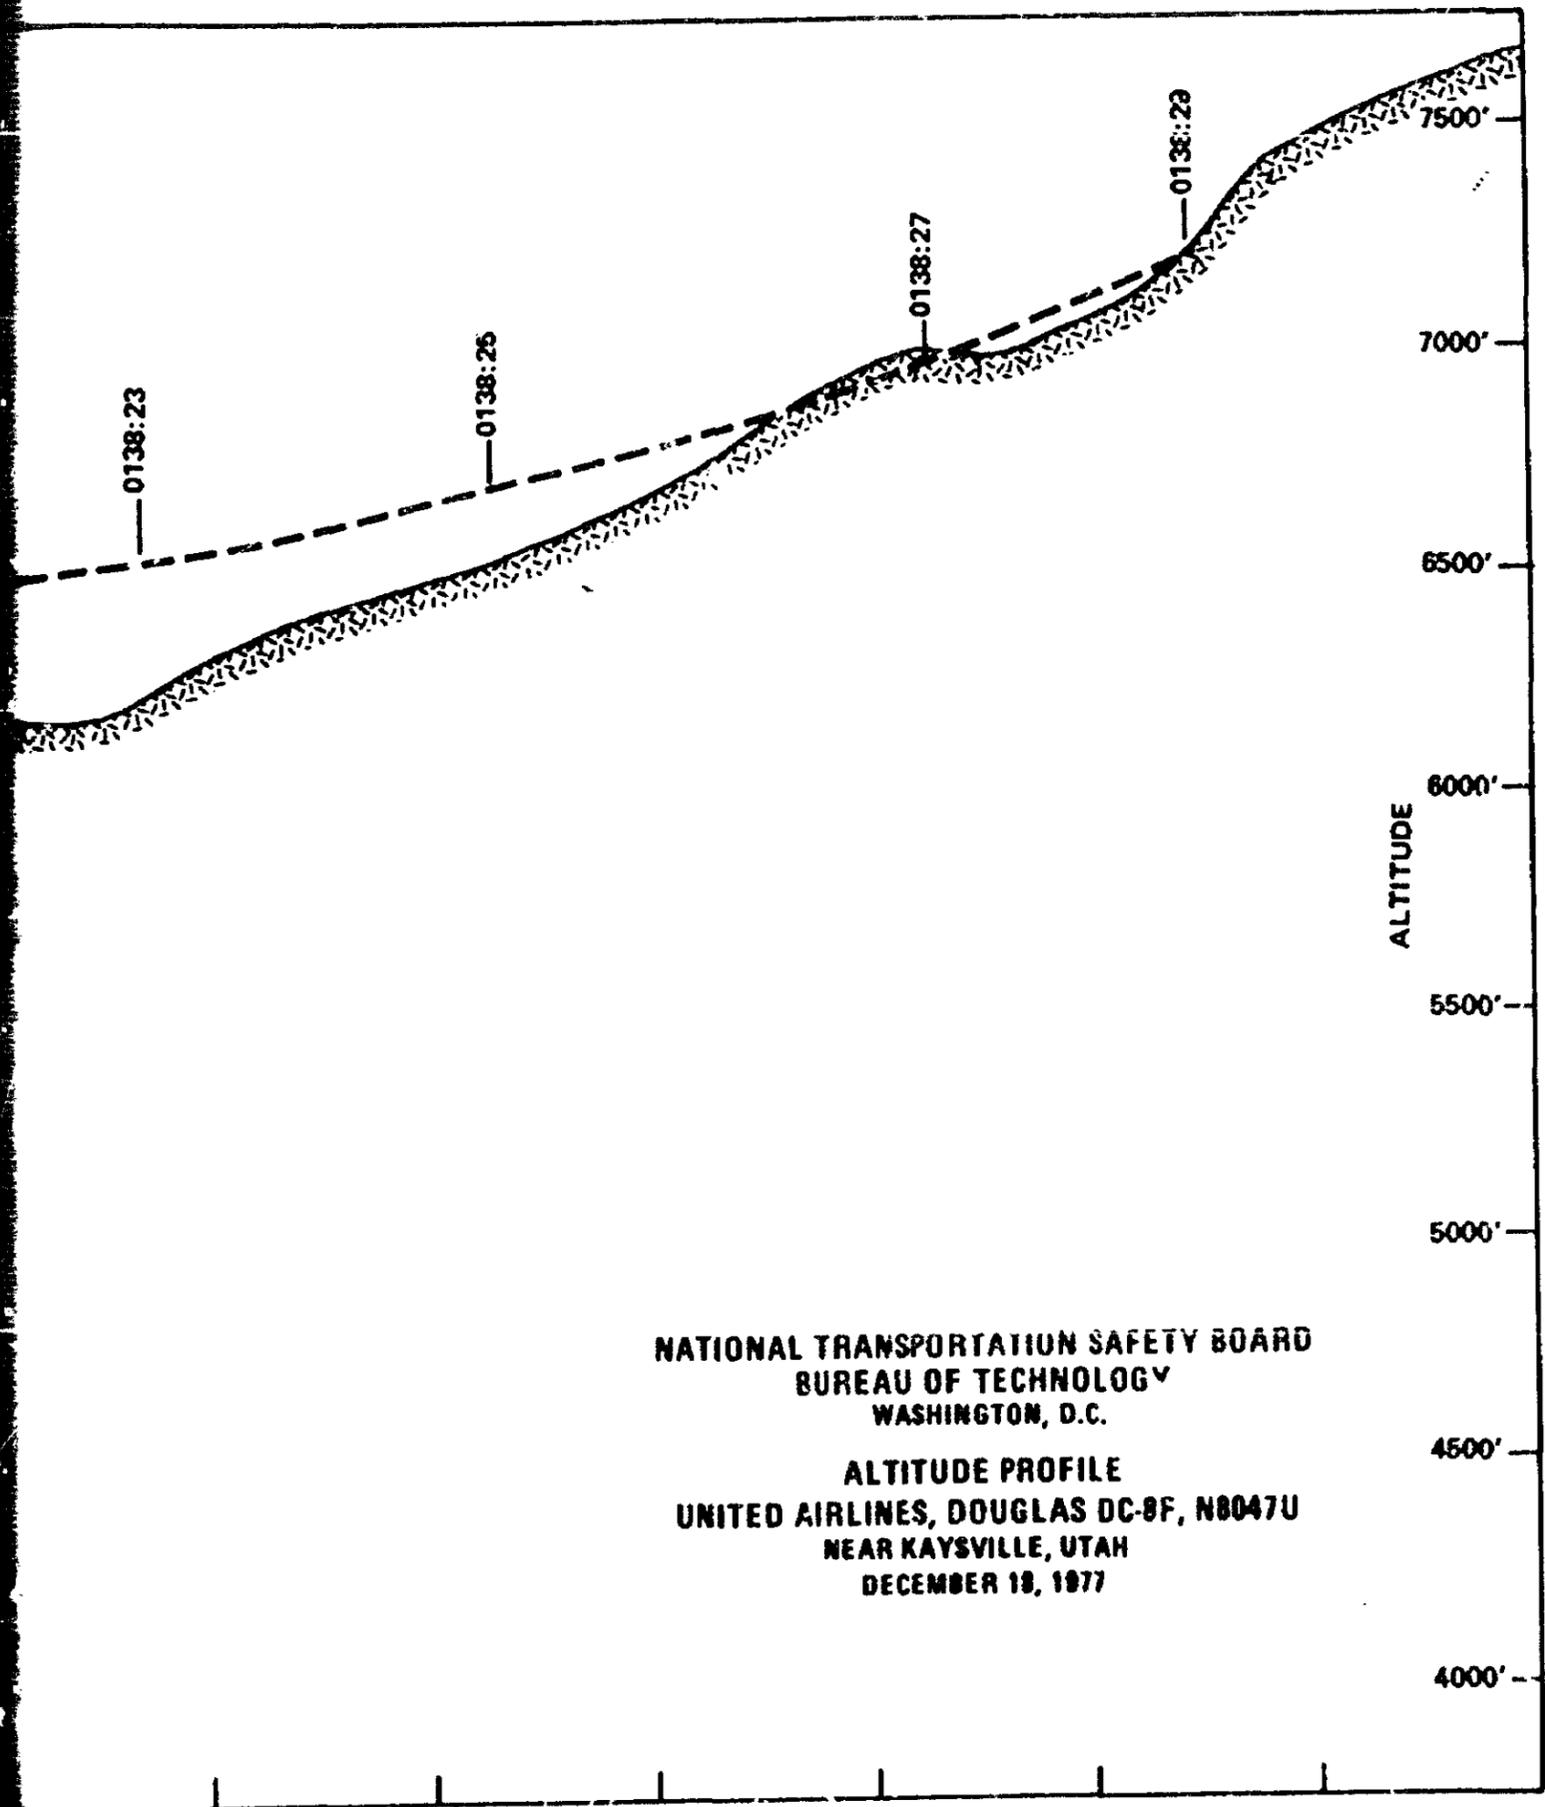
APPENDIX F

ALTITUDE PROFILE  
UNITED AIRLINES, DOUGLAS DC-8F, N8047U  
NEAR KAYSVILLE, UTAH  
DECEMBER 18, 1977
