**Aircraft Accident Report - Continental
Air Lines, Inc., Boeing 727-224, N32725,
Tucson, Arizona, June 3, 1977**

U.S. National Transportation Safety Board, Washington, D C

AIRCRAFT ACCIDENT REPORT

CONTINENTAL AIR LINES, INC.
BOEING 727-224, N32725
TUCSON, ARIZONA
JUNE 3, 1977

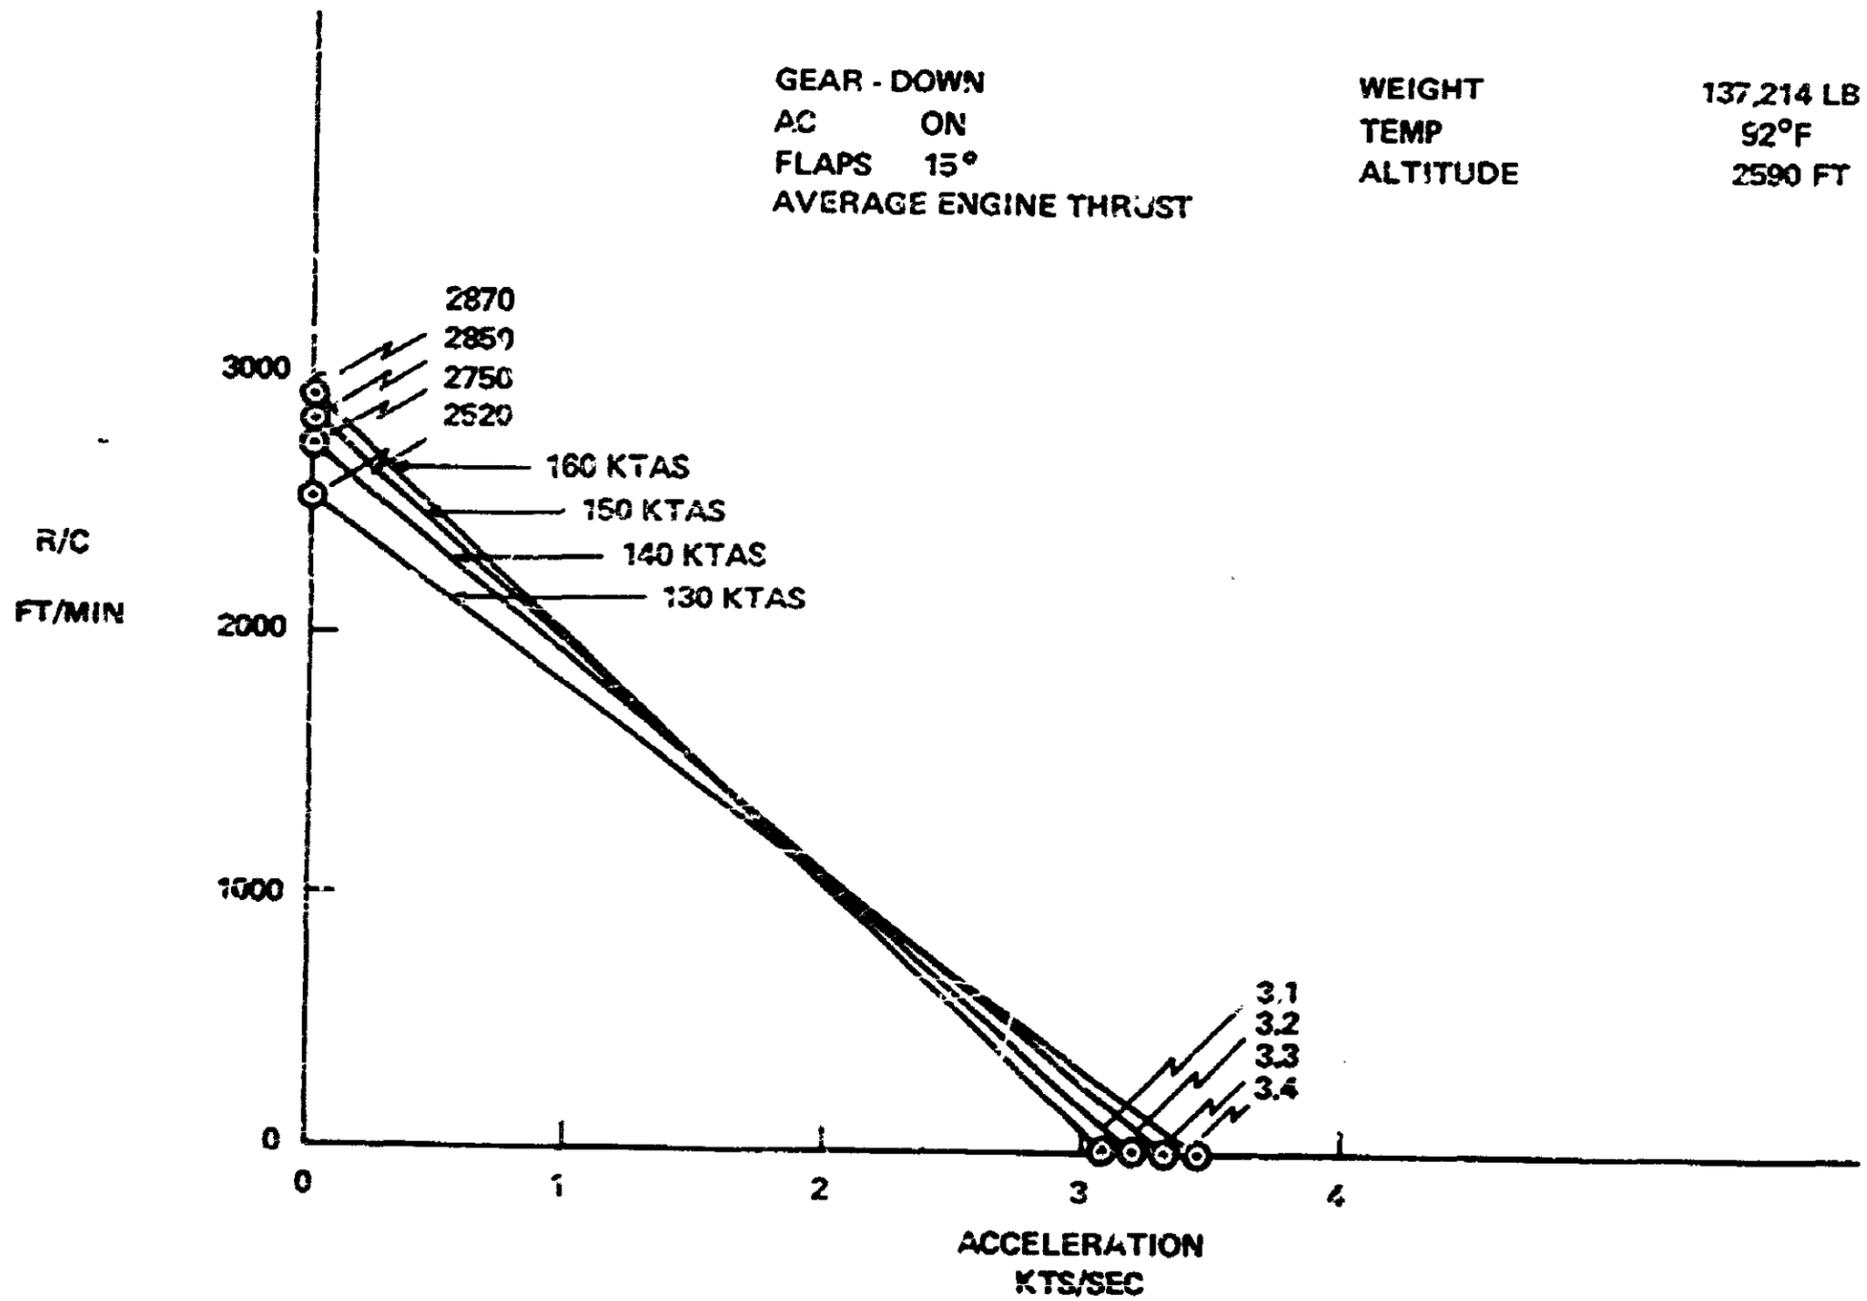
Figure 1. Acceleration vs rate of climb in ground effect Boeing 727-224.

In the first case, it was determined that when obstacle clearance became a concern, the angle of attack could have been increased to temporarily establish a steeper flightpath and clear the utility poles. Assuming that a decision was made by the pilot at a point about 710 ft from the obstacle and 20 ft above the ground at an initial airspeed of 135 kts indicated airspeed (KIAS), the average rate of climb required to clear the obstacles by 20 ft in no-wind conditions would have been 780 ft/min. If flown in winds identical to the derived wind profile, the average rate of deceleration at 780 ft/min rate of climb would have been about 2.2 kts/sec. (See Figure 1.) Thus, the airspeed above the obstacle would have been about 128 KIAS (13 KIAS above the stickshaker activation speed) and an estimated pitch attitude of at least 13° would have been required.

In the second case, it was calculated that if the highest pitch attitude reached after liftoff had been sustained, the aircraft would have cleared the obstacle. FDR data and pilot testimony indicated that pitch attitude was reduced shortly after takeoff when a drop in airspeed was noted. This probably occurred about 15 ft a.g.l. According to the captain, the initial target pitch attitude was about 11°. The FDR data indicate that the airspeed was decreasing through an airspeed of about 138 KIAS when the pitch attitude was reduced. It was determined that if the aircraft had reached and had maintained the 11° pitch attitude, it would have accelerated at an average rate of about 2.6 kts/sec. With a tailwind increasing at 4.5 kts/sec per the derived wind profile, airspeed would have been decreasing through about 125 KIAS at the utility poles and the aircraft would have been at an altitude of about 70 ft a.g.l. At Flight 63's takeoff configuration, the stickshaker would have activated at 115 KIAS and a stall would have occurred about 106 KIAS.

Significantly, the calculations for these two cases assumed that the wind effect on the aircraft, derived from the FDR data, did not change as altitude increased. There are several schools of thought regarding the wind velocities at altitude in the vicinity of thunderstorms. The best evidence indicates that vertical wind speeds associated with thunderstorm downdraft activity diminish rapidly below 300 ft and that the direction of movement changes to a horizontal outflow.
