Aircraft Accident Report - Midair Collision
Involving a Falcon Jet, N121GW and a
Cessna 150M, N6423K, Memphis, Tennessee, May 18, 1978

1. Report No. NTSB-AAR-78-14	2. Government Accession No.	3. Recipient's Catalog No.	
4. Title and Subtitle Aircraft Accident Report - Midair Collision Involving a Falcon Jet, N121GW and a Cessna 150M, N6423K, Memphis, Tennessee, May 18, 1978		5. Report Date November 30, 1978

MIDAIR COLLISION
FALCON JET DA-20, N121GW
AND
CESSNA 150M, N6423K
MEMPHIS, TENNESSEE
MAY 18, 1978

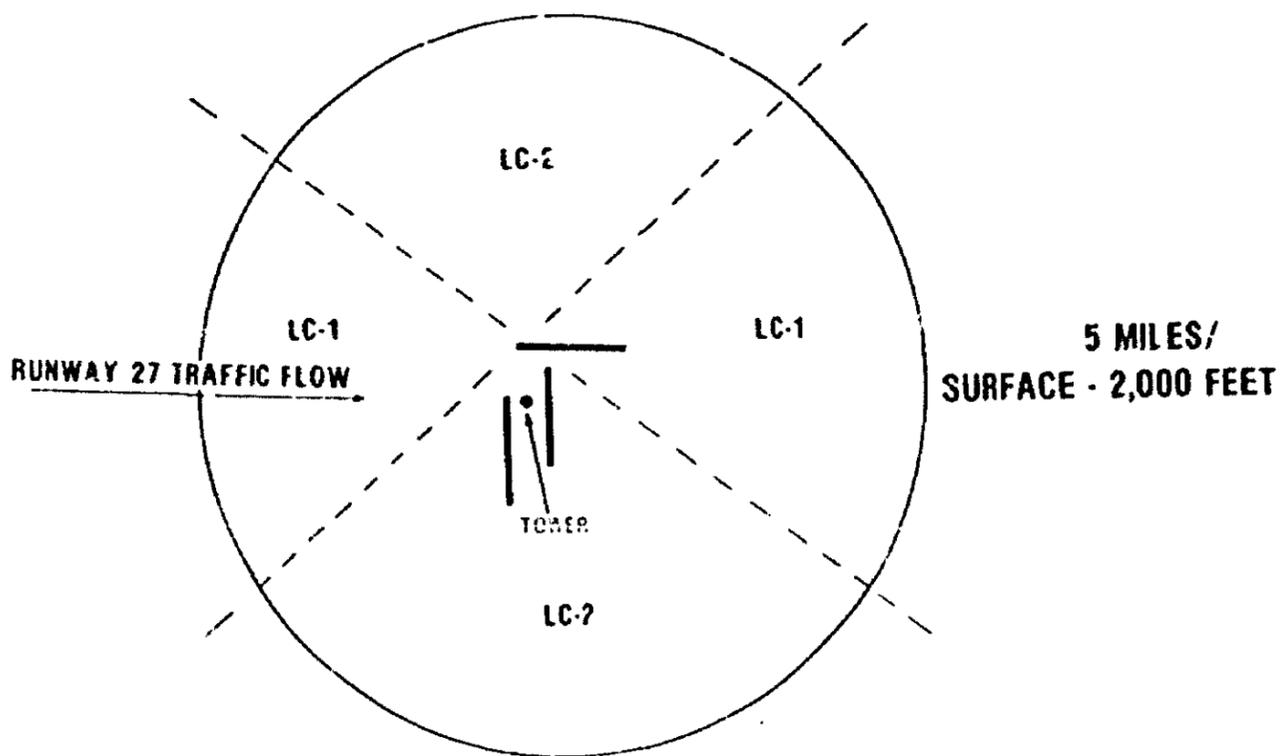
Figure 1. Memphis local controller area of responsibility.

The local controllers, LC1 and LC2, were responsible for controlling traffic in the airspace within a 5-mile radius of the airport from the surface to 2,000 feet. LC1, who controlled operations on runway 9/27, was assigned the airspace east and west of the airport. The airspace north and south of the airport was controlled by LC2, who was responsible for aircraft operations on runways 17L/R and 35L/R. LC1 and LC2 were physically located within 10 ft of each other but operated on separate frequencies. (See figure 1.) On the day of the accident, LC1 and LC2 assumed their operating positions at 1150.

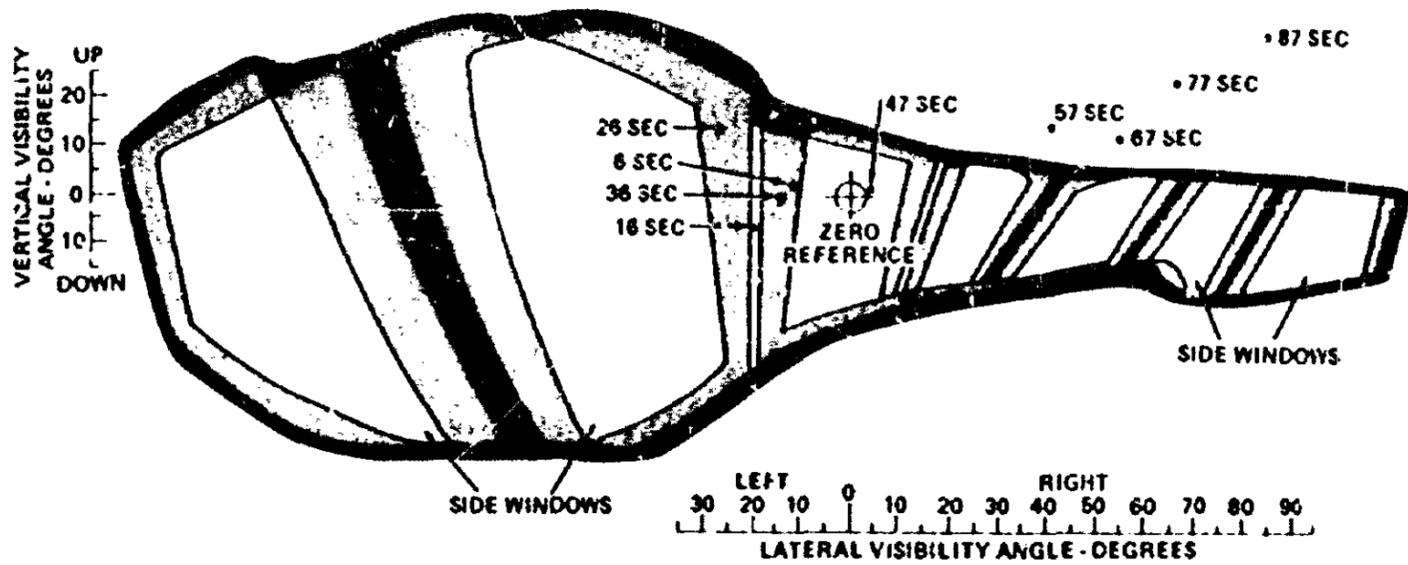
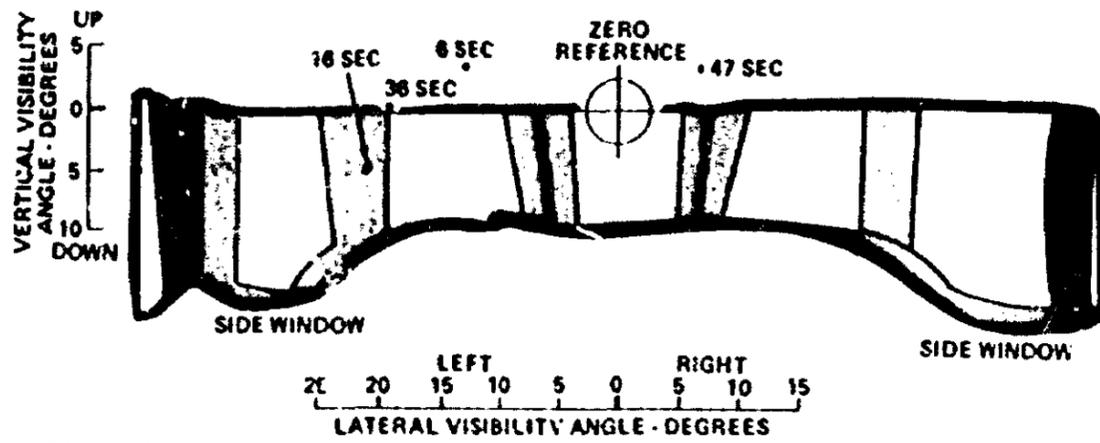
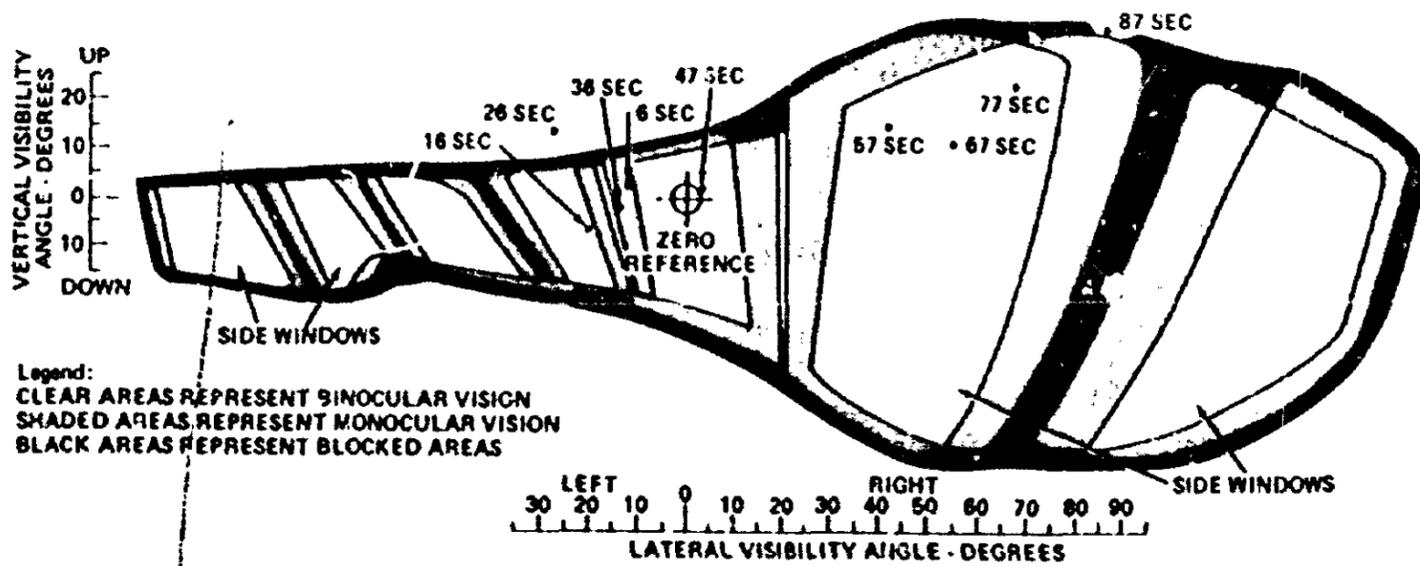
Figure 2. Falcon Jet visibility from design eye reference points.

^{5/} A dual lens camera was used to record a panoramic view from the design eye reference point from each cockpit seat. These binocular photographs show the field of vision of each seat occupant based on his fixed-eye reference point.

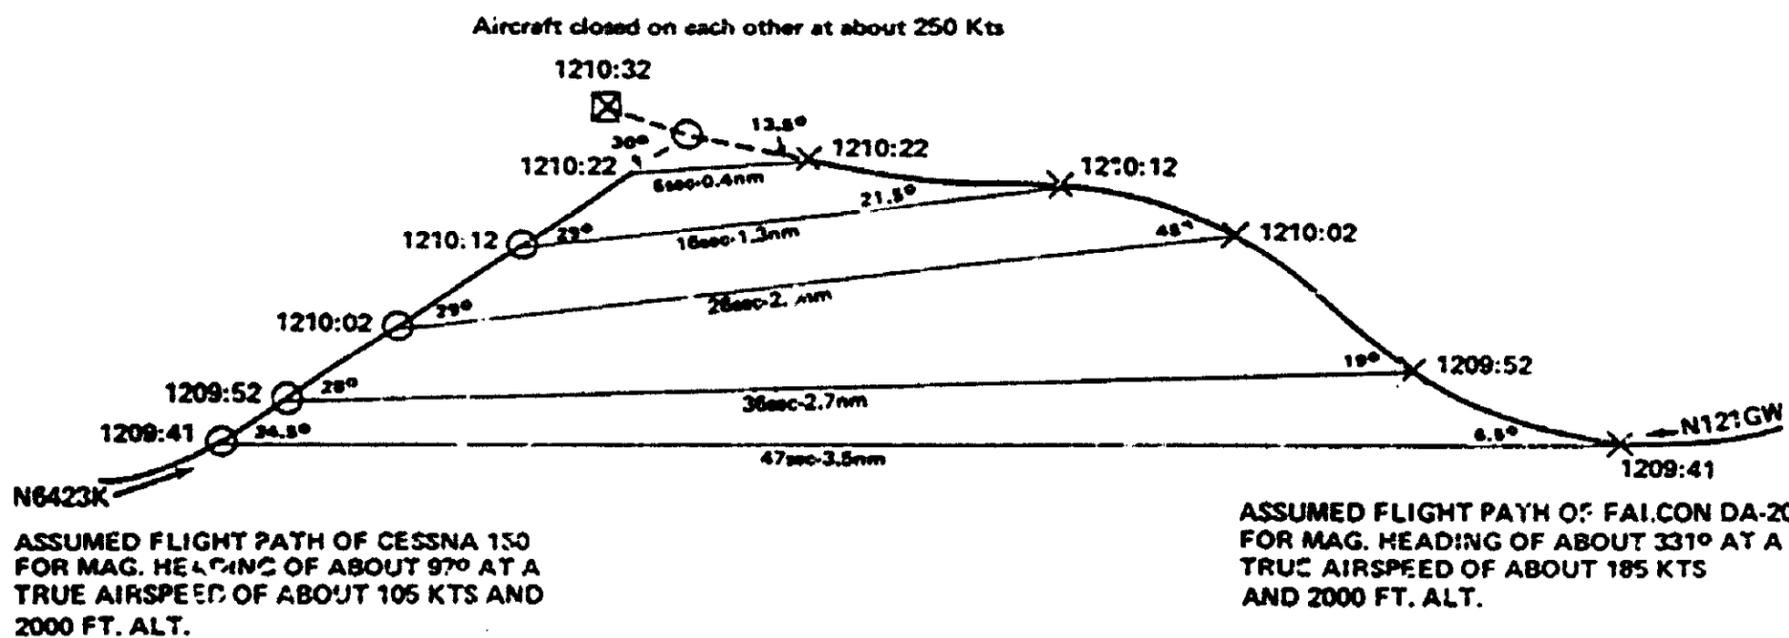
Figure 4. Probable flightpath.

Based on the communications from the local controllers to both aircraft, on radar data, on the scratch-mark analysis, and on the wreckage orientation, the Falcon Jet was probably returning to its assigned heading of 350° and passing through 331° when it was hit. This conclusion is supported by the 330° heading indicated on the copilot's radio magnetic indicator. Although the damage to the directional indicator on the Cessna would imply that the aircraft was on a heading of 108° magnetic, it appears more likely that its heading was about 097° magnetic. That heading correlates with the scuff marks on the wreckage, the radar position plot, and the heading which would be expected had the aircraft been proceeding to the position for a downwind entry for runway 27. Based on reported wind velocities and direction, true airspeeds would have been about 185 kns for the Falcon Jet and 105 kns for the Cessna. This collision geometry indicates that the planes collided 3 or 4 seconds before the single primary radar return was received at 1210:32. (See Appendix C.)

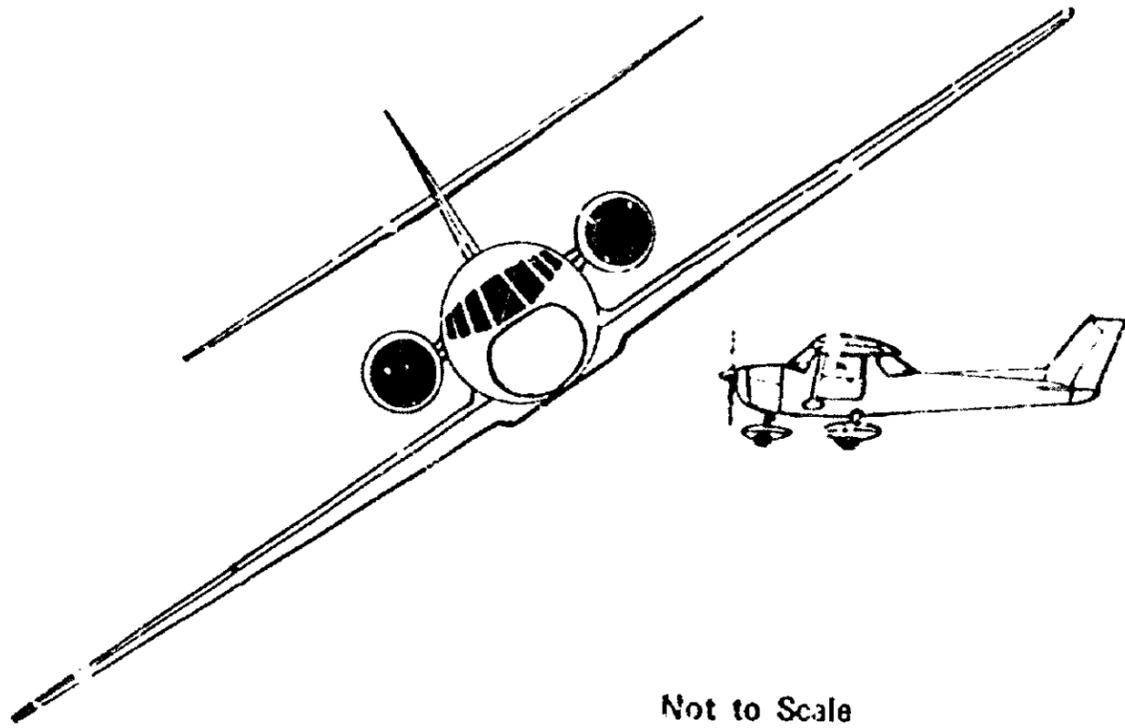
Figure 5. Relative positions of aircraft at impact.

The Cessna 150 fragmented before ground impact. The right wing, which separated from the fuselage, exhibited a concaved leading edge just outboard of the right wing fuel tank. Blue paint scuff marks were noted at various locations on this wing leading edge.

The left wing leading edge, from the wing/fuselage root fairing outboard to rib 5, was broken into pieces of various sizes. Extensive red paint scuff marks were found on the lower skin surface. The red scuff marks extended outboard at 30° from the wing root rib for a distance of 69 inches. The scuff marks extended from the leading edge lower surface aft to the forward edge of the skin panel just forward of the rear spar. The red scuff marks were measured near the leading edge and near the wing root rib. This angle measured 27° from the wing root rib direction. The scuff mark angles after the initial impact point showed varied inconsistent angles.
