**Aircraft Accident Report - Columbia  
Pacific Airlines, Beech 99, N199EA,  
Richland, Washington, February 10, 1978**

**(U.S.) National Transportation Safety Board, Washington, DC**

**21 Dec 78**

COLUMBIA PACIFIC AIRLINES  
BEECH 99, N199EA  
RICHLAND, WASHINGTON  
FEBRUARY 10, 1978

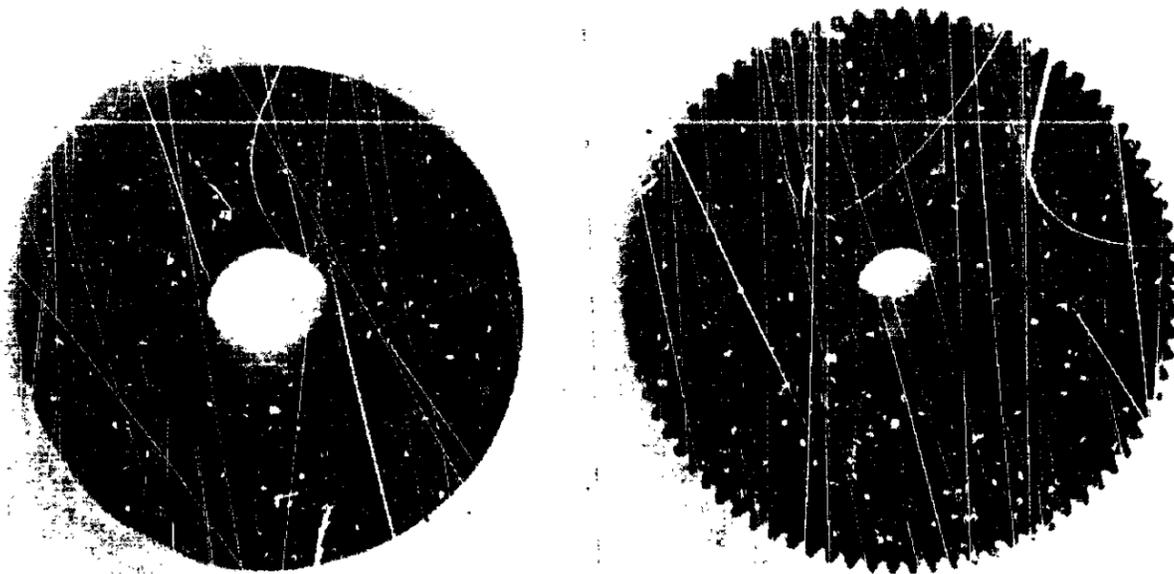
Safety Board investigators examined the actuator manufactured by the Talley Corporation of Newbury Park, California, at Talley's facility. Four of the ball bearings were loose and were outside the clutch detent plate--all exhibited little to no wear. Two ball bearings within the detent plate were worn to an oval shape. Engineering specifications require a 0.045-inch clearance between the spacer and the clutch output gear. When the clearance was measured with four unworn balls installed in the clutch, there was not sufficient clearance to allow a normal size ball bearing to miss the detent plate. (See figures 5 through 8.)

Figure 7. Bearing faces of the ball retainer (left) and torque limit gear (right). Brackets indicate rings of ball material deposited on these components. X2

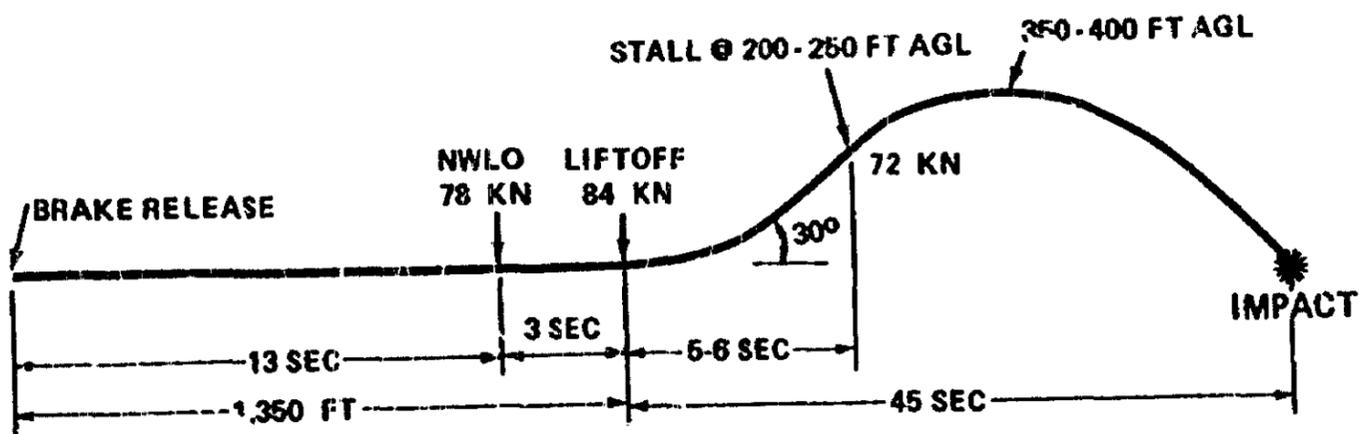
Figure 9. Flight profile of N199EA.

The tests disclosed that the nosewheel lifted off at 78 KIAS and the aircraft lifted off at 84 KIAS with the stabilizer in the full noseup trim position. The aircraft flight manual requires a liftoff speed of 94 KIAS for a maximum gross weight takeoff. Ground roll distance from brake release to liftoff was 1,350 ft--nearly the same distance averaged from witness statements. Control wheel push forces did not become significant until after liftoff.
