Aircraft Accident Report - E. S. M. Group, Inc.  
Cessna Citation, N51MW and North Central Airlines, Inc.  
DC-9-30, N957N, La Guardia Airport, Flushing, New York  
June 21, 1978

1. Report No. NTSB-AAR-79-3	2. Government Accession No.	3. Recipient's Catalog No. <i>NTISUB/L/104-003</i>	
4. Title and Subtitle Aircraft Incident Report - E.S.M. Group, Inc., Cessna Citation, N51MW, North Central Airlines, Inc., DC-9-30, N957N, La Guardia Airport, Flushing, New York, June 21, 1978		5. Report Date February 22, 1979

AIRCRAFT INCIDENT REPORT

E.S.M. GROUP, INC., CESSNA CITATION, N51MW  
NORTH CENTRAL AIRLINES, INC.  
DC-9-30, N957N  
LA GUARDIA AIRPORT, FLUSHING, NEW YORK  
JUNE 21, 1978

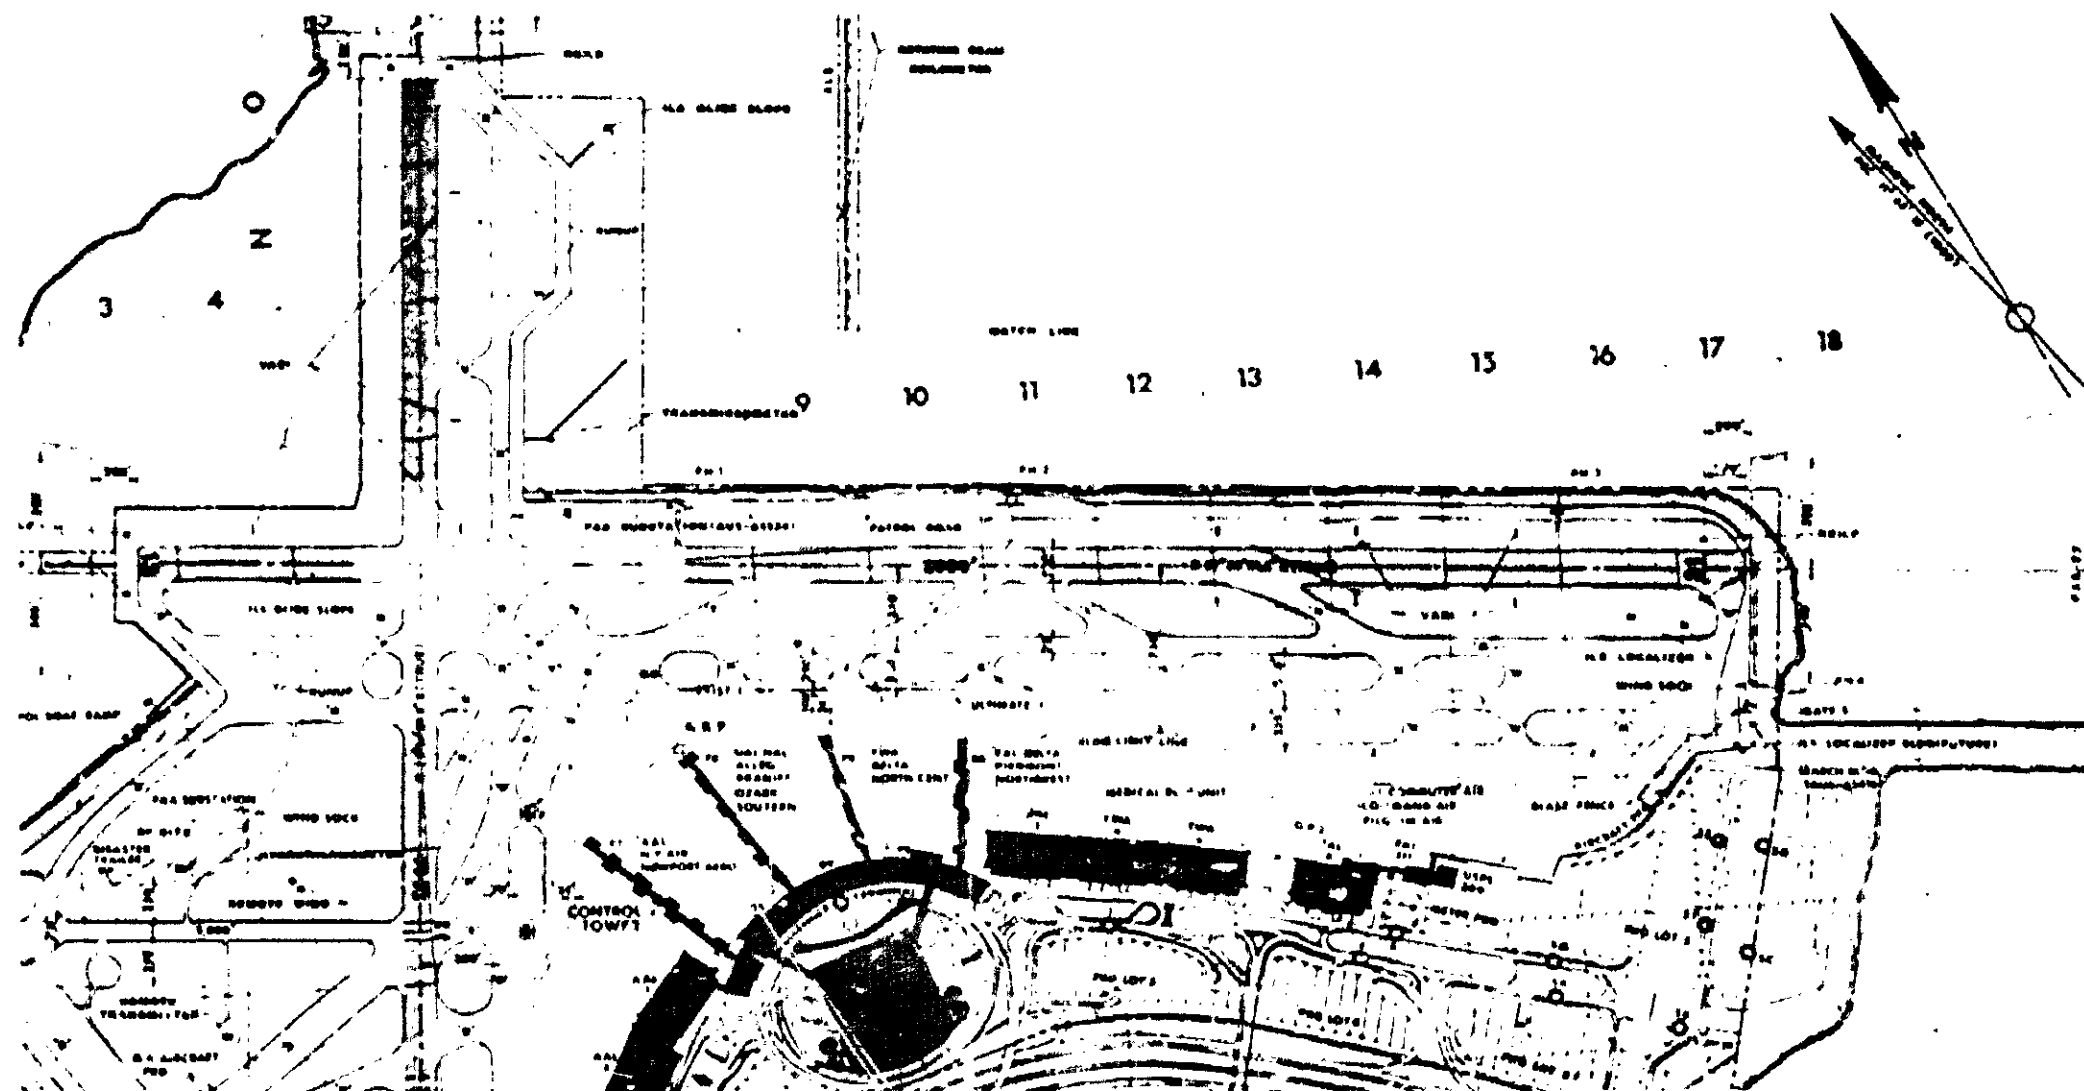
Figure 1. La Guardia Airport Runway 13/31 and Associated Taxiways.

The captain said that he taxied on one engine. The taxi route required a right turn of almost 135° from taxiway Oscar to taxiway Tango and a left turn of almost 135° from Tango onto runway 31. Because the left turn onto the runway was more than 90°, he could not see the northwest end of the runway when he began the turn. As he was completing the turn -- the captain estimated he had "about 40° to go" -- he saw two lights coming down the runway at a high rate of speed. Shortly thereafter, he said he saw rotating beacons around the lights. He stopped his airplane and turned on his landing lights. The DC-9 stopped with its nose just over the runway's centerline. The flightcrew was not monitoring the local control frequency nor were they required to do so.

The 135° left turn from taxiway Tango to the active runway made it almost impossible for the DC-9 flightcrew to see the takeoff end of runway 13 before they began the turn and during the initial stages of the turn.

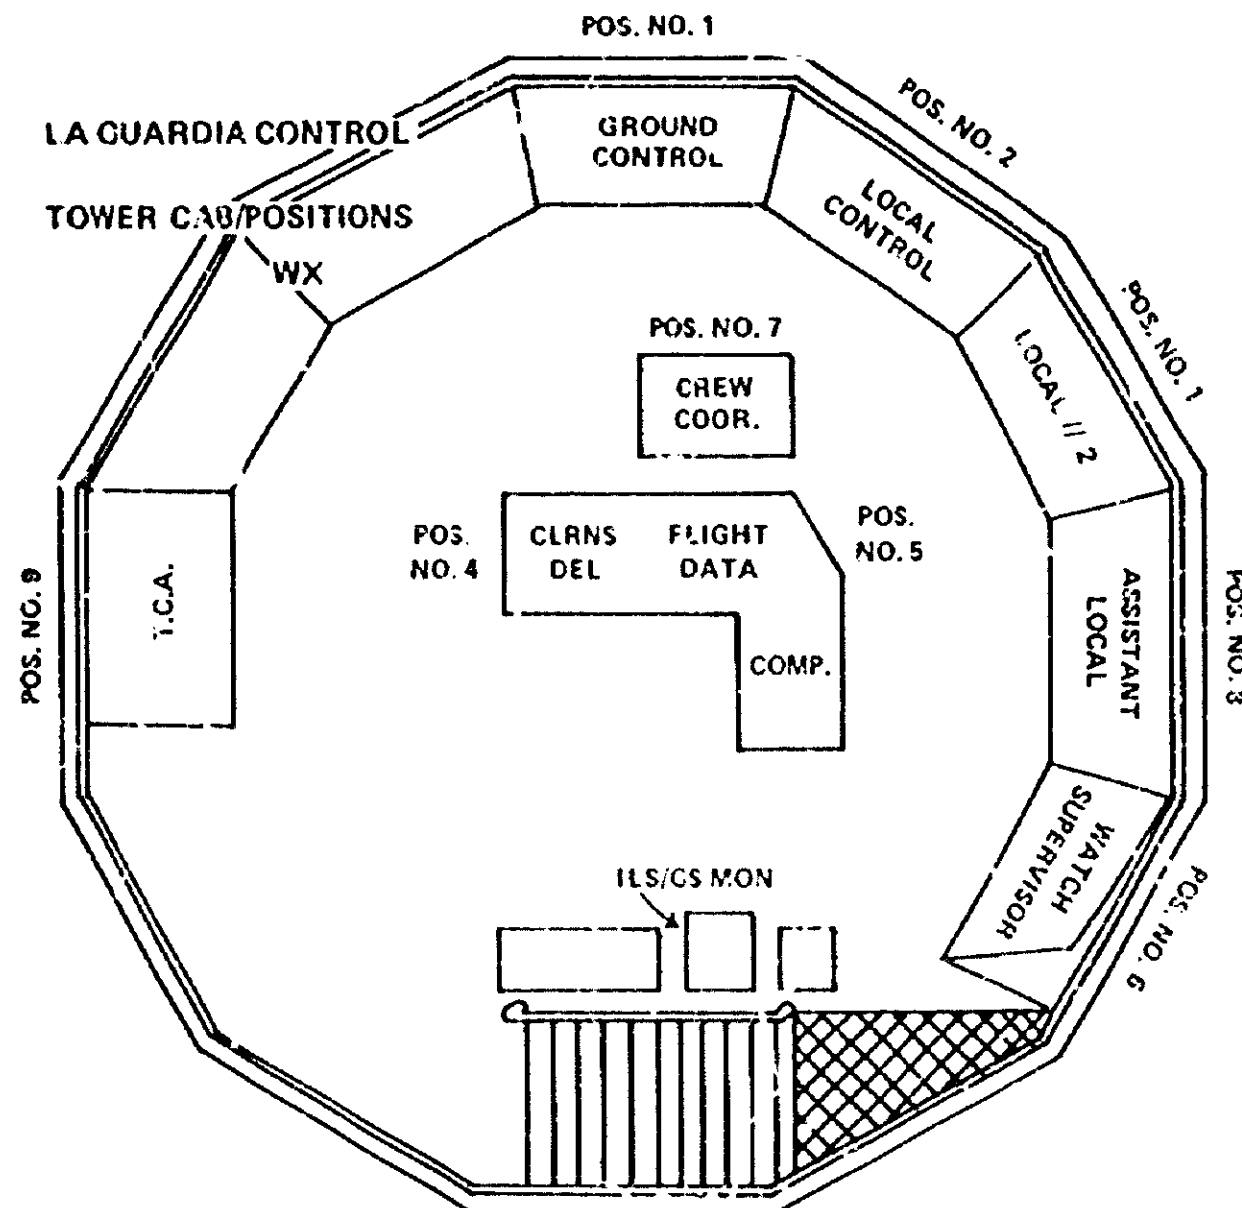
Figure 2. La Guardia control tower Cab positions.

The local controller and ground controller are positioned approximately side by side in the tower cab. The crew coordinator is positioned between and behind the ground and local controller positions. (See figure 2.) The local controller is responsible for handling all arriving and departing traffic and has the responsibility for the use of all runways on the airfield. The ground controller is responsible for the handling of ground movements of aircraft.
