NATIONAL TRANSPORTATION SAFETY BOARD

AIRCRAFT ACCIDENT REPORT

**LAS VEGAS AIRLINES
PIPER PA-31-350, N44LV**

**LAS VEGAS, NEVADA
AUGUST 30, 1978**

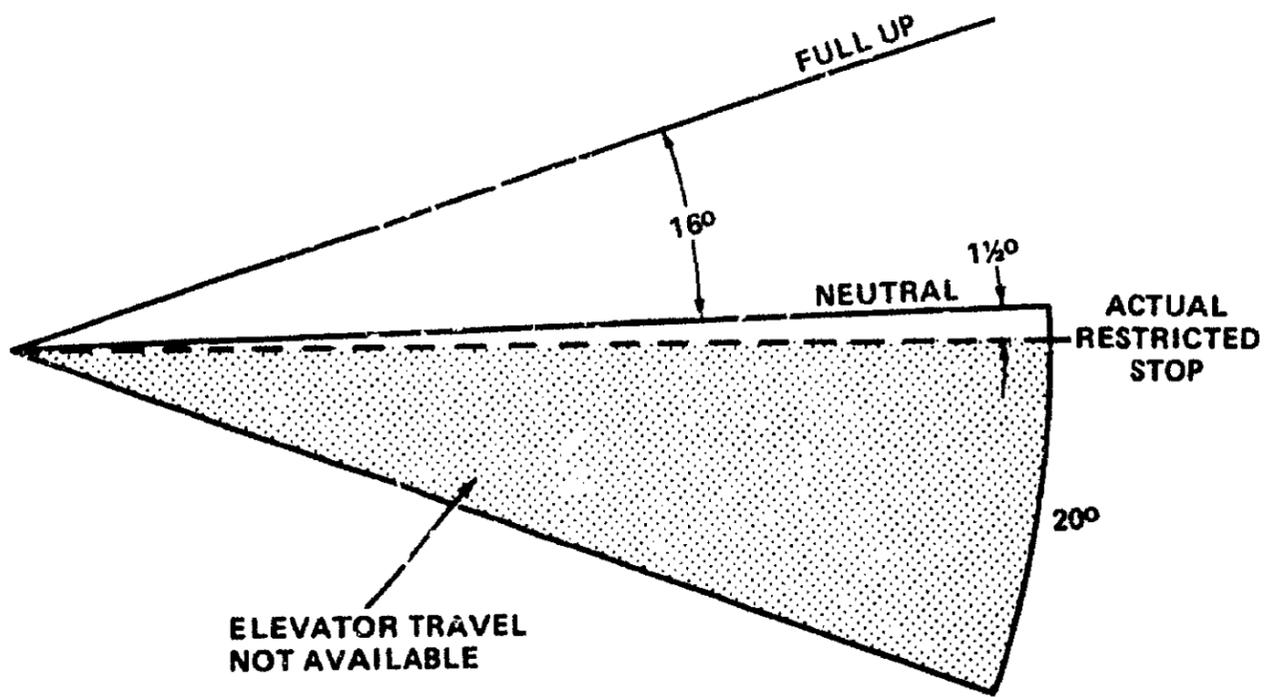
Figure 2. Elevator down travel restriction resulting from backed out down stop.

Except for the backed out elevator control stop bolt, all flight controls, flight control surfaces, and cables showed no evidence of preimpact failures or binding. The elevator down-stop bolt was found backed out from its correct position, which limited down elevator deflection to a maximum of 1 1/2°.

8. The down elevator control stop was found backed out from its normal installed position. The position of the bolt limited the down elevator travel to only 1 1/2° of a normal 20° range.
