**Aircraft Accident Report - Near Collision of Delta Air
Lines, Inc., Boeing 727-200, N467DA, and Flying Tiger,
Inc., Boeing 747-F, N804FT, O'Hare International Airport
Chicago, Illinois, February 15, 1979**

1. Report No. NTSB-AAR-79-11	2. Government Accession No.	3. Recipient's Catalog No.	
4. Title and Subtitle Aircraft Accident Report, Delta Air Lines, Inc., Boeing 727-200, N467DA and Flying Tiger, Inc., Boeing 747-F, N804FT, O'Hare International Airport, Chicago, Illinois, February 15, 1979		5. Report Date August 2, 1979

DELTA AIR LINES, INC., BOEING 727-200, N467DA
AND
FLYING TIGER, INC., BOEING 747-F, N804FT
O'HARE INTERNATIONAL AIRPORT, CHICAGO, ILLINOIS
FEBRUARY 15, 1979

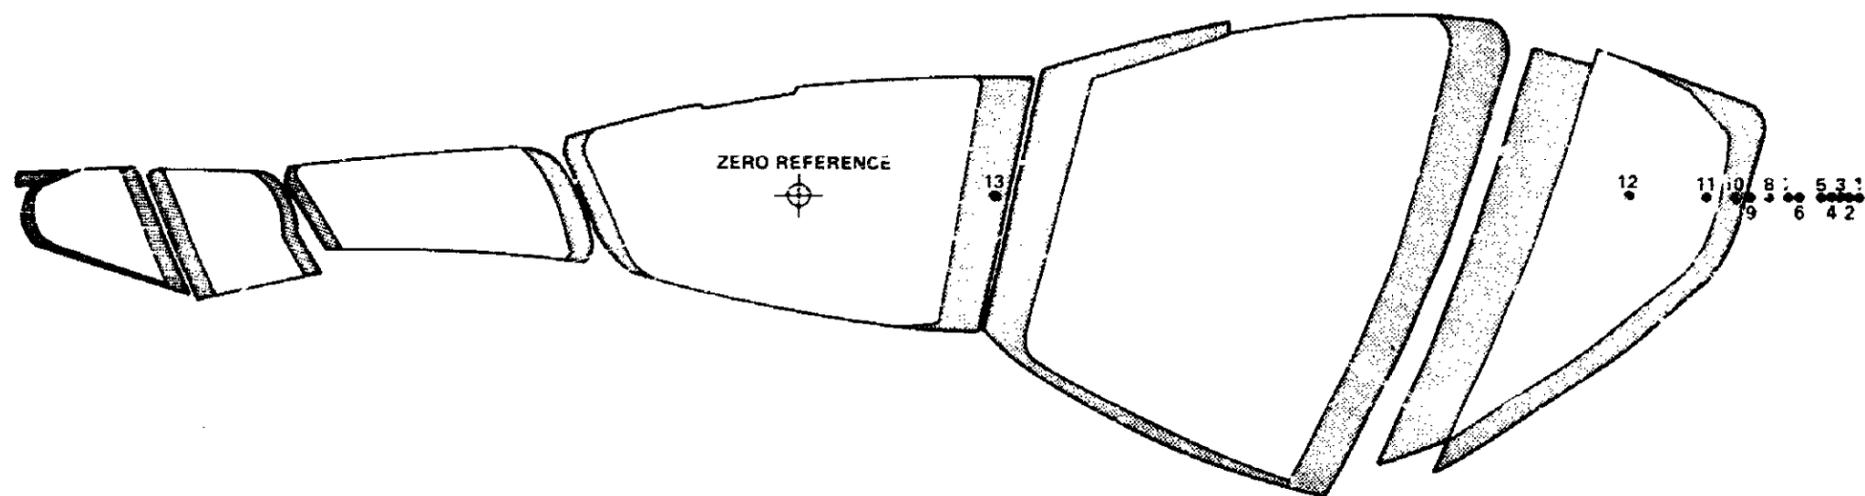
FIGURE 1

• REPRESENTS LOCATION OF BOEING 747
NAFEC PHOTO AJB DECEMBER 1978

NUMBERS DENOTE TIME AND POSITION OF B-747
AS REFERENCED APPENDIX D

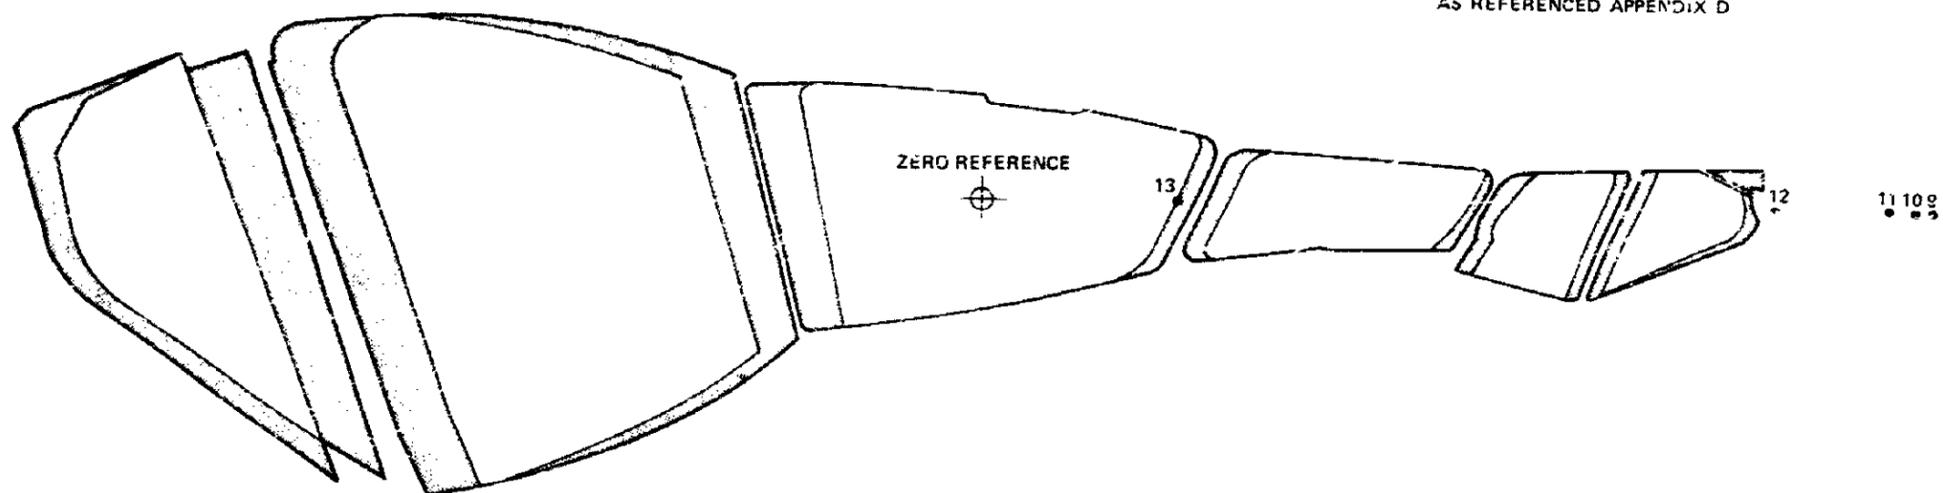
FIGURE 2

BOEING 727-200 QD326
AIRCRAFT POSITION: LEVEL
CAPTAIN'S NORMAL EYE REFERENCE POINT
CAMERA POSITION:
27.22" AFT OF INSTRUMENT PANEL LOWER EDGE
20" LEFT BUTT LINE
46" ABOVE DECK

• REPRESENTS LOCATION OF BOEING 747
NAFEC PHOTO AJ3 DECEMBER 1978

NUMBERS DENOTE TIME AND POSITION OF B-747
AS REFERENCED APPENDIX D

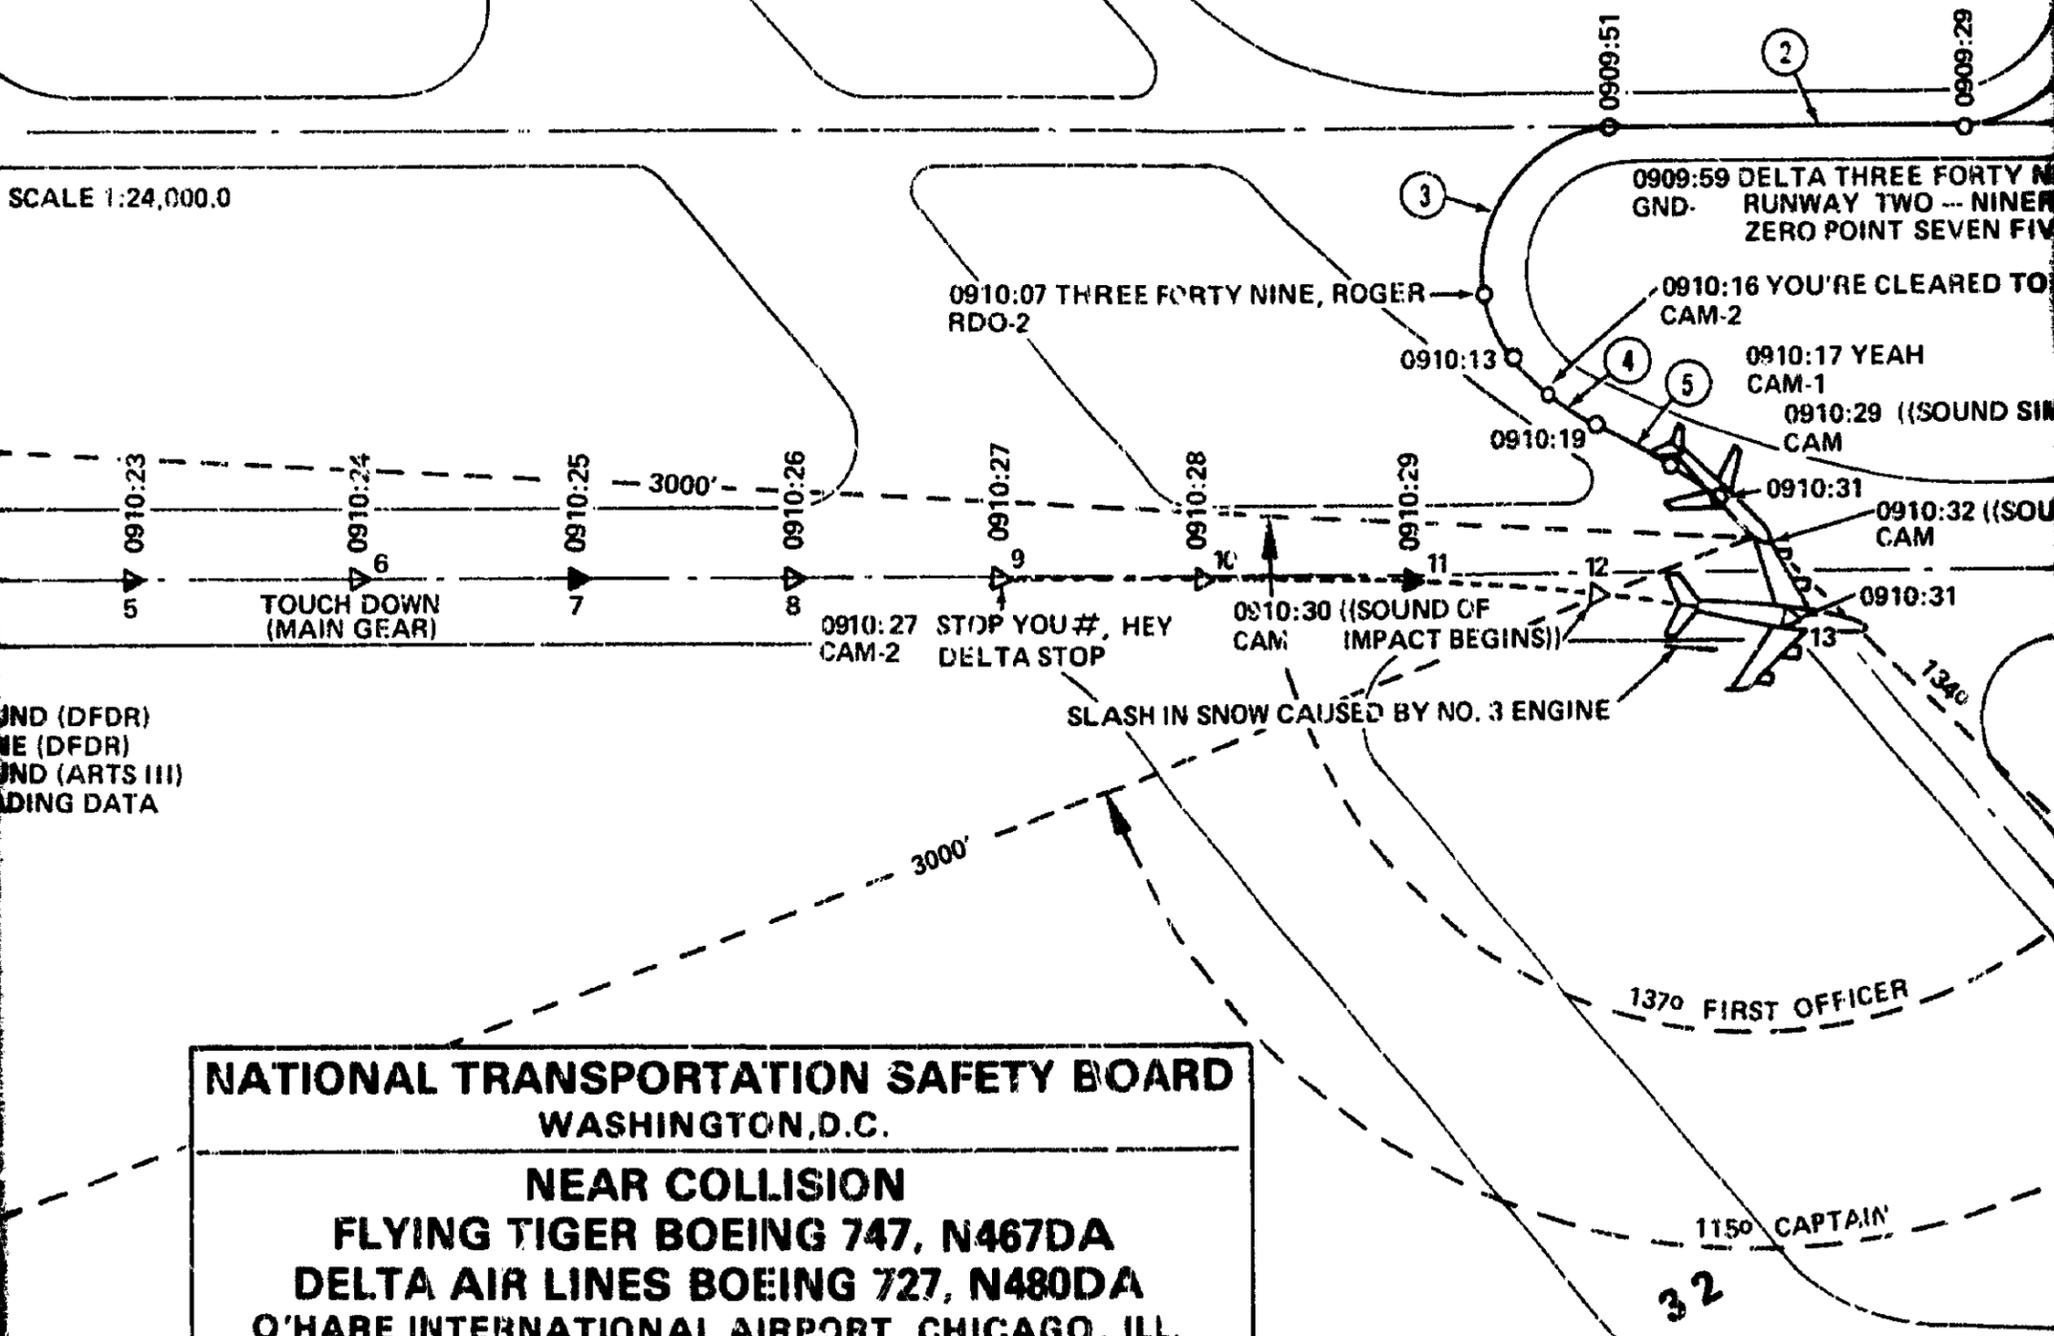
APPENDIX D

NEAR COLLISION
FLYING TIGER BOEING 747, N467DA
DELTA AIR LINES BOEING 727, N480DA
 O'HARE INTERNATIONAL AIRPORT, CHICAGO, ILL.
 FEBRUARY 15, 1979 DCA 79-A-A003

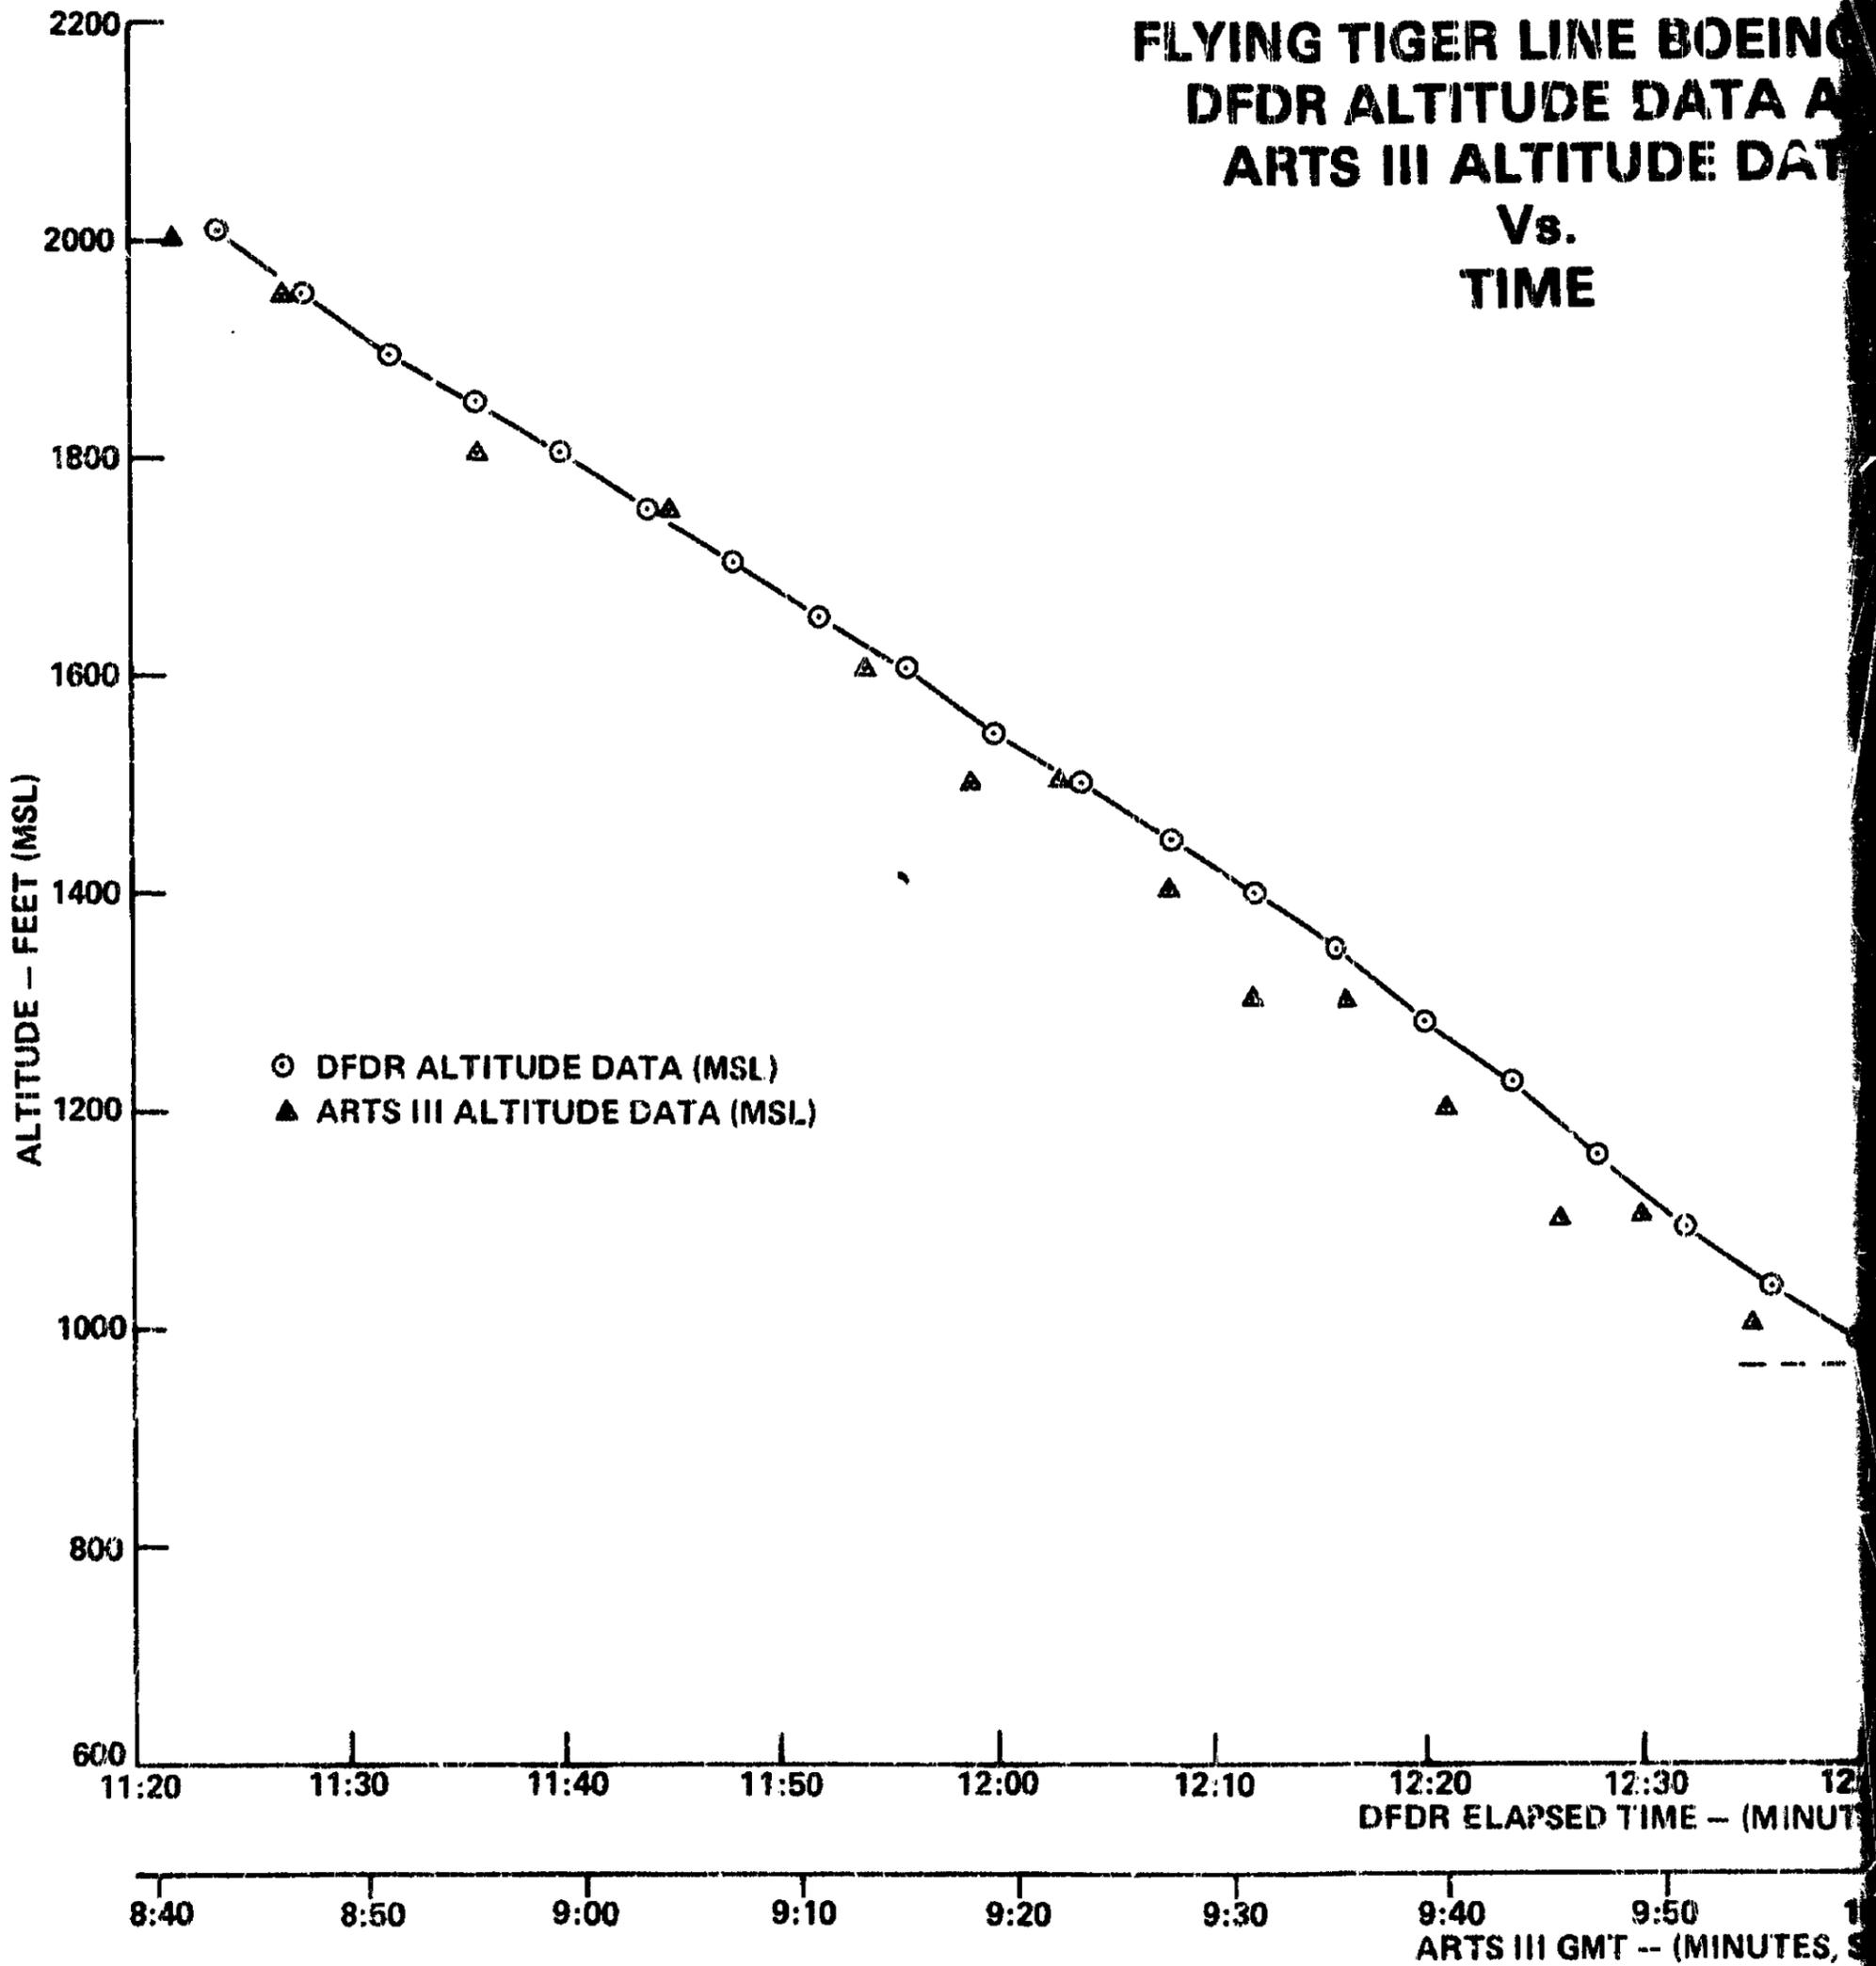
**FLYING TIGER LINE BOEING
DFDR ALTITUDE DATA AND
ARTS III ALTITUDE DATA
Vs.
TIME**

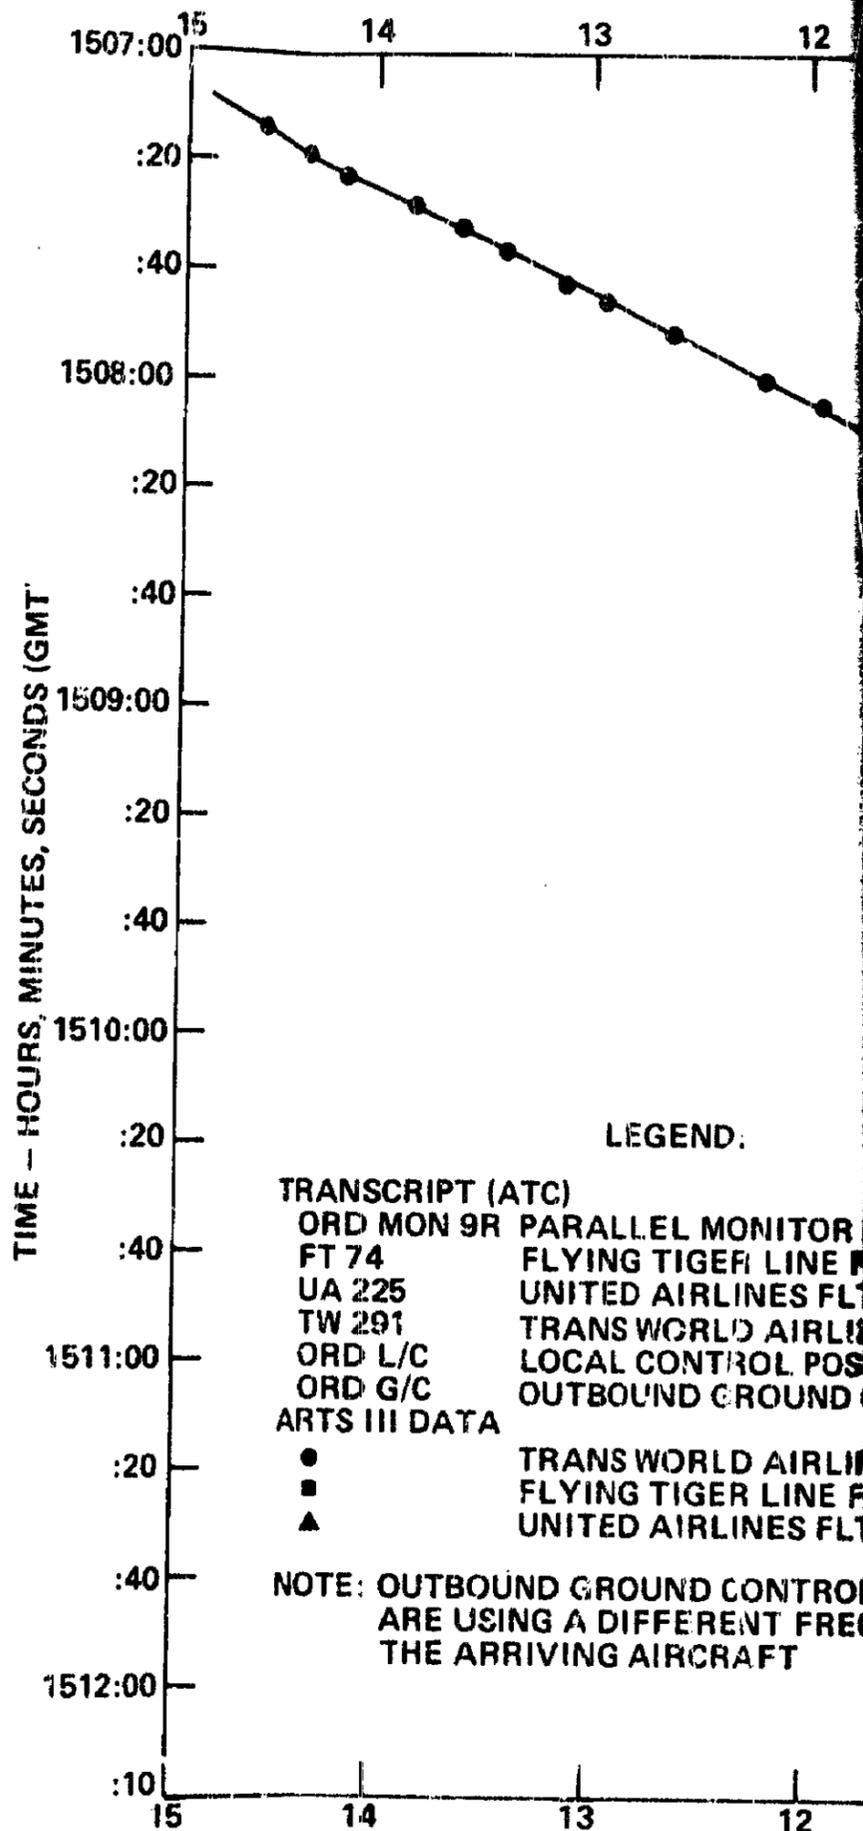
PLOT OF LANDING SEPARATION DISTANCE Vs. TIME (GMT)
