# NATIONAL TRANSPORTATION SAFETY BOARD

## AIRCRAFT ACCIDENT REPORT

NEW YORK AIRWAYS, INC.  
SIKORSKY S61-L, N618PA  
NEWARK, NEW JERSEY  
APRIL 18, 1979

NTSB-AAR-79-14

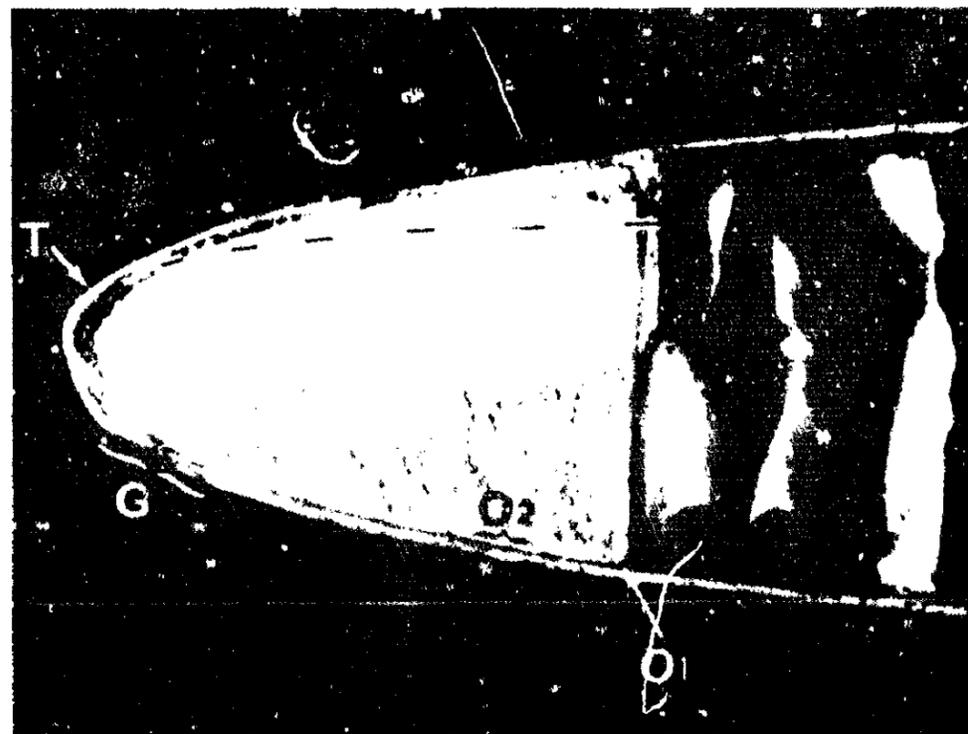
The black tail rotor blade separated about 15 in. from the butt end of the blade. An area of disturbed paint extended along a line from a point on the trailing edge at the fracture to a point near the leading edge at the tip of the blade. The inboard surface contained a similar, but smaller, area of disturbed paint. (See Figure 1.) The inboard portion of the blade had been damaged substantially after the outboard portion separated from it.

Figure 1. Overall view of the outboard face of the fractured tail rotor blade. (Arrows denote line of disturbed paint.)

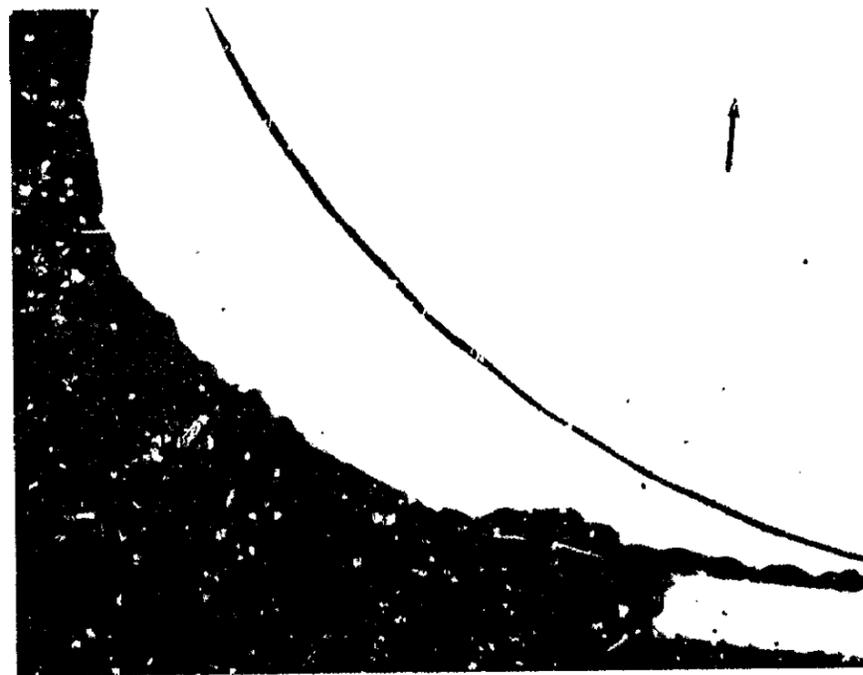
The area of the spar in which fatigue originated is shown in Figure 3. A dark stain was found in the immediate origin area. The most probable location of the origin would be at the center of this stain area as shown by the arrow in Figure 3.

Figure 3. High magnification visible light photograph of the origin of the fracture on the spar (arrow). X400

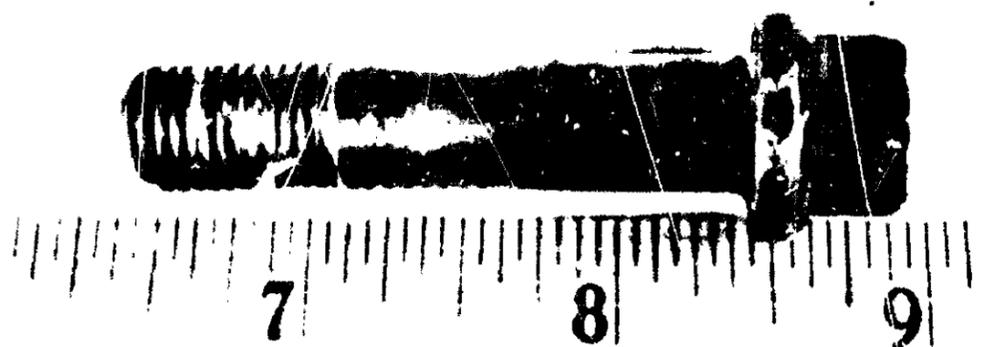
The tail rotor gearbox was bolted to the tail boom through four mounting flanges. Three of the gearbox mounting flanges had fractured and at the the fourth flange, the left aft position, the barrel nut had become disengaged from the bolt. All fractures in the mounting flanges of the gearbox appeared typical of overload separations. (See Figure 5.)

Figure 5. Tail rotor gearbox mounting bolts and nuts with fractured pieces of the gearbox mounting flanges.

The failure of the rotor blade generated an unbalanced force in the rotor system which caused three of the four tail gearbox attachment lugs to fail under static overload. As a result, the tail rotor and tail rotor gearbox assemblies separated from the helicopter and complete directional control was lost.

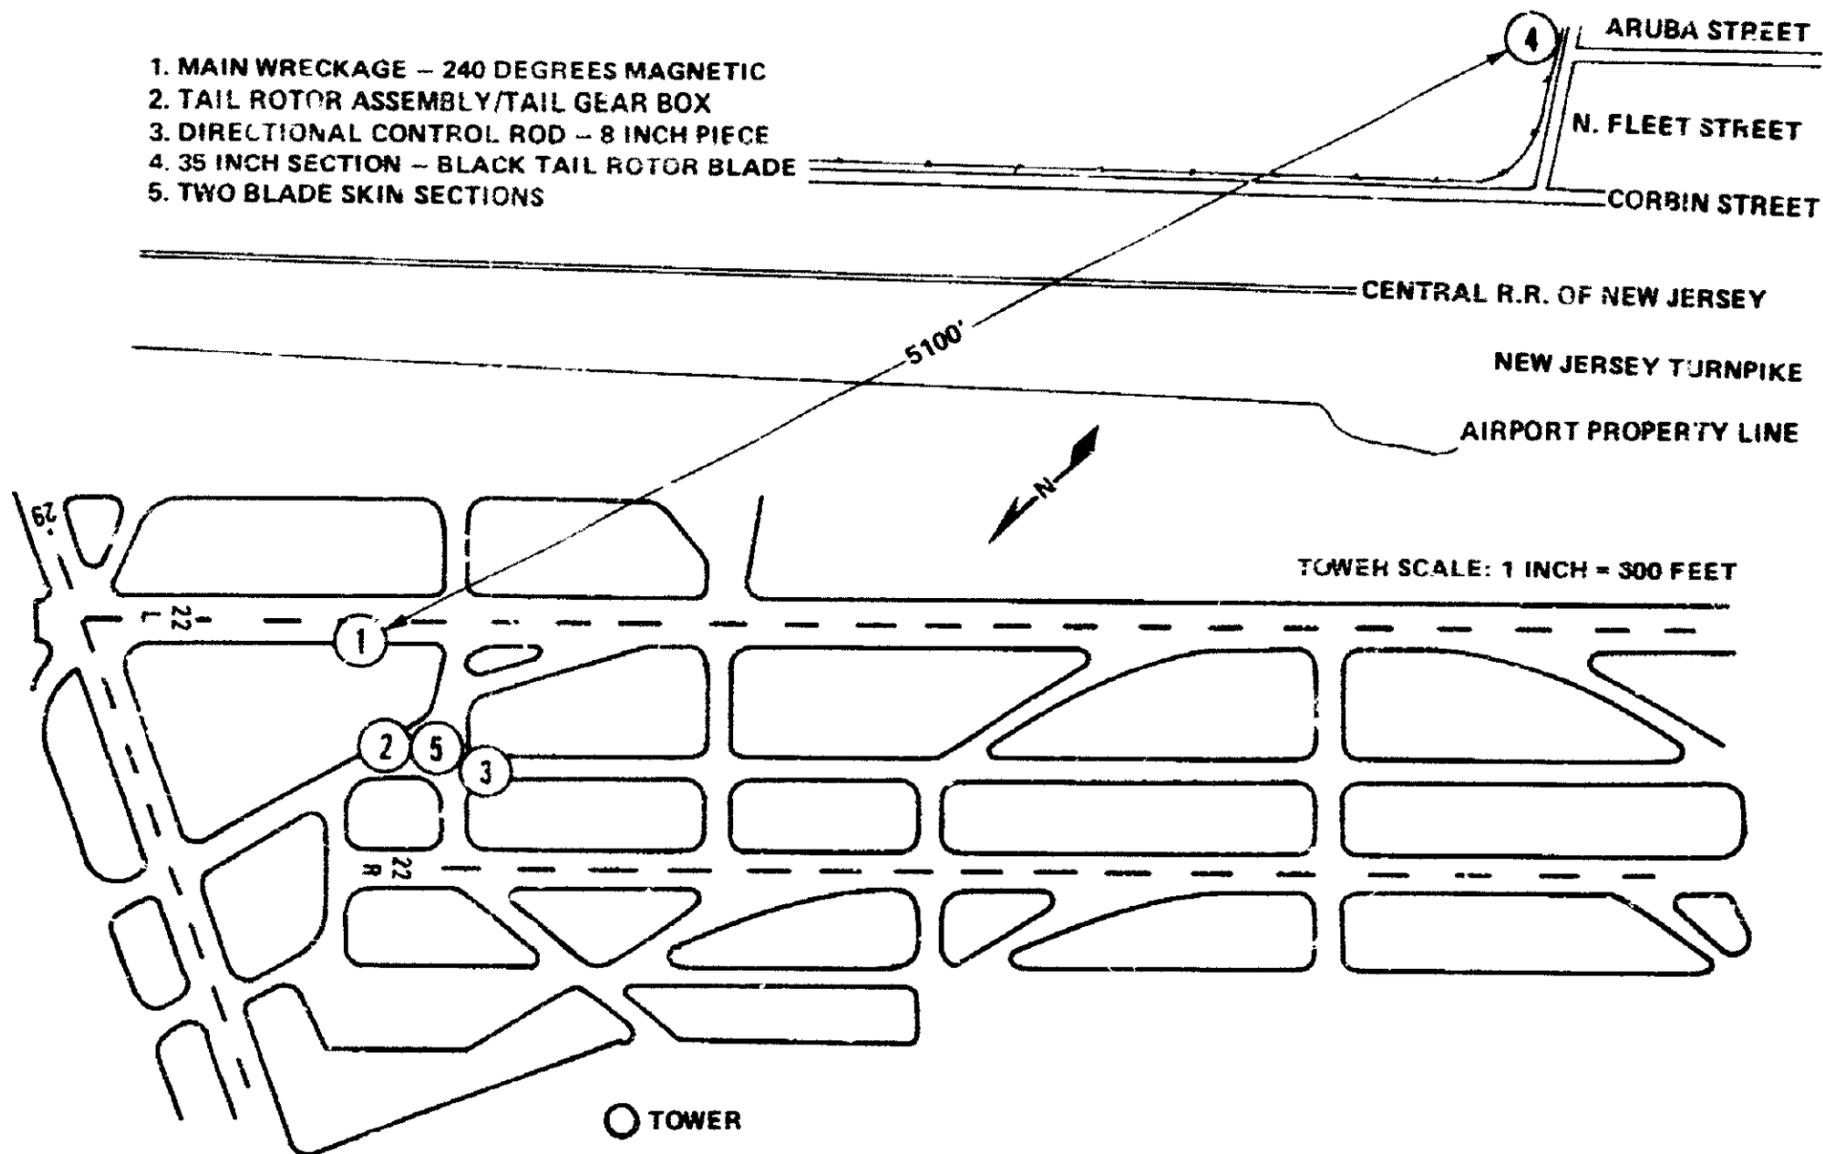
WRECKAGE DISTRIBUTION CHART

The tail rotor gearbox and the attached tail rotor assembly were found about 410 ft west of the main wreckage; an 8-in. section of the tail rotor control rod was found 650 ft west of the main wreckage; two blade skin sections were found about 500 ft west of the main wreckage; and a 35-in. outboard section of one of the tail rotor blades was found 5,100 ft south of the main wreckage site. All other major components were found at the main wreckage site.

1. MAIN WRECKAGE - 240 DEGREES MAGNETIC
2. TAIL ROTOR ASSEMBLY/TAIL GEAR BOX
3. DIRECTIONAL CONTROL ROD - 8 INCH PIECE
4. 35 INCH SECTION - BLACK TAIL ROTOR BLADE
5. TWO BLADE SKIN SECTIONS
