AIRCRAFT ACCIDENT REPORT

**CHAMPION HOME BUILDERS COMPANY
GATES LEARJET 25B, N999HG
SANFORD, NORTH CAROLINA
SEPTEMBER 8, 1977**

NTSB AAR-79-15

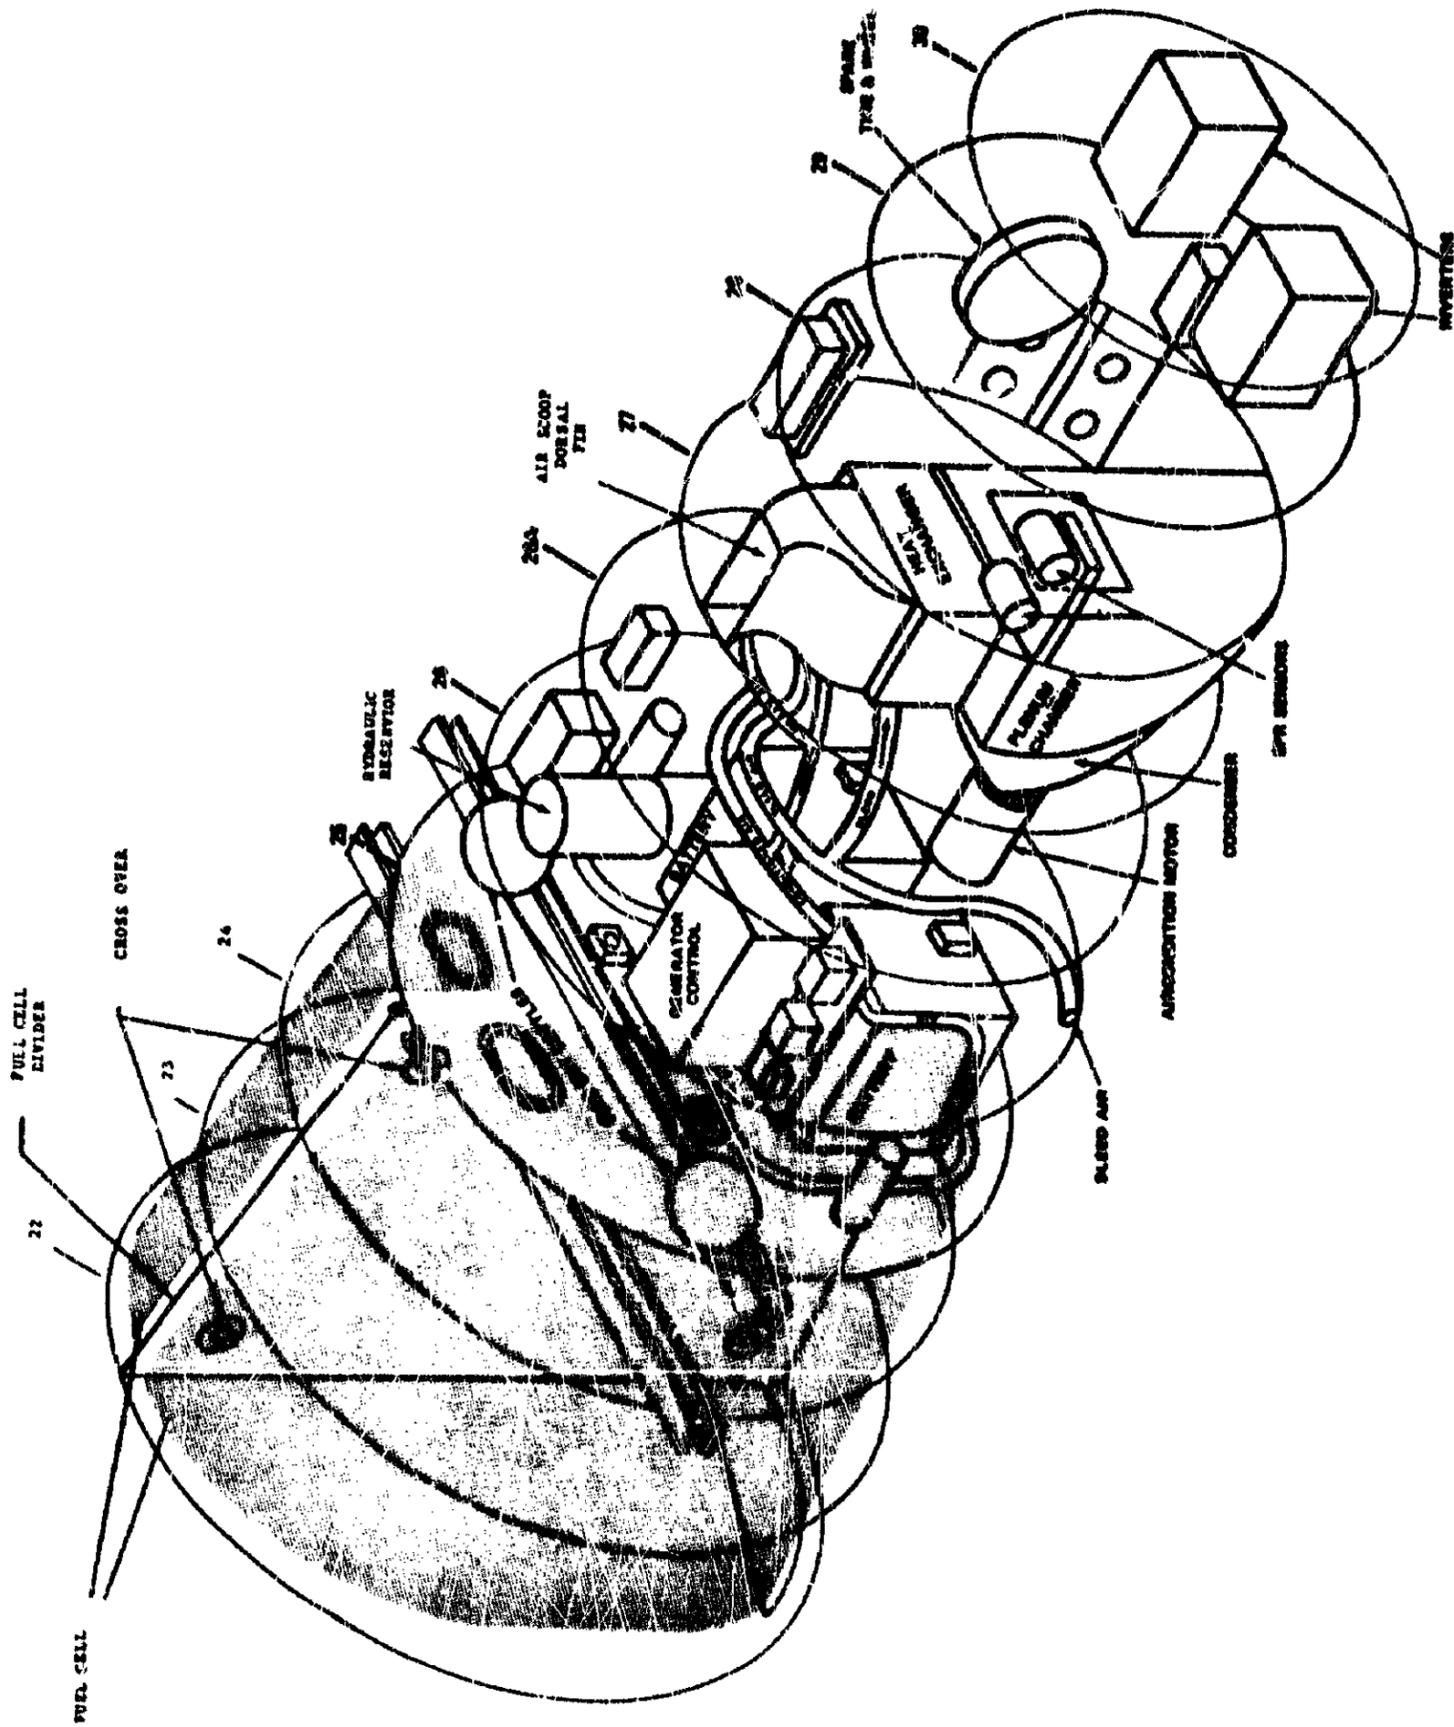
APPENDIX E
DIAGRAM OF FUSELAGE AFT SECTION

The fuselage fuel tank compartment was located between FF 22 and FF 25. (See appendix E.) The compartment contained two bladder-type fuel cells which were interconnected. The compartment was fragmented extensively. Some pieces of fuselage skin and stringers surrounding the compartment were damaged and sooted by heat and fire; other pieces were clean. A piece of the top left portion of the tank compartment just forward of FF 25 was torn in a sawtooth pattern. It was not damaged by fire or sooted. Another piece which mated with the sawtooth tear was burned. Also, a 12-in piece of stringer from the top right portion of the fuselage between FF 22 and FF 23, with attached pieces of fuselage skin, intercostal, and compartment liner was burned and sooted except for the forward 5 in of the stringer; this stringer mated with another piece of burned fuselage skin.

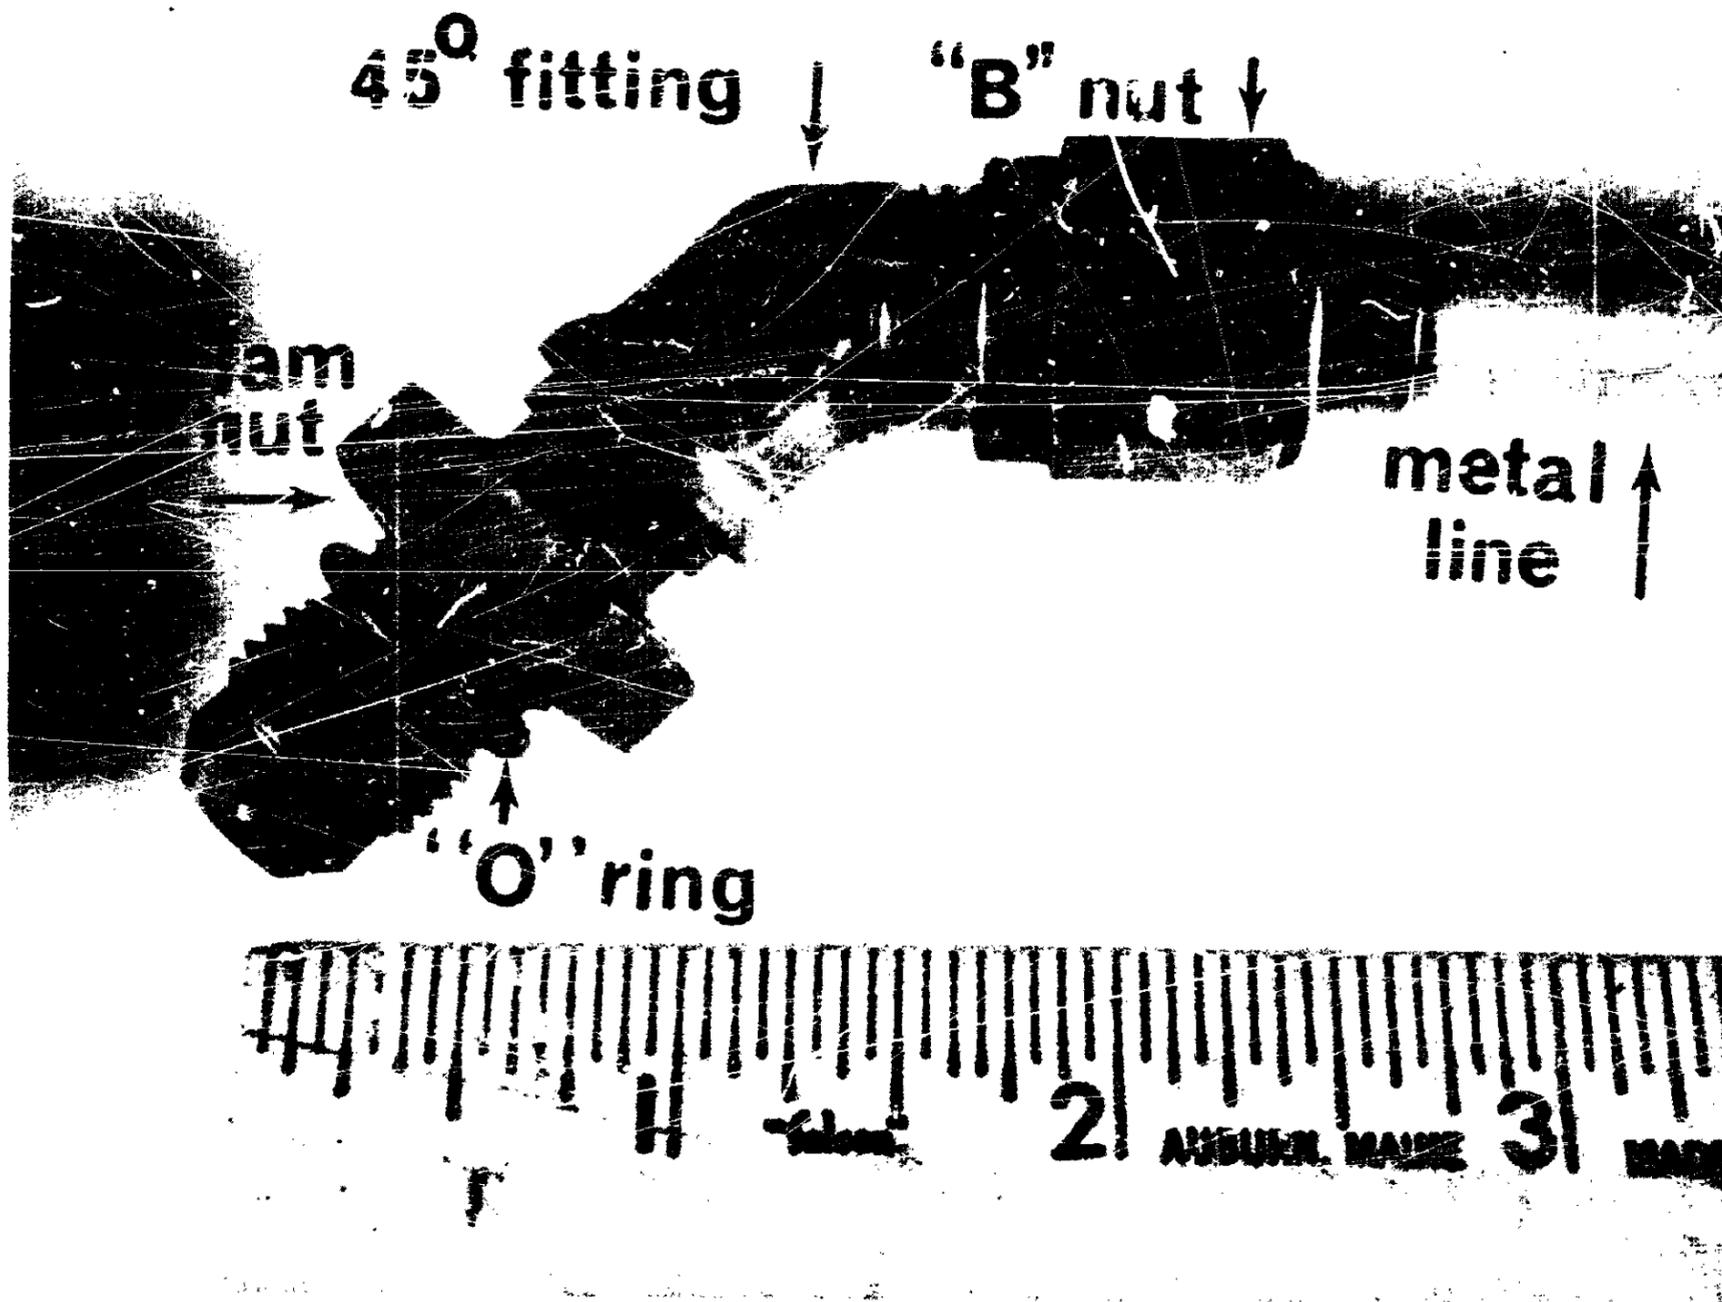
PHOTOGRAPH OF MOTIVE FLOW CONTROL VALVE

The left and right motive flow control valves remained partially attached to the aft face of the FF 25 bulkhead. Both valves were in the open position. On the left valve, the inlet line was disconnected from the inlet port and the O-ring seal was not located. The threads of the attachment fitting were not stripped or scored; they were discolored from heat and were sooted slightly. The right valve was broken into two pieces; both pieces were damaged by fire.

The Safety Board was not able to determine conclusively the initial source of the combustible material. However, two possible sources were identified. The first possible source involves a disconnected fuel inlet line on the left motive flow control valve. Tests established that the line could not have been disconnected when the left engine was started and that it was not likely that the line was disconnected before takeoff. However, it is possible that the jamnut was loose, that it backed off after takeoff, and that fuel escaped from the loosened connection into the compartment aft of FF 25. Fuel escaping into this section would have vaporized in the comparatively warm air there, and although tests showed that during flight, the airflow in the tailcone area was sufficient to totally displace the volume of air in the area about 11 times per minute, the Safety Board believes that a progressively larger fuel leak into the area could have formed an explosive mixture. Furthermore, the mixture would have been in close proximity to many electrical components in the area, such as the air conditioner motor, which could have provided ignition.
