NATIONAL TRANSPORTATION SAFETY BOARD

AIRCRAFT ACCIDENT REPORT

UNIVERSAL AIRWAYS, INC.
BEECH 70, EXCALIBUR CONVERSION, N777AE
GULFPORT, MISSISSIPPI
MARCH 1, 1979

NTSB-AAR-79-18

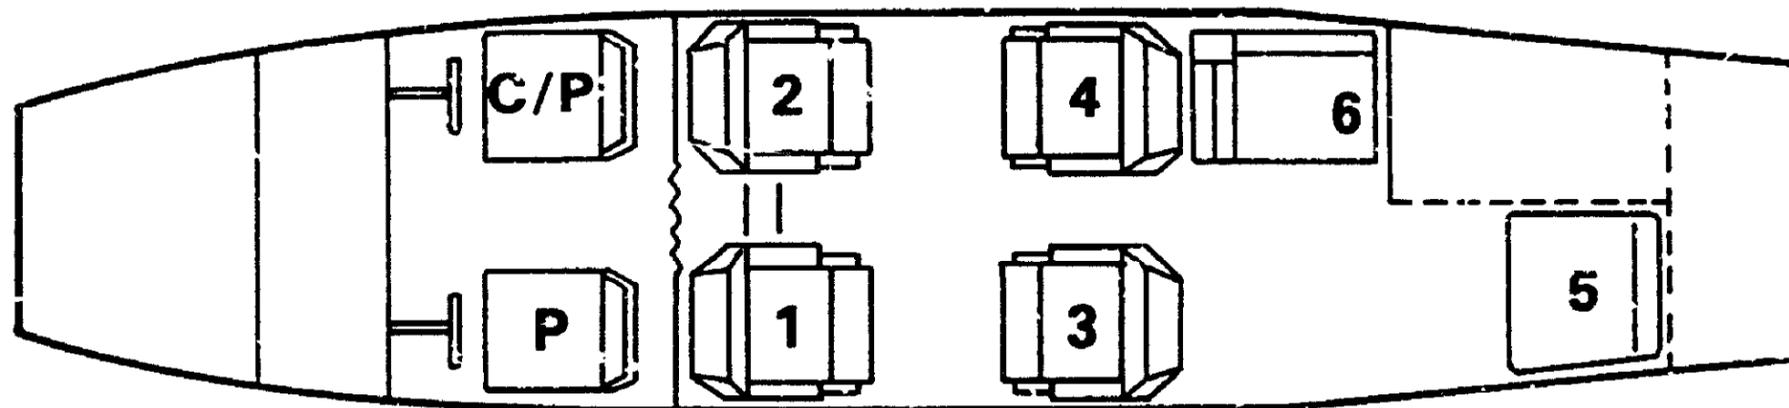
Seat 6, a plywood, side-facing seat, collapsed and failed completely. The insert hardware on the seatbelt faced toward the rear of the aircraft and the buckle hardware toward the front. The belt adjusted only on the buckle side and was found in the full length adjustment.

Figure 3. Seat arrangement for N777AE.

The rear baggage area was separated from the passenger area by a bulkhead aft of seat 6 and a net of nylon straps next to seat 5. The net failed, and most of the baggage was found at the seat 6 position.
