**NATIONAL
TRANSPORTATION
SAFETY
BOARD**

AIRCRAFT ACCIDENT REPORT

**PUERTO RICO INTERNATIONAL
AIRLINES, INC. (PRINAIR)
DeHAVILLAND HERON, DH-114, N575PR
ALEXANDER HAMILTON AIRPORT
CHRISTIANSTED, ST. CROIX,
U.S. VIRGIN ISLANDS
JULY 24, 1979**

NTSB-AAR-80-3

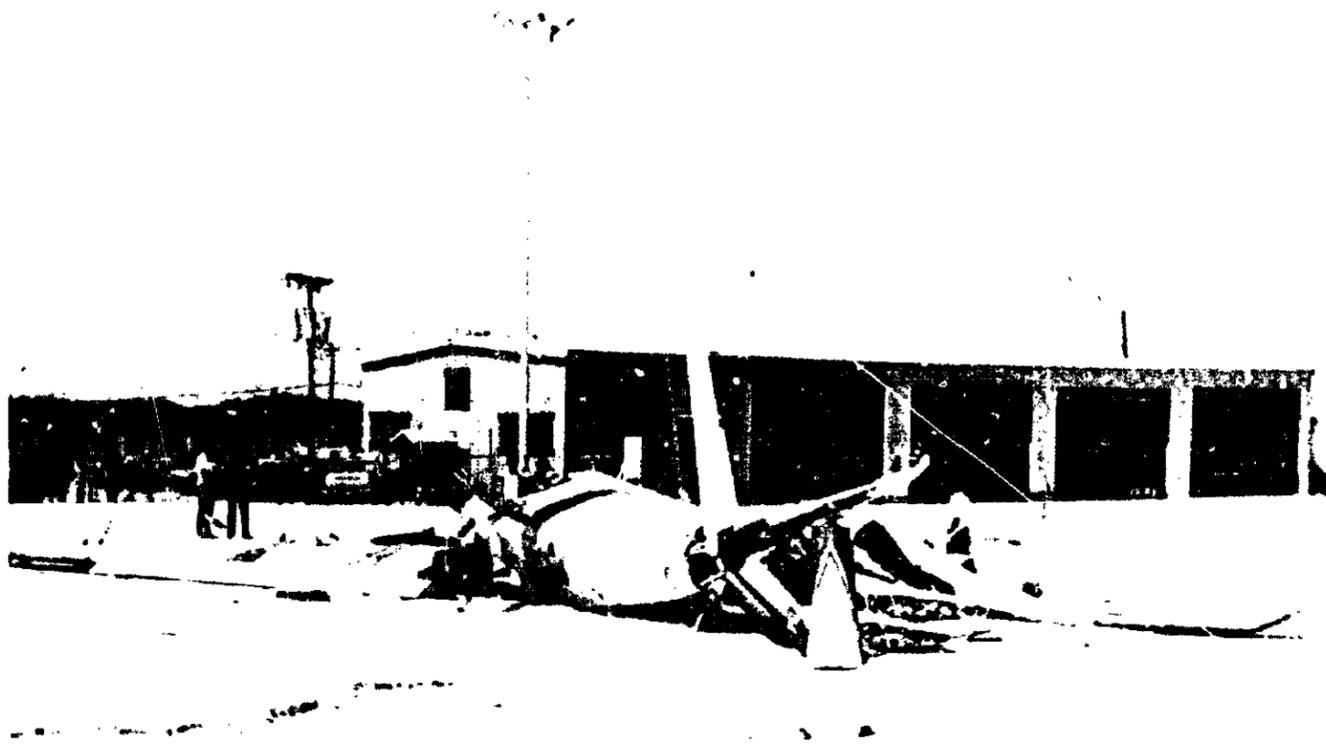
Figure 1.--Left side of aircraft

The aircraft came to rest on its right side adjacent to the firehouse. A small postaccident engine fire was extinguished immediately. (See figure 1.)

The fuselage remained on its right side throughout the crash sequence. The cockpit and the right cabin wall were torn apart during the ground slide, which reduced severely the occupiable volume of the forward cabin. The remainder of the cabin received progressively less severe damage.

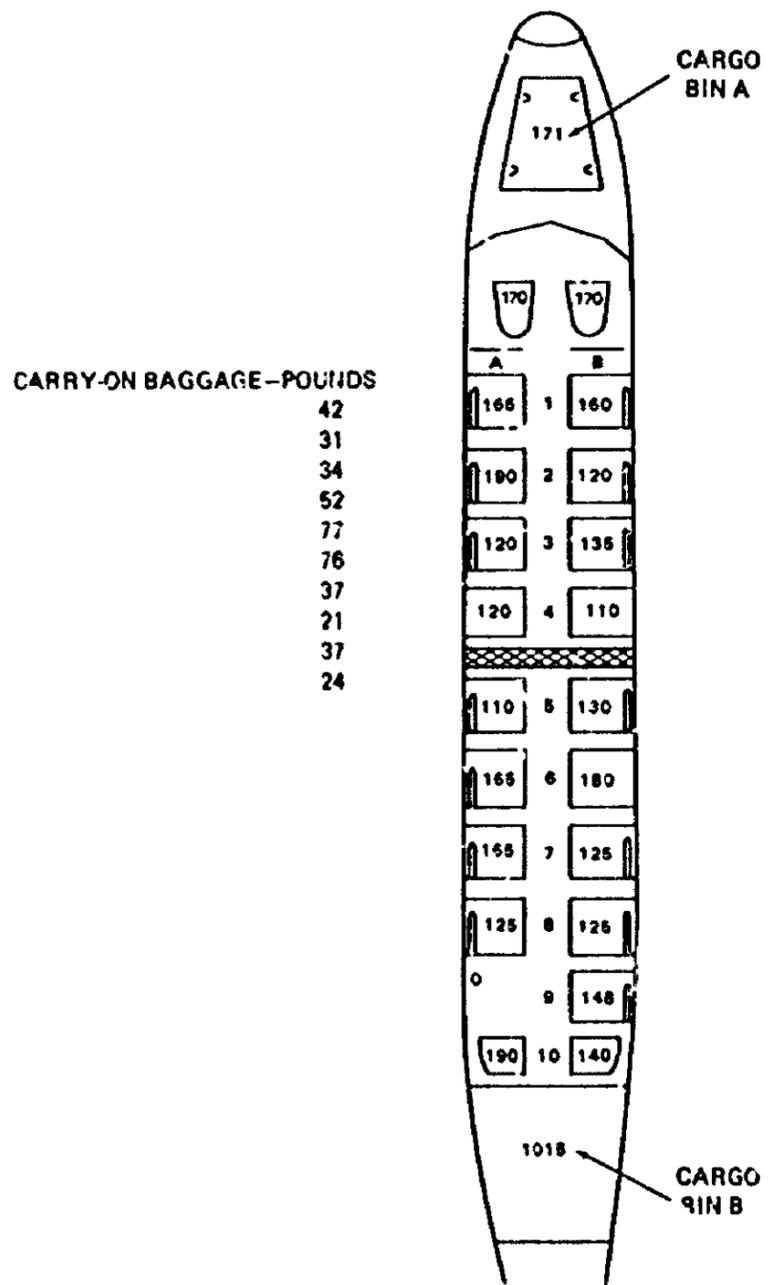
Figure 2.--Location of Persons and Baggage

Following the accident, the Safety Board obtained the actual weights of all passengers. The baggage in bins "A" and "B" and the carry-on baggage were removed from the wreckage and weighed. Although the weight and balance manifest prepared by St. Croix load control indicated 229 lbs in bin "A", the actual weight of the baggage was total of 171 lbs. The weight and balance manifest indicated 289 lbs of baggage in bin "B"; however, when weighed, the baggage totaled 1,015 lbs. When the actual weight of the two passengers that occupied the divan was added, the total weight for the rear compartment area was 1,315 lbs. Baggage marked "A" was found in bin "B". The total weight of carry-on baggage and crew bags was 431 lbs. (See Table 1.)
