## AIRCRAFT ACCIDENT REPORT

NEVADA AIRLINES, INC.  
MARTIN 404, N40438,  
TUSAYAN, ARIZONA

NOVEMBER 16, 1979

NTSB-AAR-80-7

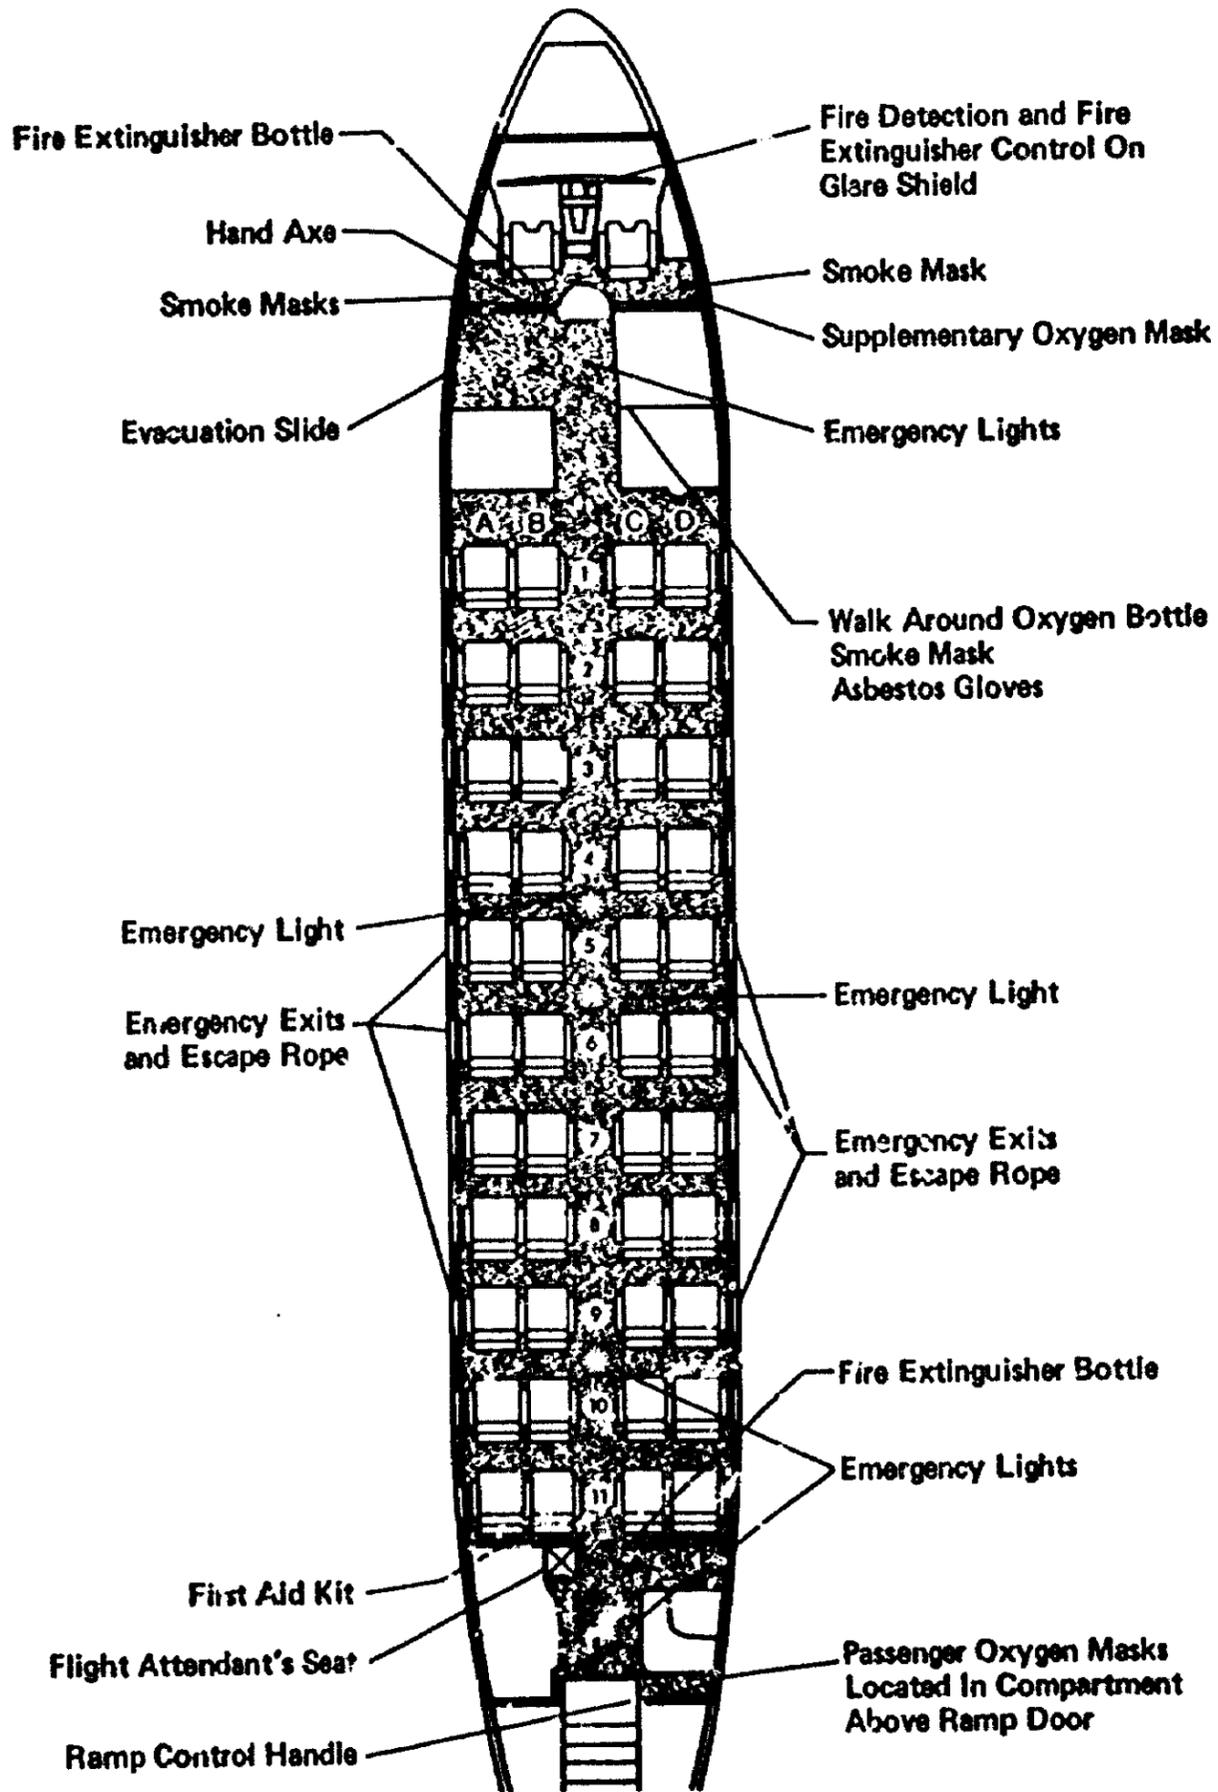
Figure 1.—Floor Plan and Location of Emergency Equipment of the Martin 404.

The flight attendant's seat was mounted in a baggage area separate from the main passenger cabin and on the back left side of the rear cabin bulkhead. (See figure 1.) The seat was not damaged. The seatbelt was found unfastened and undamaged after the accident. The fabric had not been abraded when the knurled bar slipped.

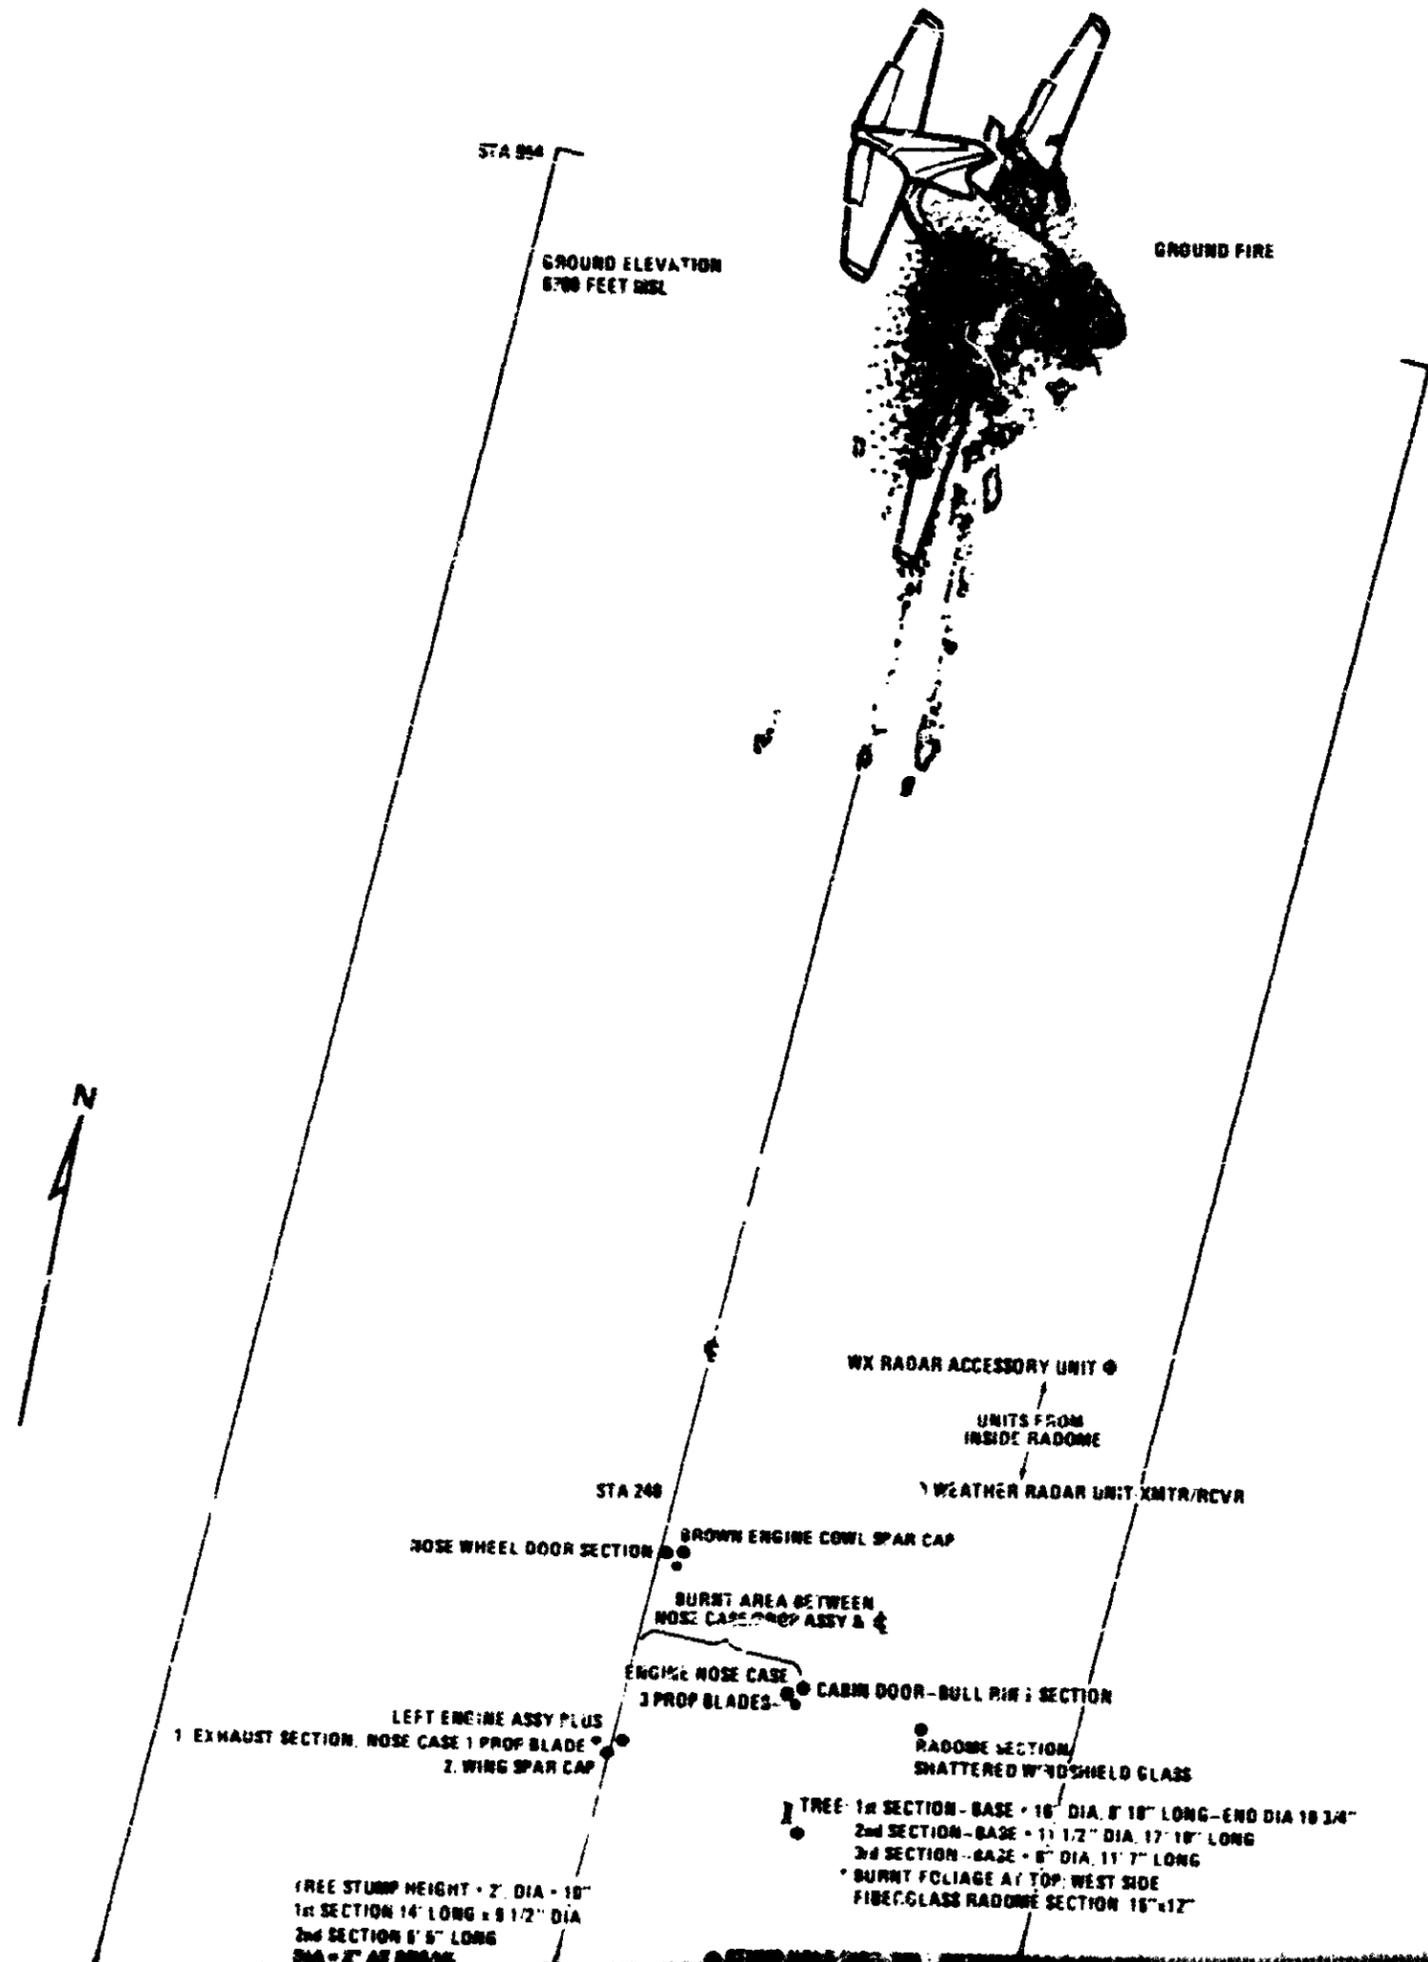
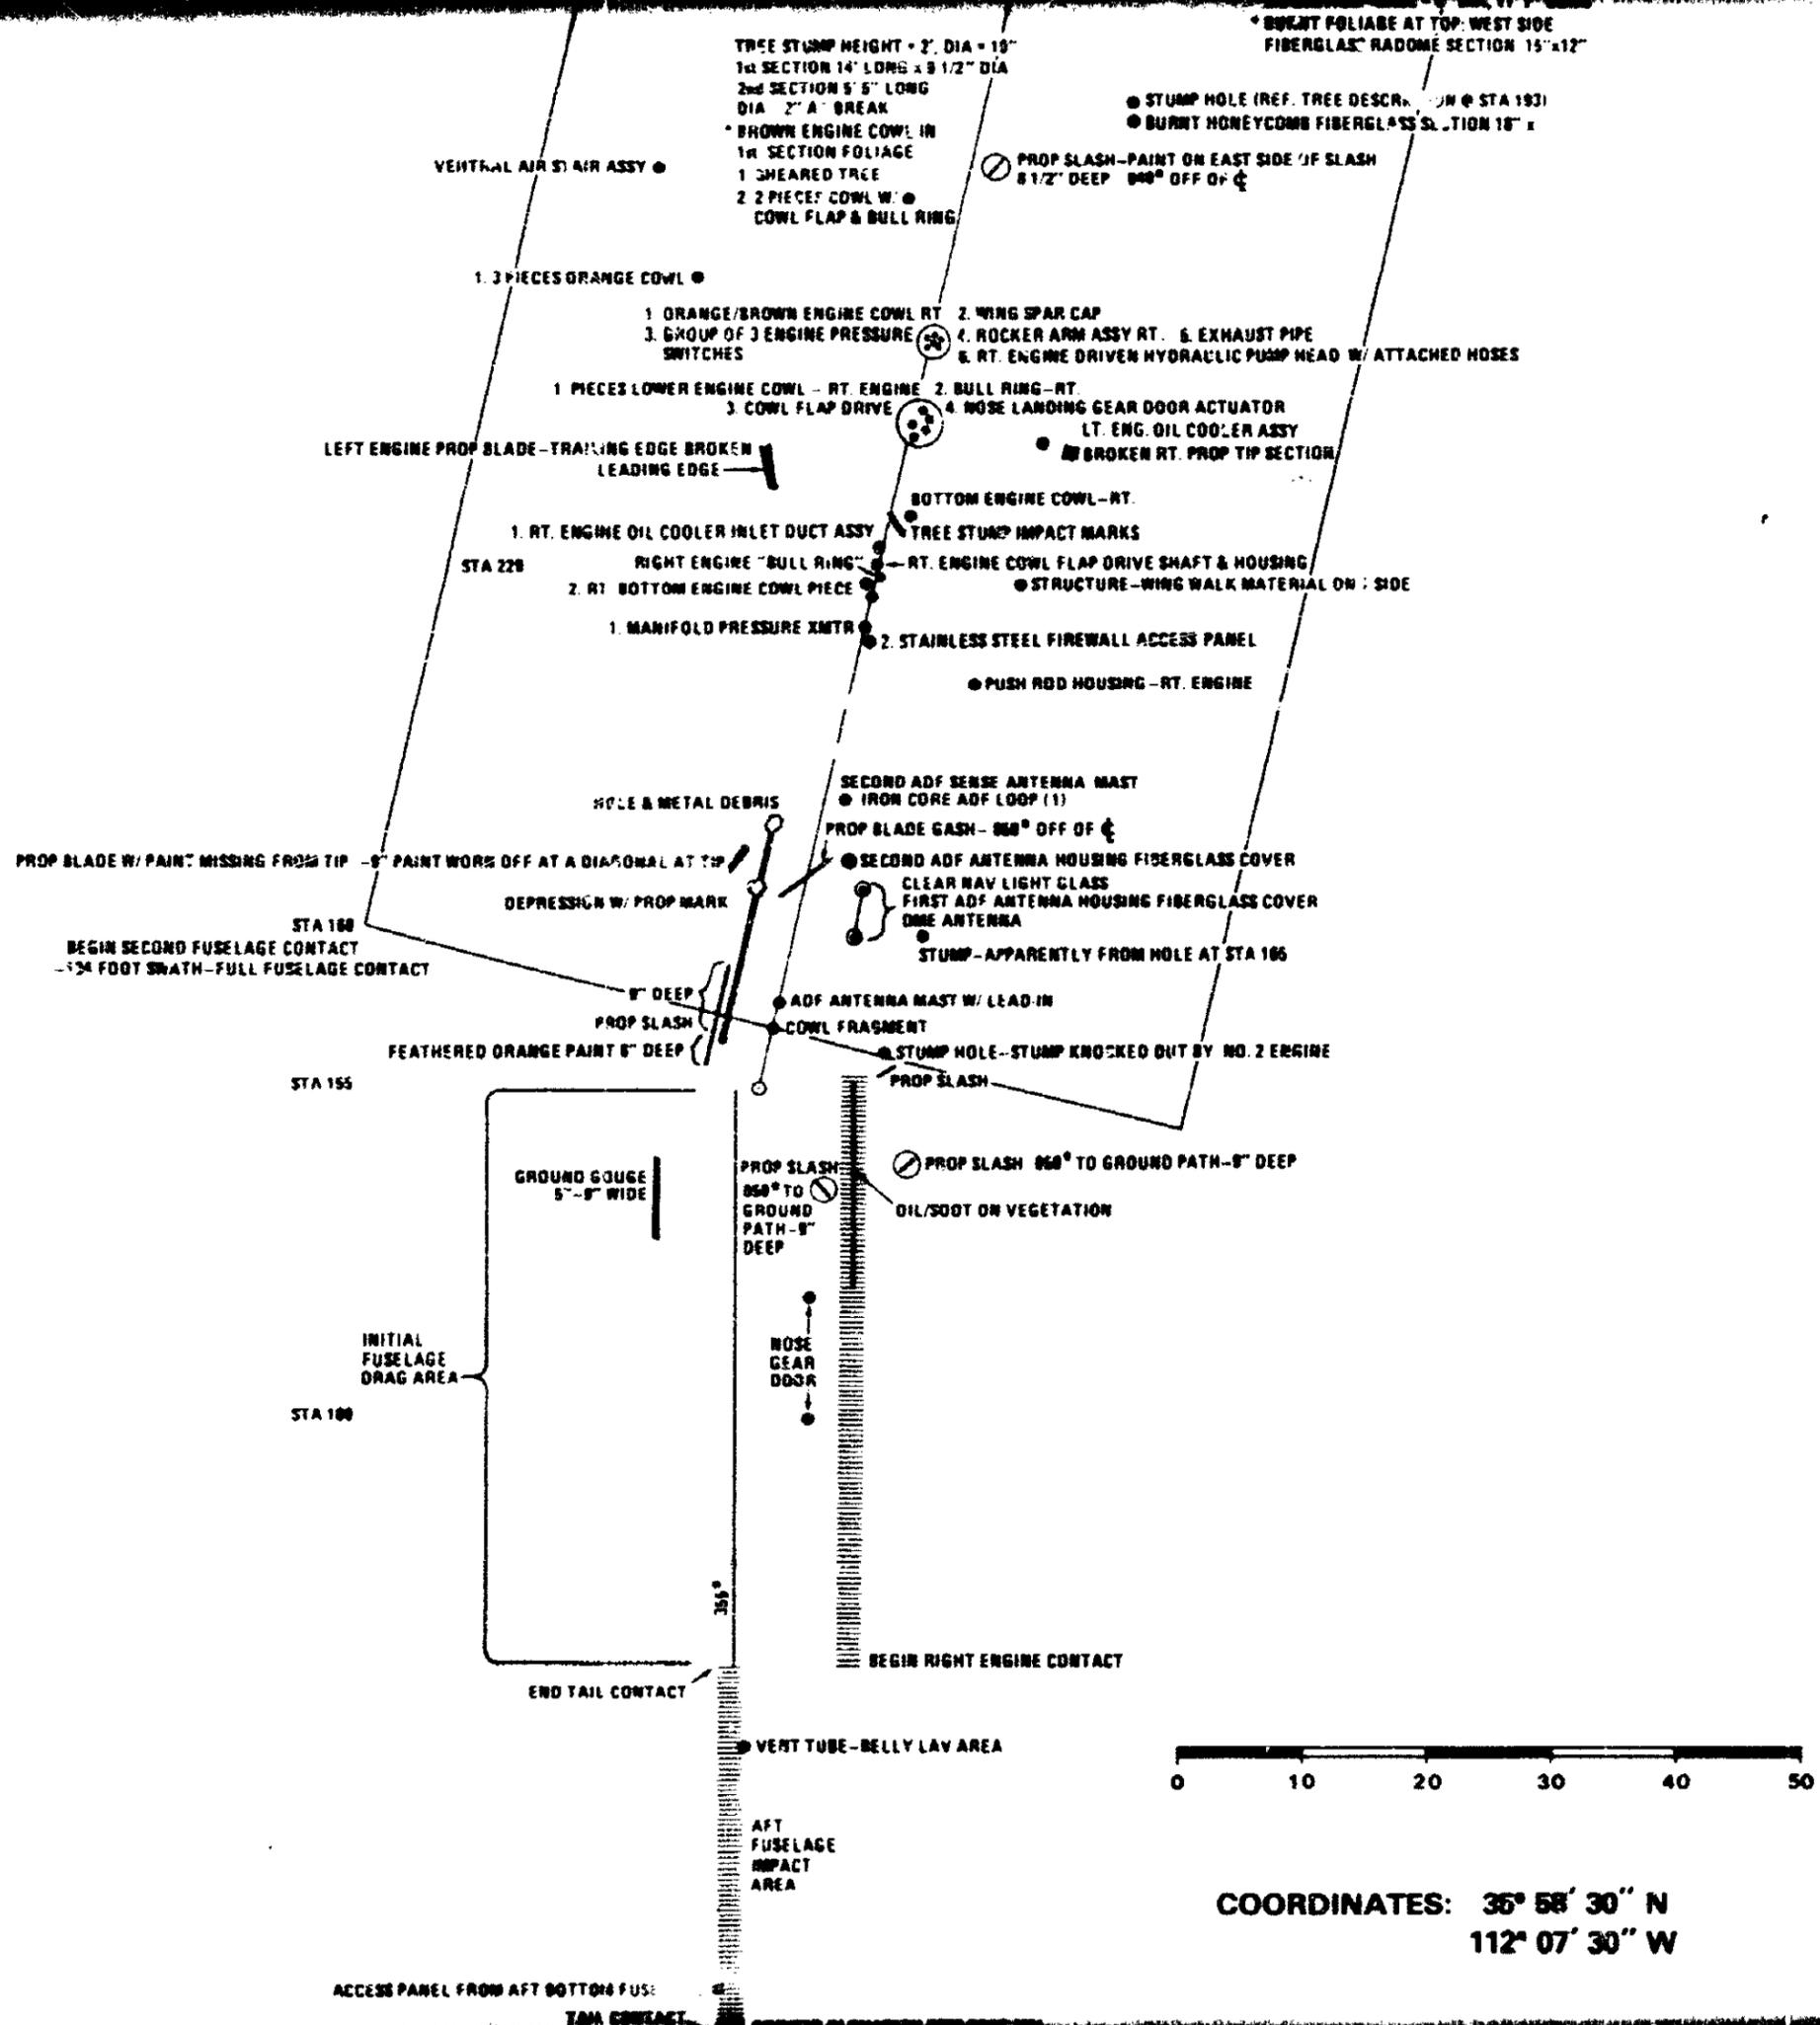
**APPENDIX D**  
**WRECKAGE DISTRIBUTION CHART**

The aircraft first struck the top of two trees at an elevation of about 6,731 ft while on a heading of 355°. Several broken and cut branches were found on the ground below the trees. The aircraft descended on a heading of 355° until the lower aft fuselage struck the ground at an elevation of 6,680 ft, 420 ft beyond the trees. The aircraft then slid along the ground and came to rest 434 ft beyond the first ground impact point. The aircraft came to rest oriented on a heading of 070° and at an elevation of 6,700 ft. The wreckage was confined to an area 434 ft long and 134 ft wide.

The first aircraft part found along the wreckage path was the aft fuselage access door, which had been installed on the bottom aft portion of the fuselage. The remainder of the wreckage path contained gouges in the earth, uprooted and broken trees, propeller slashes, and various aircraft components. (See appendix D.) The terrain over which the aircraft slid was a relatively level clear area with scattered small trees, stumps, and rocks.
