AIRCRAFT ACCIDENT REPORT

COMAIR, INC.
PIPER PA-31, N6642L
COVINGTON, KENTUCKY

OCTOBER 8, 1979

NTSB-AAR-80-8

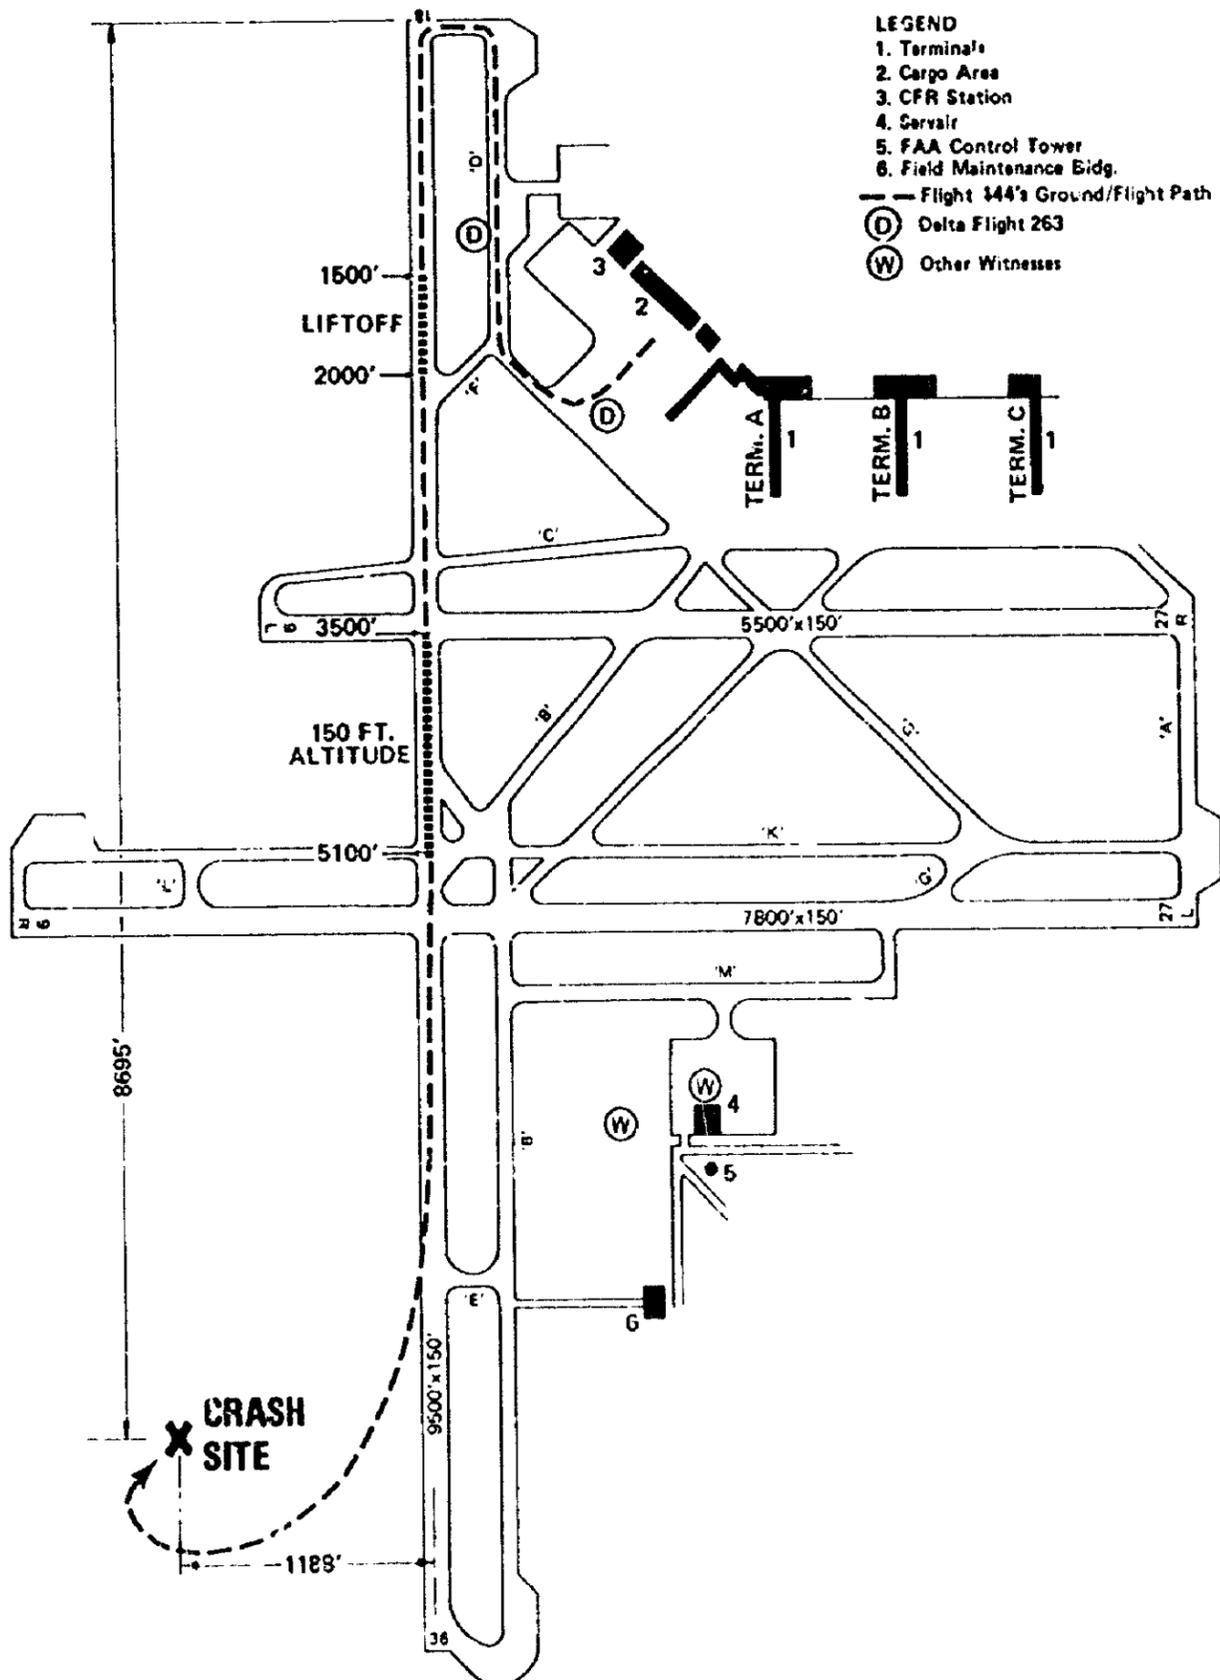
Figure 1.--Diagram of Great Cincinnati Airport.

Another witness stated that as the aircraft commenced a slight right bank turn, the nose came up slightly, and the aircraft rolled into an inverted, nosedown attitude. (See figure 1.)
