NATIONAL TRANSPORTATION SAFETY BOARD

AIRCRAFT INCIDENT REPORT

AEROMEXICO
DC-10-30, XA-DUH
OVER LUXEMBOURG, EUROPE
NOVEMBER 11, 1979

NTSB-88R-80-10

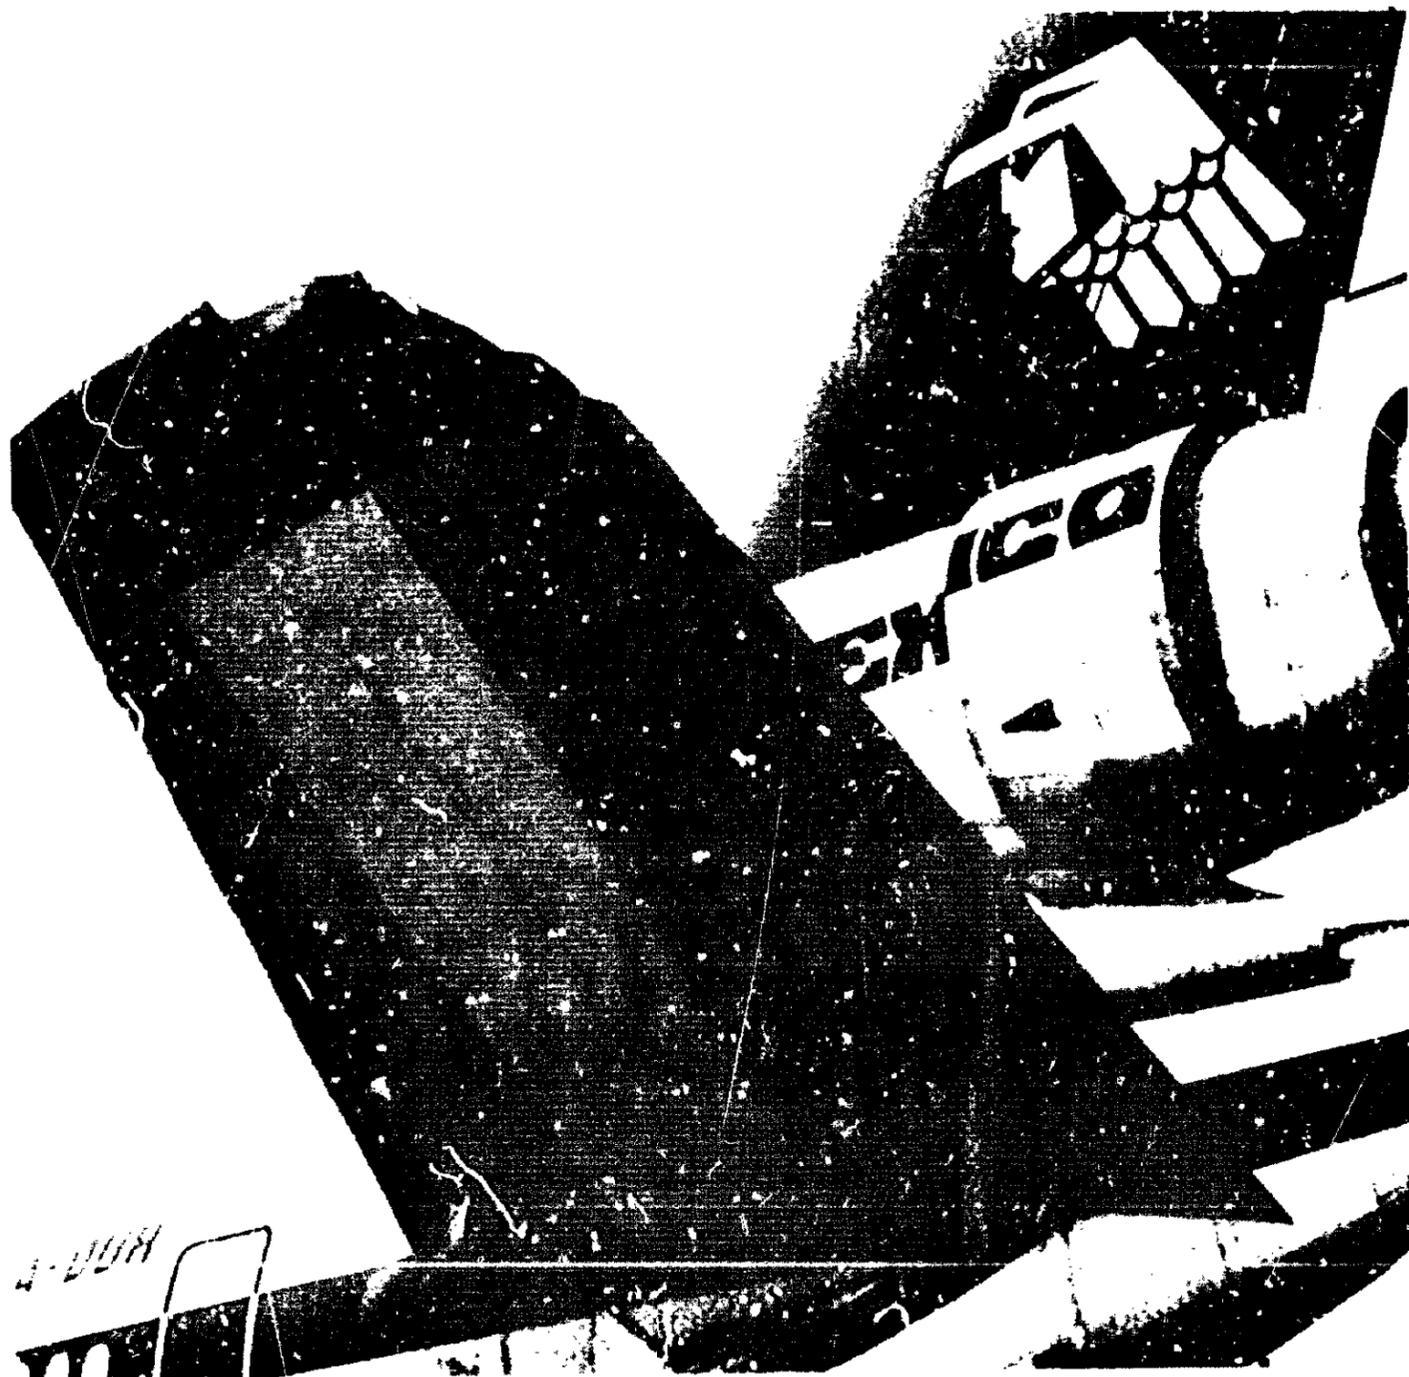
The aircraft damage was confined to both aircraft outboard elevator tips and related counterweights and the tail lower area access door. (See figures 1 and 2.)

Figure 1.--View of left outboard elevator tip.

Approximately 4 ft of the outboard ends of both outboard elevators were missing and had separated at almost identical locations. The approximate line of separation connected the trailing edge channel at Station XE 436 to the elevator spar at Station XE 455. The elevator outboard hinge fitting mounted on the elevator spar and the eyebolt mounted on the hinge fitting had separated with the outboard end of the elevators. Visual examination of the fracture surfaces on the elevator showed no indication of prior cracking. The fracture surfaces were clean and bright with smearing on some portions of the sheet metal surfaces.

The left outboard elevator hinge fail safe "A" frame attached to the horizontal stabilizer sustained minor damage. Scrape marks a few thousandths of an in deep were evident in the bore and flange of the bushing. The outboard lug of the two lugs on the outboard hinge "A" frame was broken about 1 in forward of the elevator hinge line. The inboard lug was bent inboard approximately 1/8 in, and

The tips of both the right and left elevators separated similarly indicating that the failures were produced by a symmetrical loading condition. The evidence indicated a torsional buckling failure of the elevator skin and an aft bending failure of the spar. Smearing on some of the sheet metal fracture surfaces was consistent with a cyclic load application.

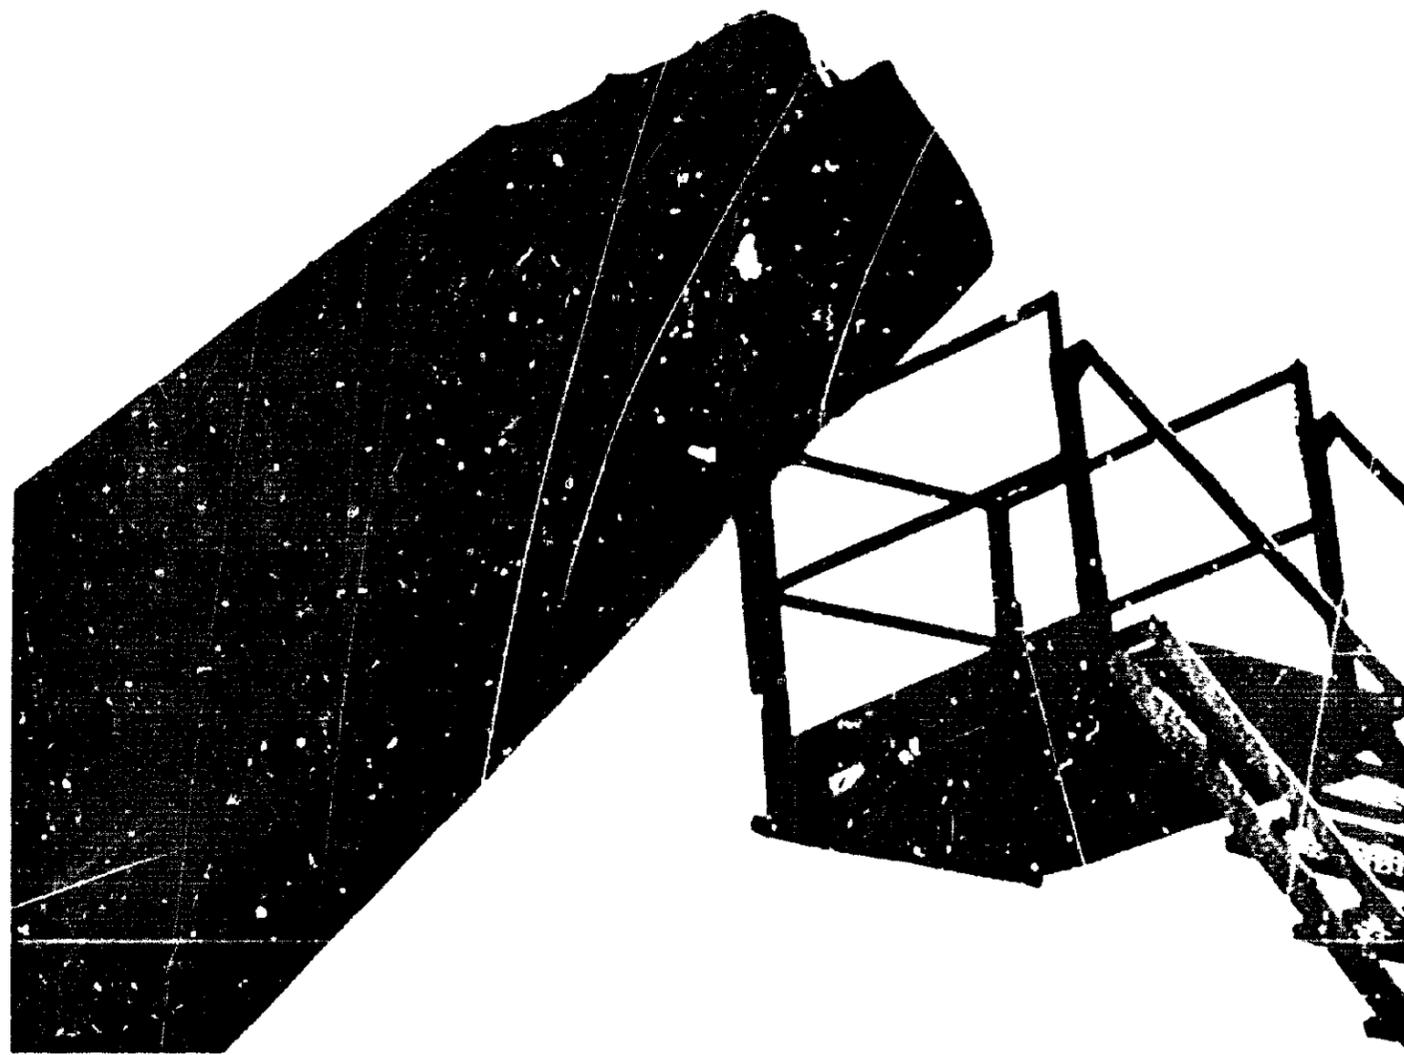
Figure 2.--View of right outboard elevator tip.

The right outboard elevator outboard hinge fail safe "A" frame attached to the horizontal stabilizer was broken about 2 in forward of the hinge line. No indication of prior cracking was evident. The outboard lug of the two lugs on the outboard hinge "A" frame was broken about 2 in forward of the hinge line. No indication of prior cracking was evident. The inboard lug was bent inboard about 1/2 in. A scrape mark approximately .005 in deep was observed on the outboard side of the inboard lug. The scrape mark extended from the edge of the hinge hole to the upper edge of the lug. The horizontal stabilizer tip fairing had two small buckles about .060 in deep and 2 in long located just forward of the aft closing rib. The aft edge of the fairing was bent outboard approximately 1/16 in and an impact mark was evident on the aft edge of the fairing.
