AIRCRAFT ACCIDENT REPORT

TRANSAMERICA AIRLINES, INC.,
LOCKHEED L-188, N859U
SALT LAKE CITY, UTAH
NOVEMBER 18, 1979

NTSB-AAR-80-11

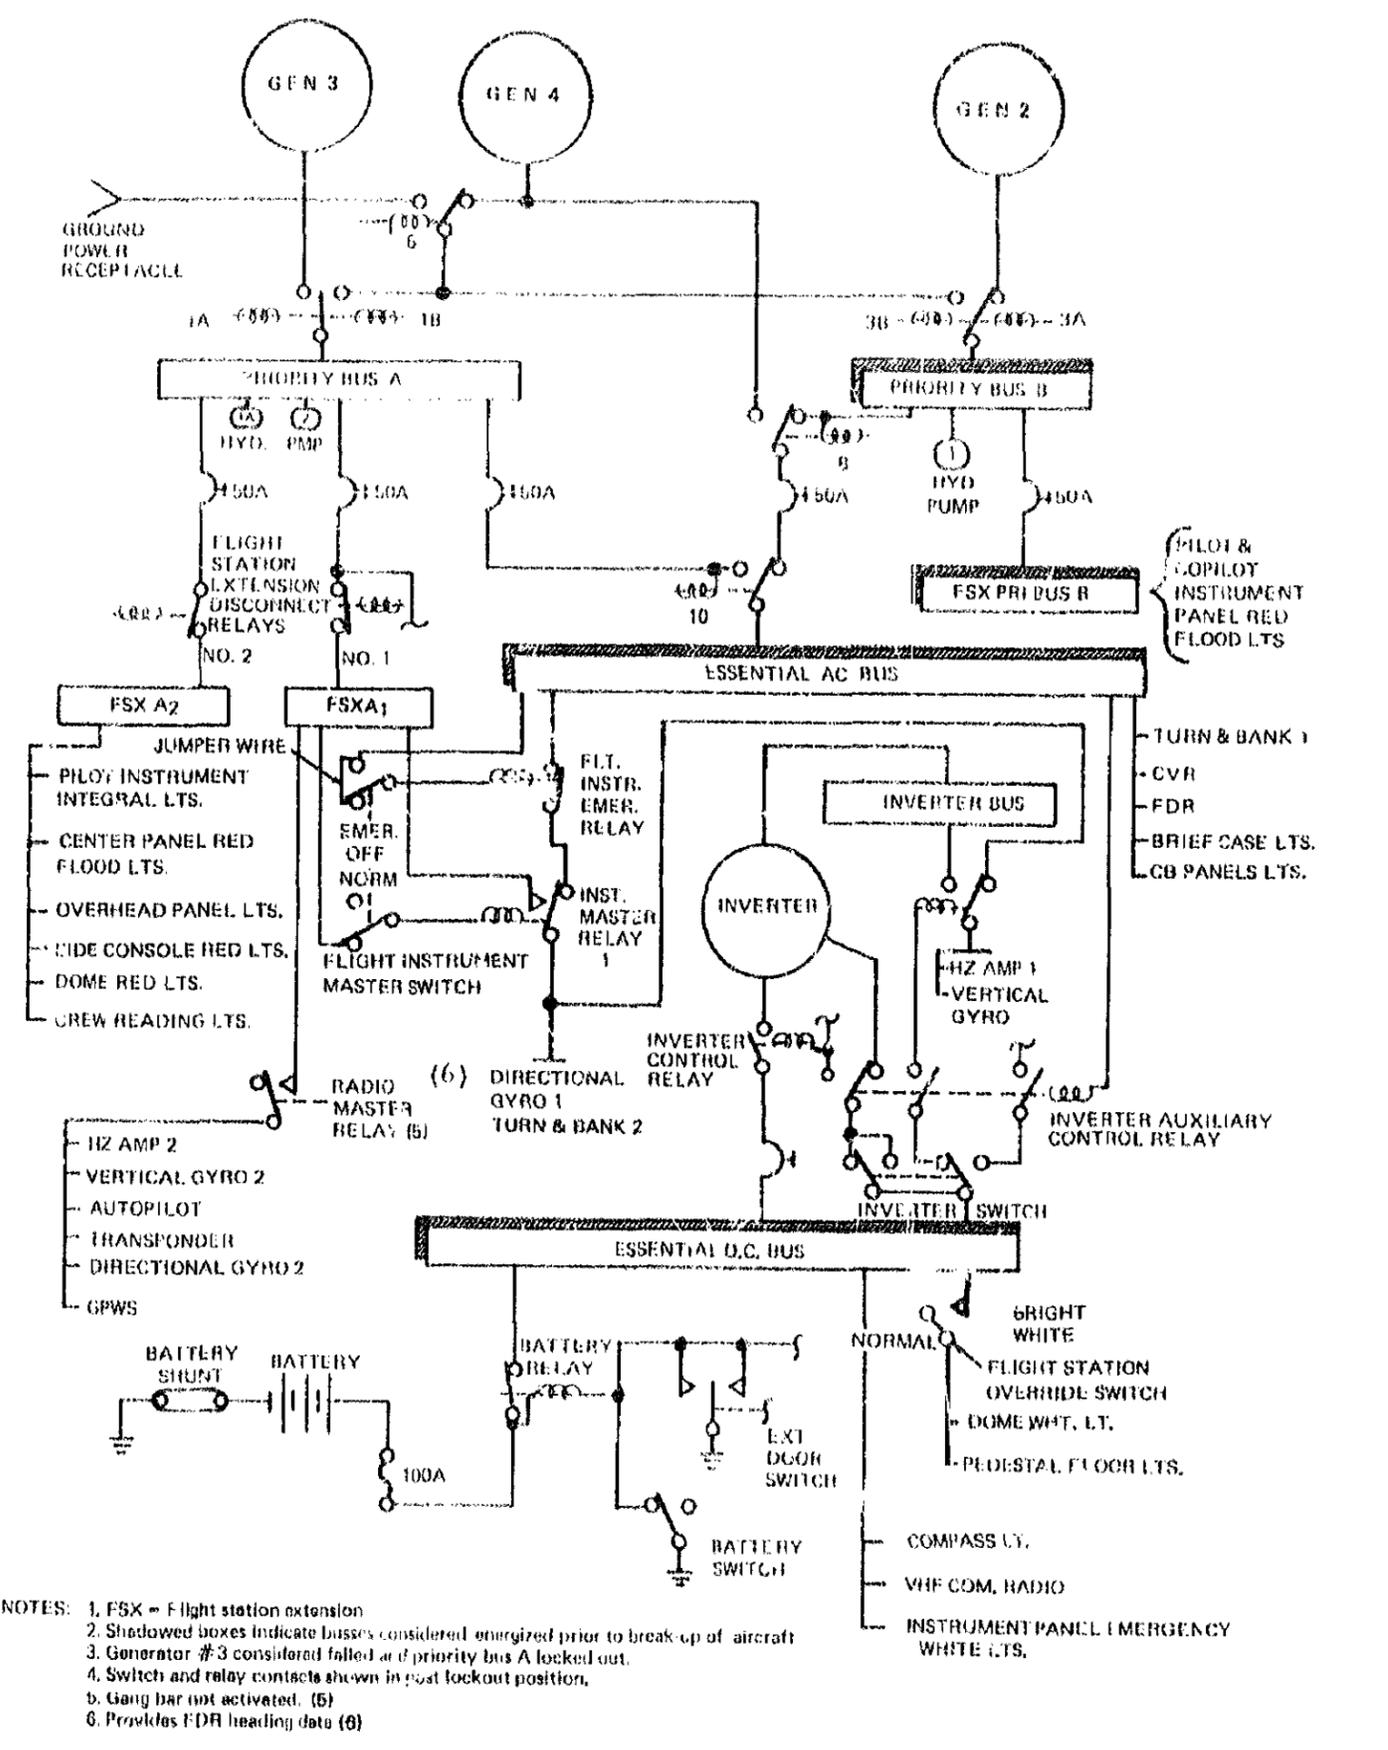
Figure 1. —Schematic of Electrical System, L-188, N859U

- NOTES:
1. FSX = Flight station extension
 2. Shadowed boxes indicate busses considered energized prior to break-up of aircraft
 3. Generator #3 considered failed and priority bus A locked out.
 4. Switch and relay contacts shown in post lockout position.
 5. Gang bar not activated. (5)
 6. Provides FDR heading data (6)

The design of the L-188's automatic transfer system provides for, in the event of a failure of the No. 3 generator, that priority bus A be automatically powered by the No. 4 generator. However, if priority bus A is locked out by the under voltage protection circuitry within the No. 3 generator's control unit, the bus is completely inoperative and the essential a.c. bus is transferred to priority bus B which is powered by generator No. 2. Consequently, since the aircraft's transponder and integral instrument lights and the copilot's gyrosyn compass indicator remained inoperative, the Safety Board concludes that priority bus A was locked out by a system malfunction.

Tests showed that a disconnected ground wire on the No. 2 generator such as was found on the accident aircraft had no effect on the operation of either priority bus A or priority bus B, or on the transfer of the essential a.c. bus to bus B when bus A was failed. Additionally, there was no evidence of malfunction or distress in the Nos. 3 and 4 generators. Further, since a malfunction in either of these generators should have produced a trip light which would have been plainly visible to the crew, and since there was no mention on the CVR of a trip light, the malfunction apparently involved a fault on the priority A bus which prevented either the No. 3 or No. 4 generator from providing power to the bus. Accordingly, all equipment powered by the bus would have been inoperative. Because of the postaccident condition of the control components of the electrical system, the reason or reasons for the fault on the priority A bus could not be determined.
