NATIONAL TRANSPORTATION SAFETY BOARD

AIRCRAFT ACCIDENT REPORT

KENNEDY FLITE CENTER
GATES LEARJET MODEL 23, N866J
BYRD INTERNATIONAL AIRPORT
RICHMOND, VIRGINIA
MAY 6, 1980

NTSB-AAR-80-12

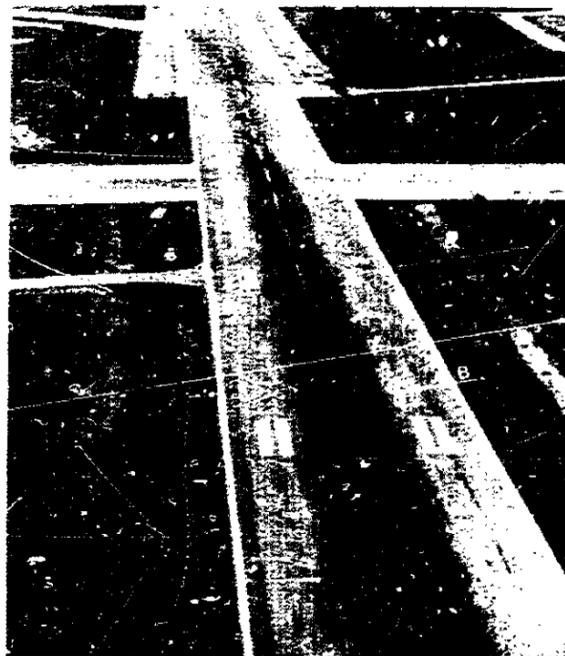
WRECKAGE DISTRIBUTION

An additional impact scar was found in the grass adjacent to the right side of the runway at 4,475 feet. The horizontal tail spar section and pieces of red glass were found in the scar at that point. The ground scarring and marks continued in a straight line to the main wreckage 665 feet farther along the side of the runway. Pieces of the aircraft scattered between the initial ground contact point and the main wreckage included access covers, wing skin, horizontal stabilizer, tip of left elevator, and left engine. There was a fire/soot pattern running throughout the wreckage path.

The main wreckage came to rest 5,140 feet beyond the runway threshold 150 feet right of the centerline on the edge of the runway. The wreckage consisted of the cockpit/cabin area, fuselage, empennage, right wing, right engine, and a part of the left wing. The wreckage was damaged by ground fire. (See appendix D.)
