## **AIRCRAFT ACCIDENT REPORT**

**AIR CANADA  
McDONNELL-DOUGLAS DC-9-32 (CF-TLU)  
EAST OF BOSTON, MASSACHUSETTS  
SEPTEMBER 17, 1979**

**NTSB-AAR-80-13**

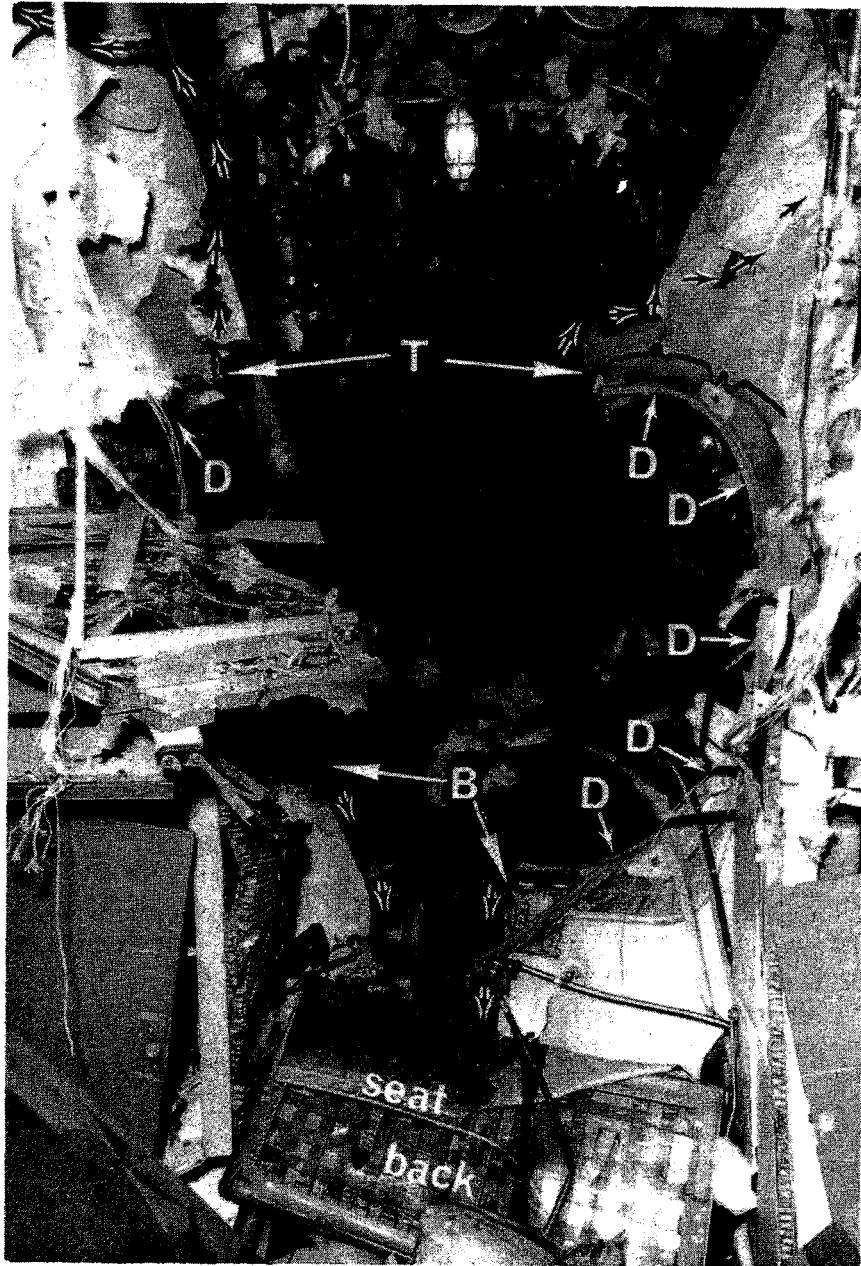
Figure 1.--Overall view looking aft on aft pressure bulkhead as first viewed in Boston. Arrows "D" outline the aft access door frame that is visible in this photograph. Mating areas at the top of the door jamb are denoted by arrows "T" and mating areas at the bottom of the door jamb are indicated by arrows "B". Unmarked arrows show principal fracture directions.

Fracture of the aft pressure bulkhead initiated from a large preexisting crack below the access door area. Primary crack initiation was by low-load,

high-cycle fatigue originating at a mechanical gouge in the lockbolt fastener hole that most likely occurred during assembly of the bulkhead. ~~Cyclic~~ loading of the bulkhead was produced by cabin pressure fluctuations, each of which correlated to one complete cycle per flight. The density of fatigue striations in the access doorjamb and the magnitude of the fatigue crack extension suggests that the fatigue crack began upon initial pressurization of the aircraft. The aircraft had 26,816 landings recorded at the time of the accident, and it is possible that each of the service cycles (equated to landings) produced a striation or incremental crack extension. The loads producing fatigue crack extension in the doorjamb would have been distributed to the door web when the jamb cracks extended to the location corresponding to the top of the web. Low-load, high-cycle fatigue cracking in the web most likely was occurring simultaneously with that in the jamb as the crack extended downward below the web interface. The web most probably tore downward incrementally to about 10 in from the lower rivet hole used to attach the web to the jamb. From this point, the failure appeared to progress catastrophically without further stoppage.

4. Separation of the aft bulkhead below the access door stemmed from a large fatigue crack in the doorjamb which originated in areas of preexisting mechanical damage in a lockbolt fastener hole.
