**NATIONAL
TRANSPORTATION
SAFETY
BOARD**

AIRCRAFT ACCIDENT REPORT

**AIR TRADERS INTERNATIONAL
LOCKHEED 1049H, N74CA
COLUMBUS, INDIANA
JUNE 22, 1980**

NTSB-AAR-80-14

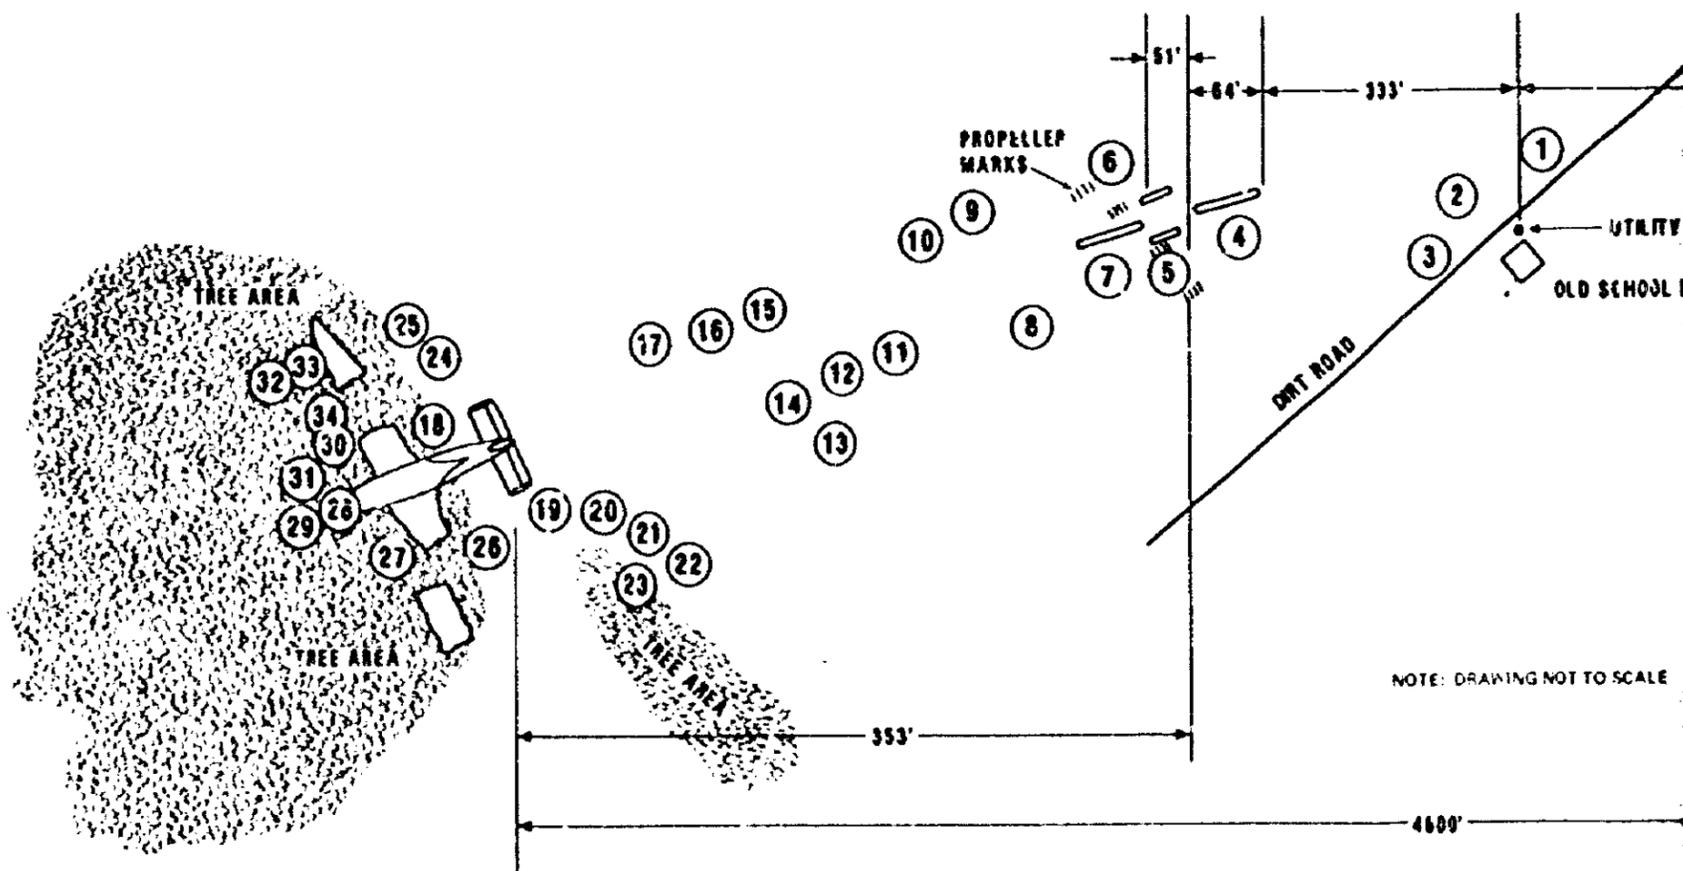
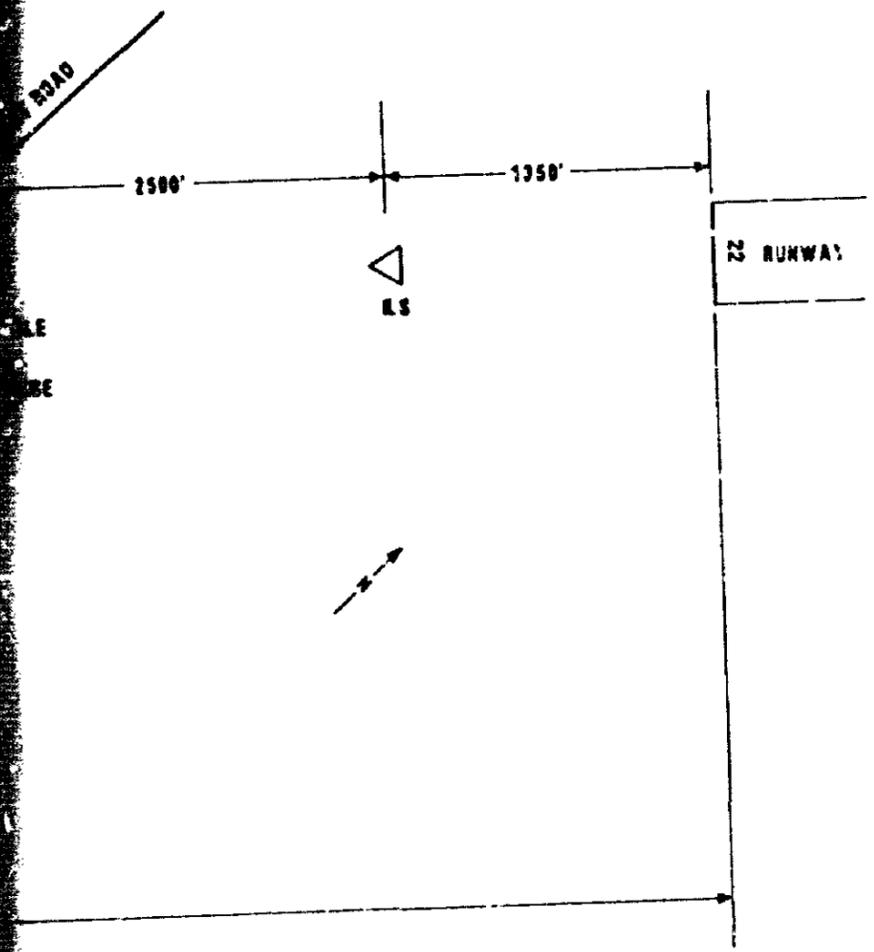
Figure 1

The aircraft crashed at 1359 at latitude 39° 15 N and 085° 54 W at an elevation of about 650 feet, approximately 4,600 feet beyond the departure end of the runway. (See figure 1.)

Wreckage Distribution Chart
Air Traders International
Lockheed L-1049H, N74CA
June 22, 1980
