NATIONAL TRANSPORTATION SAFETY BOARD

AIRCRAFT ACCIDENT REPORT

**AIR WISCONSIN, INC.,
SWEARINGEN SA-226 METRO, N650S
VALLEY, NEBRASKA
JUNE 12, 1980**

NTSB-AAR-80-15

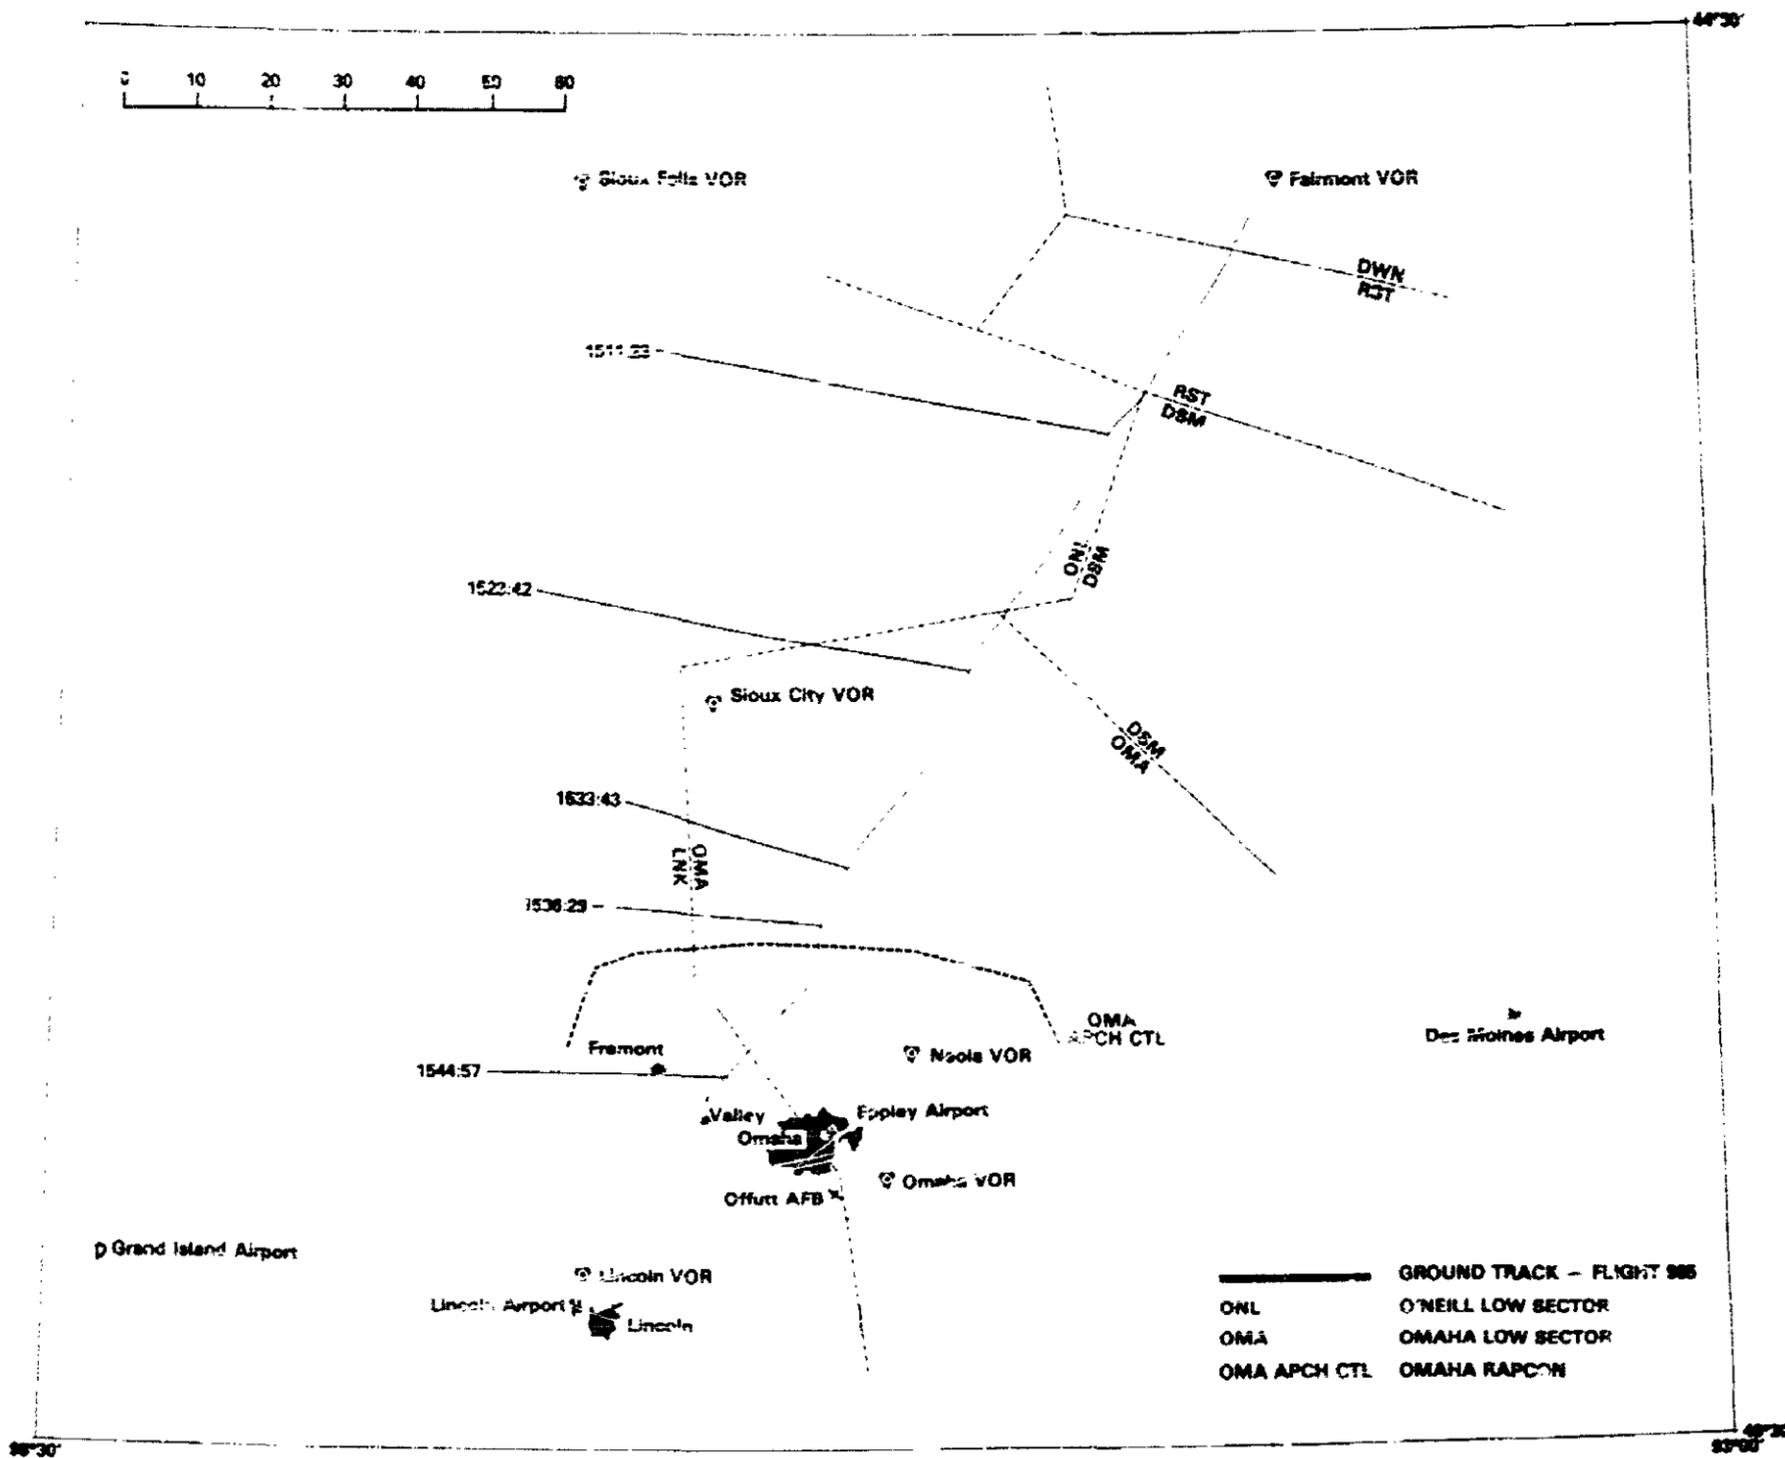
Figure 1.—Probable Ground Track

At 1511:23, the Minneapolis ARTCC O'Neill low controller said, "Wisconsin 965, there's a large area of weather twelve o'clock and about thirty five miles and extends from east of Neola up around Sioux City and down the west side to Fremont. Had one aircraft at flight level two zero zero went around the area. Another one at nine thousand inbound to Lincoln, found his way through it. Don't know how bad it is, anything else. He said he could pick his way through pretty good, though." (See figure 1.)

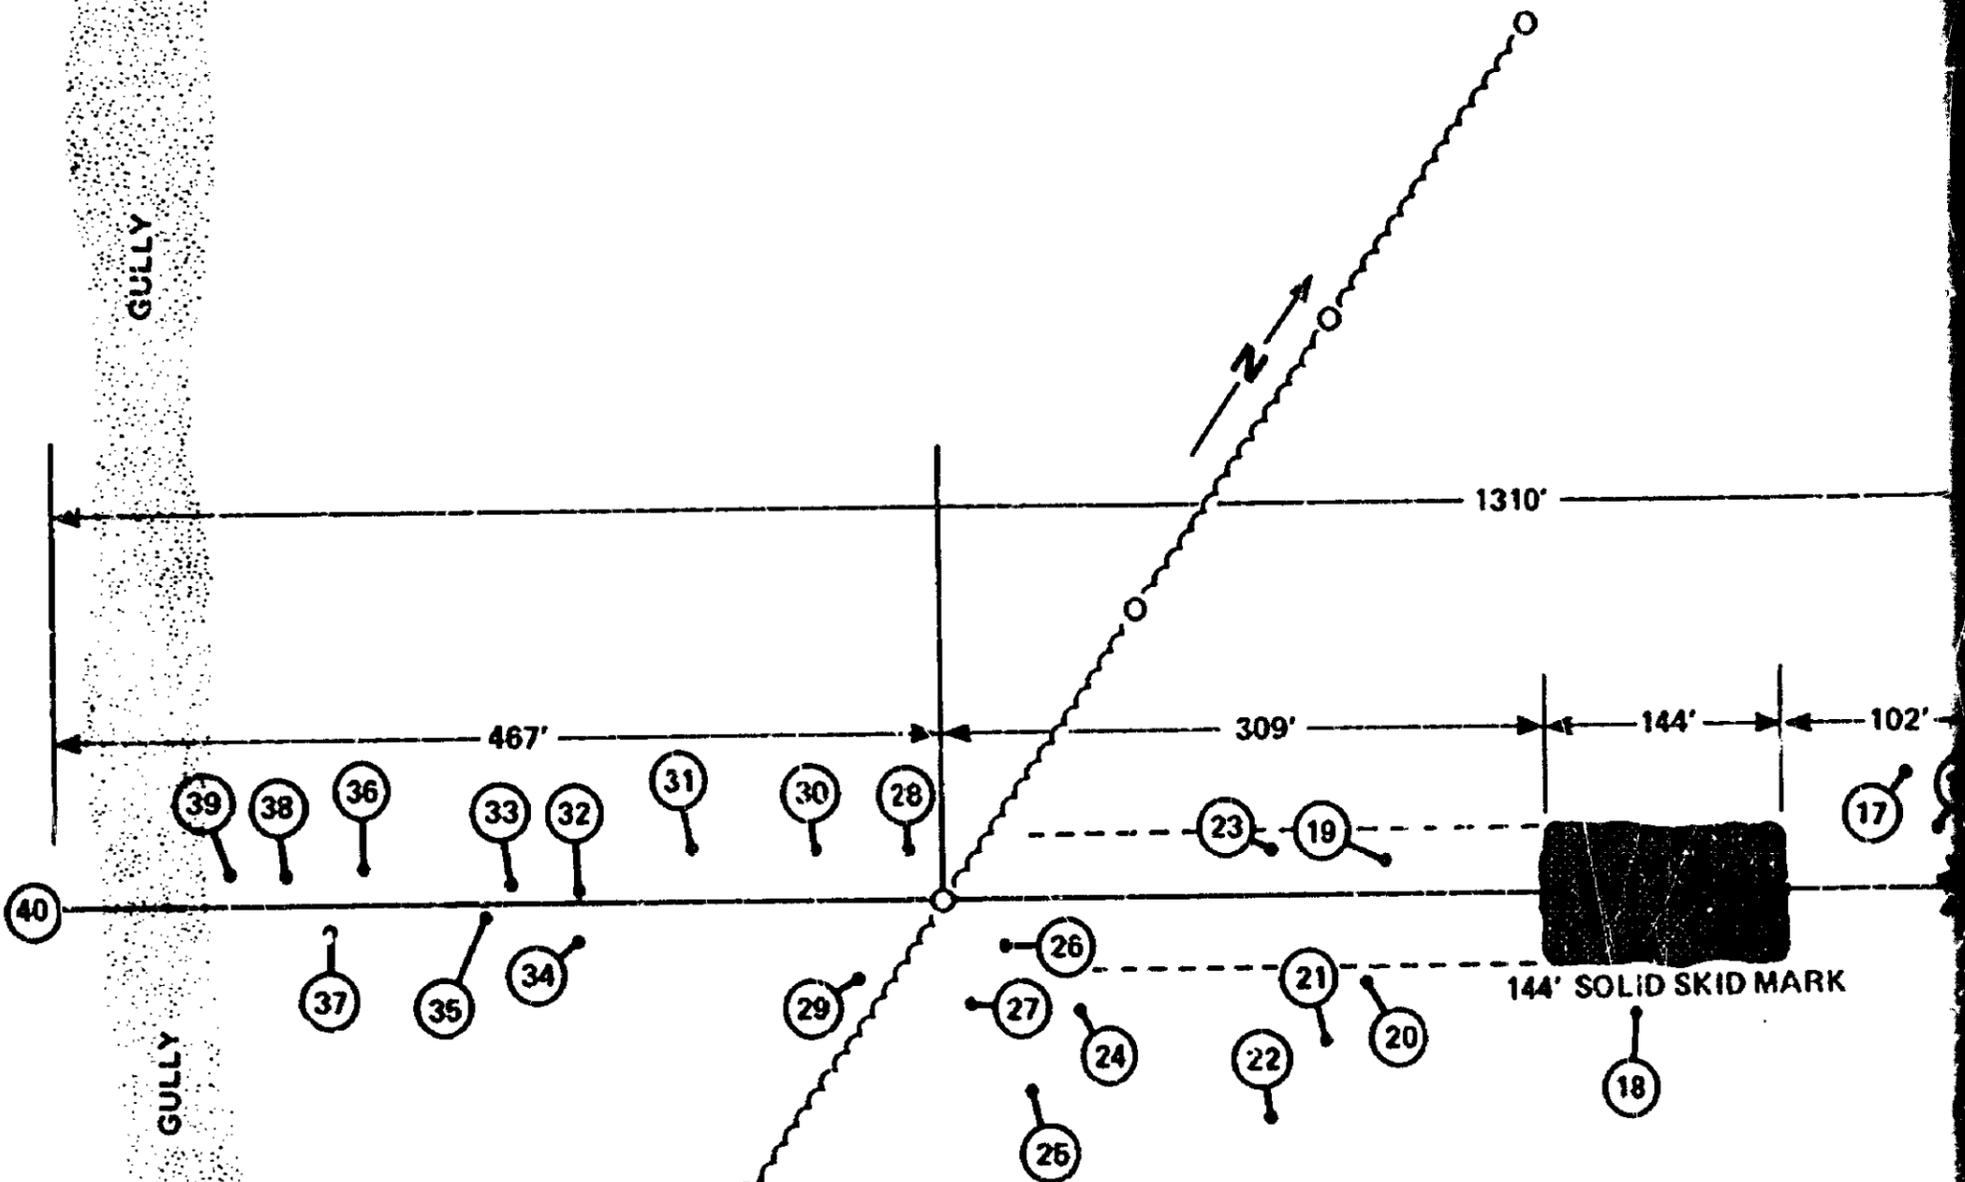
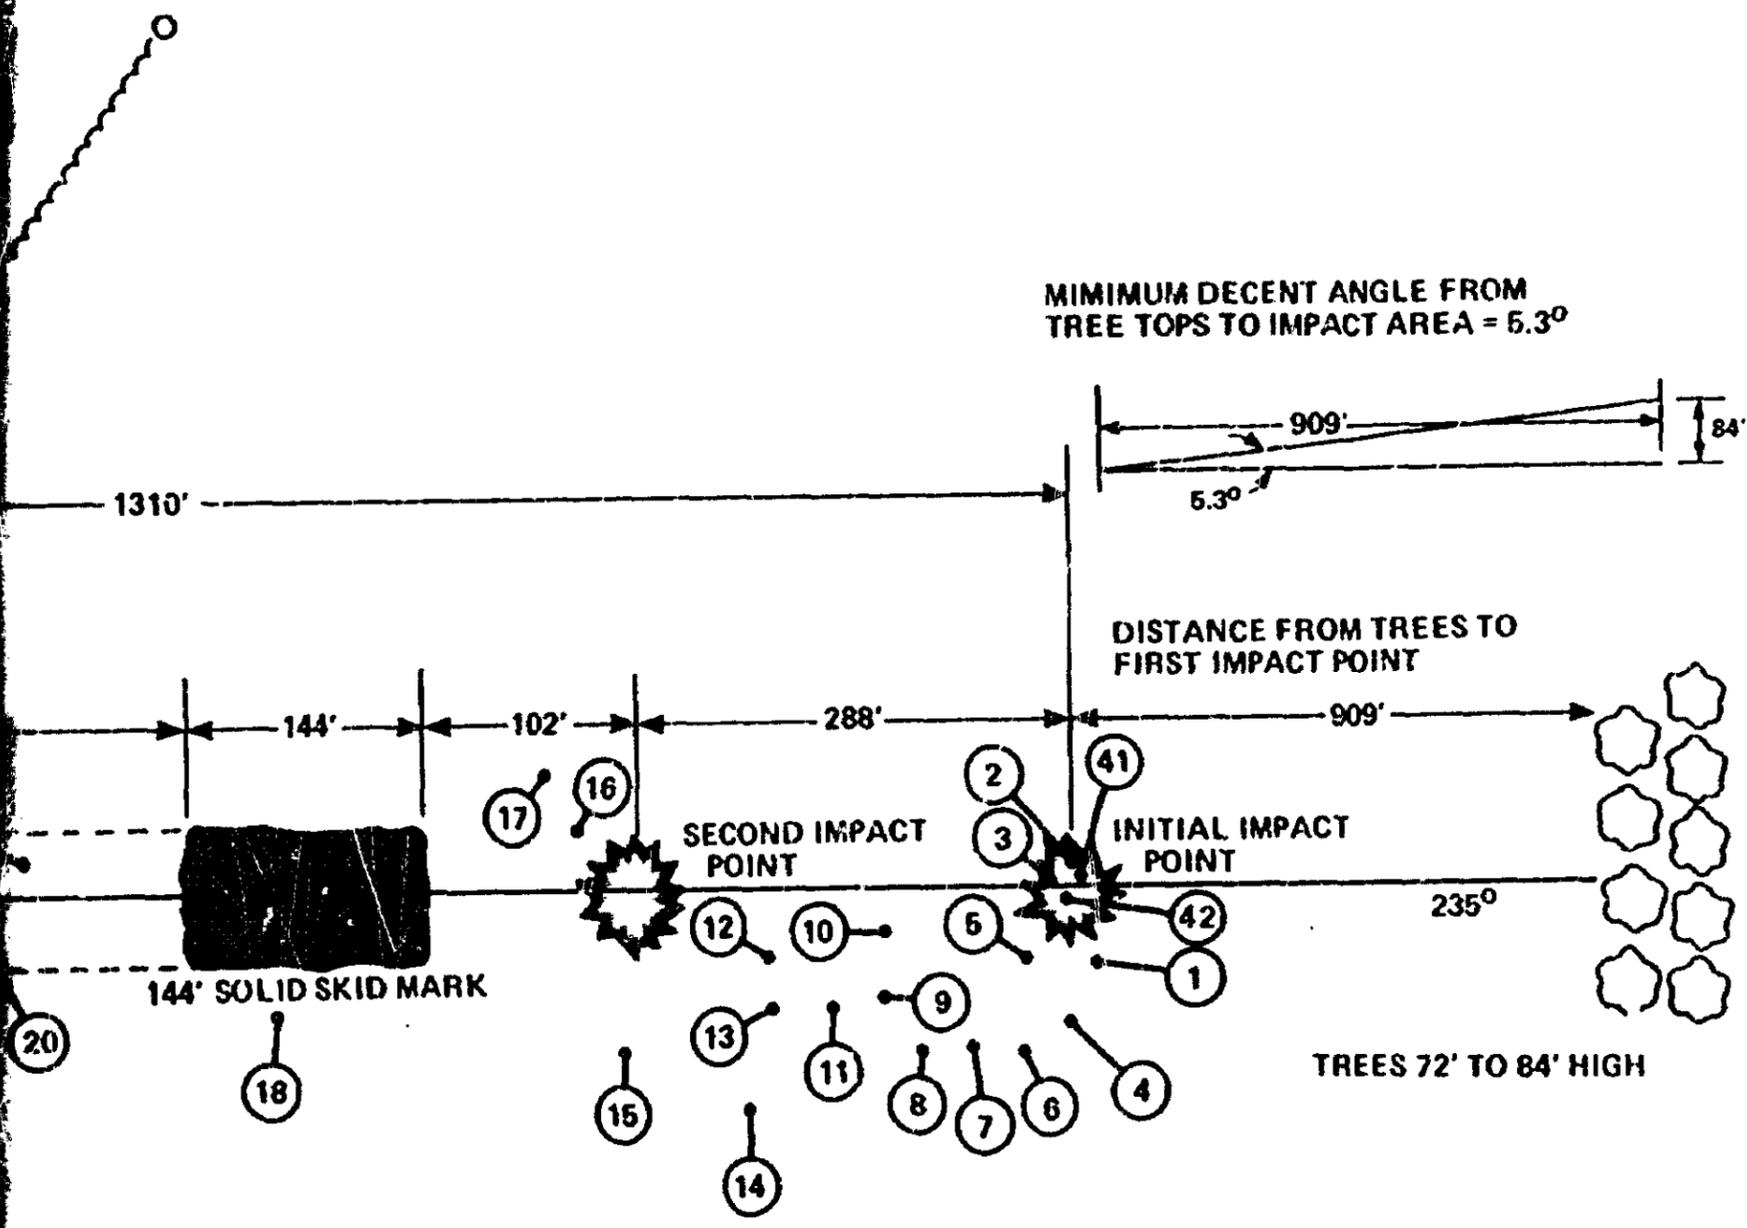
The empennage separated from the fuselage about 665 ft beyond the initial point of impact, and both engines and wings were found between 900 ft and 1,150 ft from the initial impact point. The propeller assemblies had separated from the powerplants, which had separated from the wings. (See appendix D.)

MINIMUM DESCENT ANGLE FROM TREE TOPS TO IMPACT AREA = 5.3°
