# NATIONAL TRANSPORTATION SAFETY BOARD

## AIRCRAFT ACCIDENT REPORT

SCENIC AIRLINES, INC.  
CESSNA 404, N2683S  
NEAR GRAND CANYON NATIONAL PARK AIRPORT  
TUSAYAN, ARIZONA  
JULY 21, 1980

NTSB-AAR-81-2

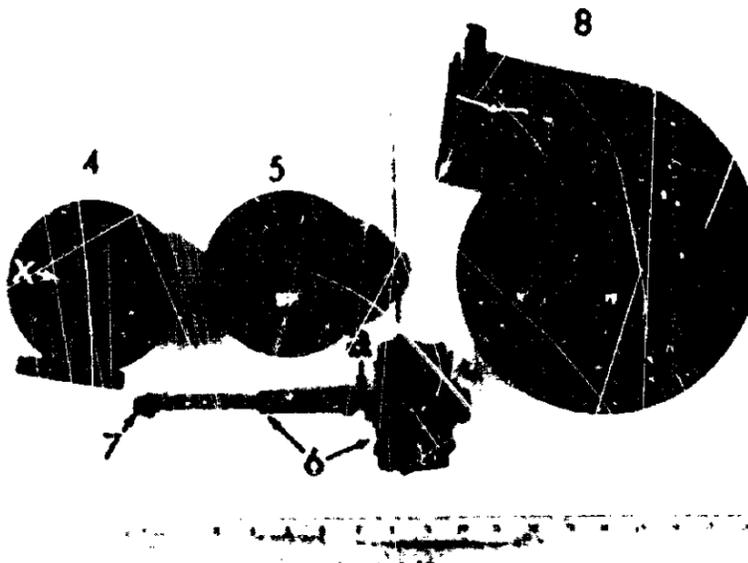
Figure 4.--Overall view of the hot section components of the turbocharger:

4. Center housing
5. Wheel shroud
6. Turbine shaft and wheel assembly
7. Locknut
8. Turbine housing

Metallurgical examination of the left engine turbocharger disclosed that it had seized suddenly but that the engine had continued to operate for some time following failure. There were hot gas erosion holes in one-half of the turbine wheel shroud and silhouette imprints of the turbine wheel blades on the housing. Both conditions indicated that hot exhaust gases impinged for an appreciable time on the turbine wheel while it was stationary. Further, metal transfer between the compressor impeller blades and housing and the turbine wheel blades and housing indicates that a severe imbalance of the turbine wheel and compressor existed within the turbocharger assembly. The wear on the center bearing and the deformation of the turbine wheel shaft, adjacent to the shaft fracture, are also consistent with an imbalance condition. Only a small portion of the fracture on the turbine shaft was clean or free of deposits; the remainder contained heavy, lead rich exhaust gas residues. The deposits indicated that the majority of the shaft fracture had been exposed to exhaust gases for some time. The discolored fracture surface exhibited cracking features which had originated at the bottom of the piston ring groove with fatigue crack propagation toward the inside diameter of the shaft. However, the crescents indicative of this type of cracking did not extend to the inside diameter. Thus, the final fracture probably occurred rapidly because of an overstress condition. As a result, the fracture was subjected to hot gases escaping through the turbine wheel shroud.

The material found on the outside diameter of the broken shaft, adjacent to the turbine wheel, and the piston ring groove sidewall had a chemical composition consistent with the piston ring. This indicated that the ring was smeared between the shaft and the inside diameter of the center housing. This condition could have occurred from unbalanced rotational forces.

The Safety Board was unable to determine precisely the source that initially produced the imbalanced condition in the turbocharger assembly. However, since all the turbine wheel blades were broken near the tips, the blades probably were broken as a result of foreign object damage (FOD). Such damage would produce severe turbine wheel imbalance and the conditions found in the turbocharger assembly. Similar conditions have been documented by the manufacturer in known FOD damaged turbochargers. While it is possible that the
