# **NATIONAL TRANSPORTATION SAFETY BOARD**

## **AIRCRAFT ACCIDENT REPORT**

**EAGLE COMMUTER AIRLINES, INC.,  
PIPER PA-31-350, NAVAJO CHIEFTAIN, N59932  
WILLIAM P. HOBBY AIRPORT  
HOUSTON, TEXAS  
MARCH 21, 1980**

NTSB-AAR-81-4

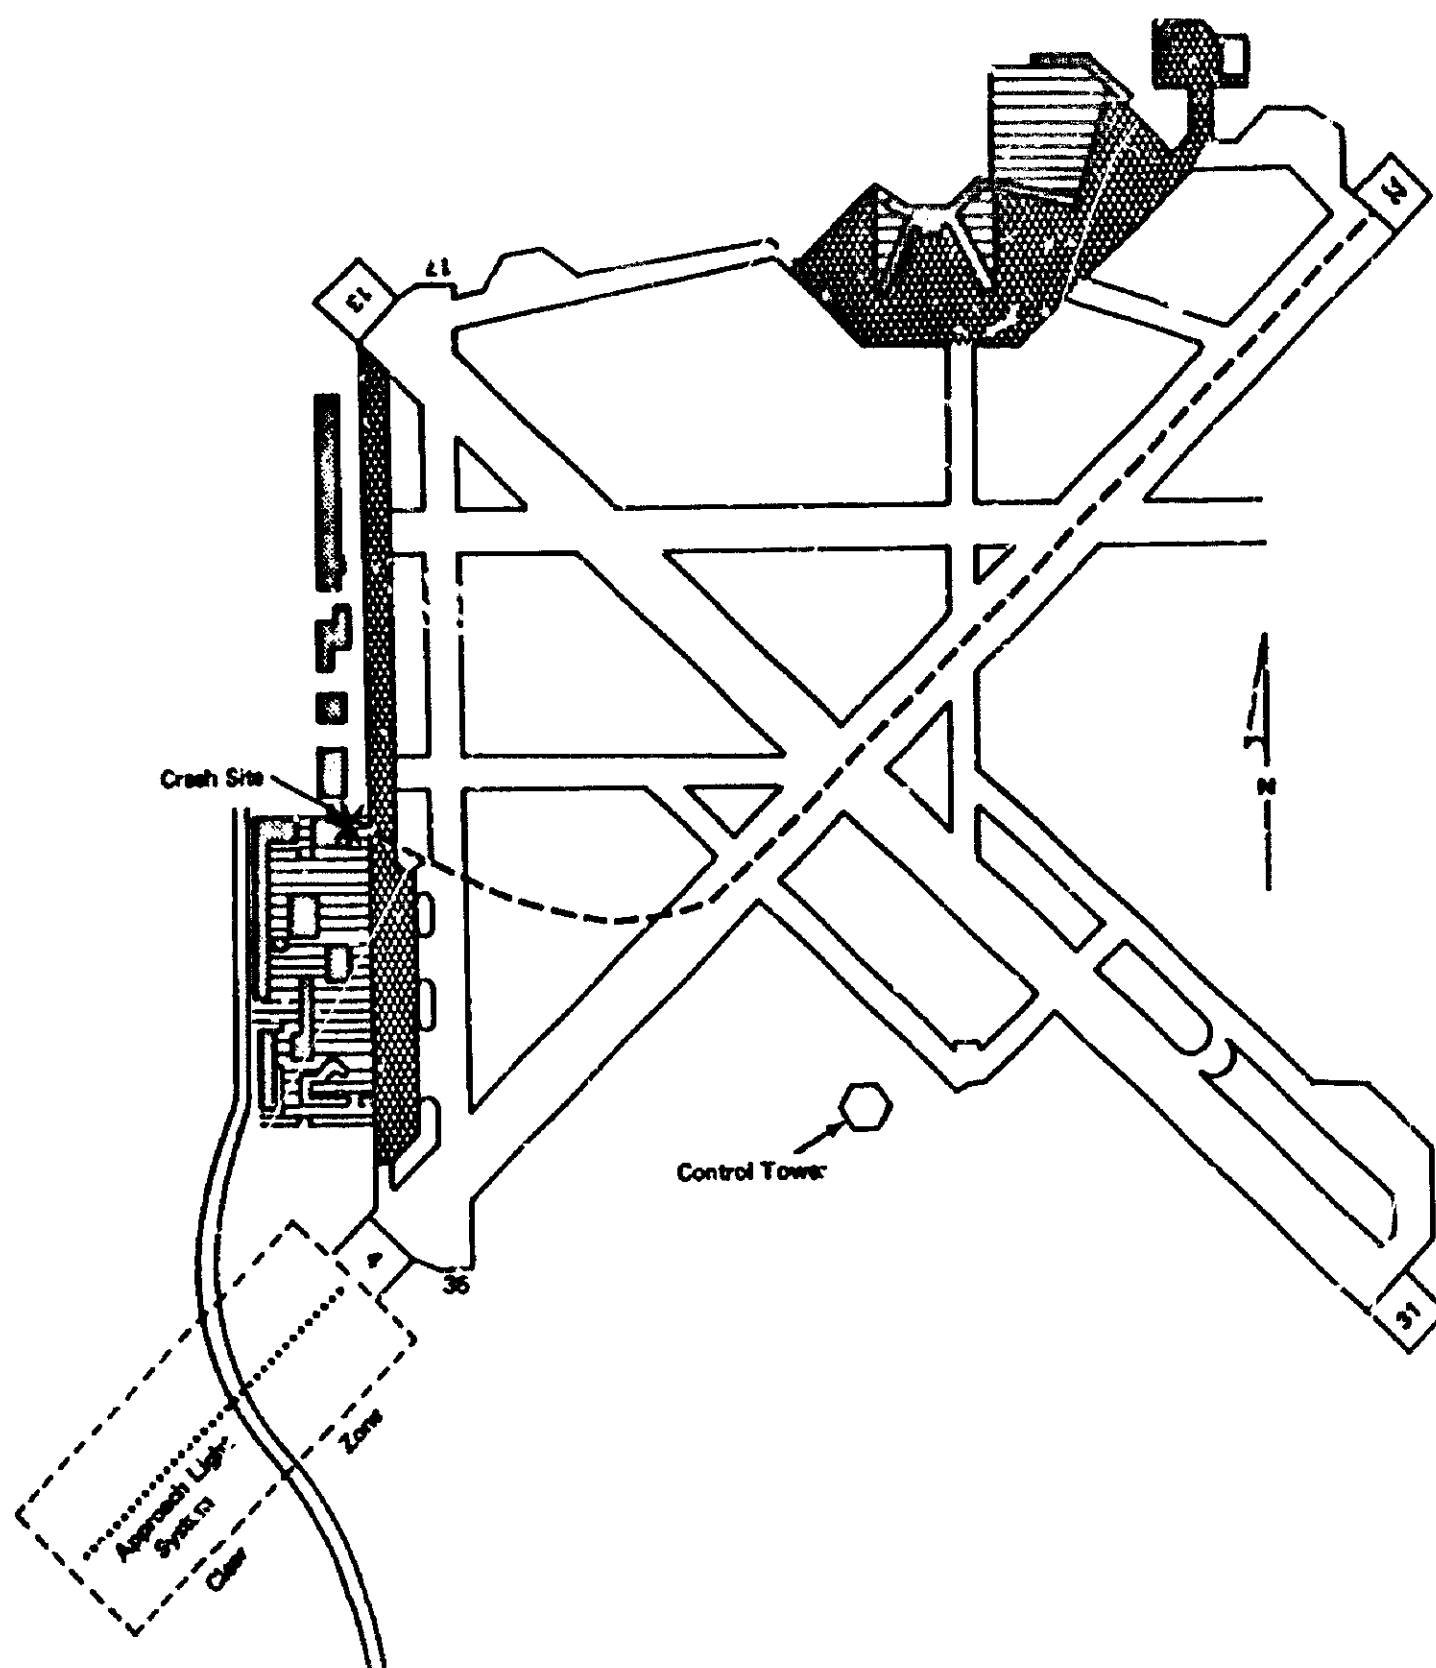
Figure 1--Diagram of William P. Hobby Airport  
and probable flight track of Flight 108.

The Safety Board believes that Flight 108 climbed to about 90 ft before it experienced a power loss in the right engine since (1) the captain probably would have aborted the takeoff before liftoff if the engine malfunction occurred earlier, (2) the ground roll and initial climb computations were compatible with the observed flight profile performance requirements, and (3) survivors reported that the aircraft was airborne when the engine problem started. Additionally, the tower controller and ground witnesses stated that the aircraft was about 100 ft above the ground when the crew reported the loss of the engine. Flight 108 would have required about 1,669 ft to climb to 50 ft after liftoff, a total of 2,991 ft from the start of the takeoff roll. (These computations are reasonable for a 2-engine climb of a 7,278 lb-aircraft, since the flight manual figure for a 7,000-lb aircraft is 2,875 ft.) Flight 108 would have reached 90 ft of altitude in another 1,334 ft, a total of 4,325 ft or 38.2 sec from the start of the takeoff roll. The difference between the cleared-for-takeoff time at 1947:50 and the report of the loss of the right engine at 1948:35 was 45 sec, which would have allowed the 38.2 sec to climb to 90 ft and 6 sec to initiate the transmission to the air traffic control tower and begin the takeoff roll. This sequence is confirmed by witnesses' observations, times on the air traffic control tapes, and the computed flight profile based on flight manual performance data.

Assuming that the aircraft lifted off the runway at an airspeed of 90 mph to 95 mph, its speed would have been about 116 mph at 50 ft above the runway and about 125 mph at 90 ft above the runway. These airspeeds are consistent with flight manual performance data and with the observed performance of Flight 108 from the start of the takeoff roll to a point 4,325 ft down and 90 ft above the runway.

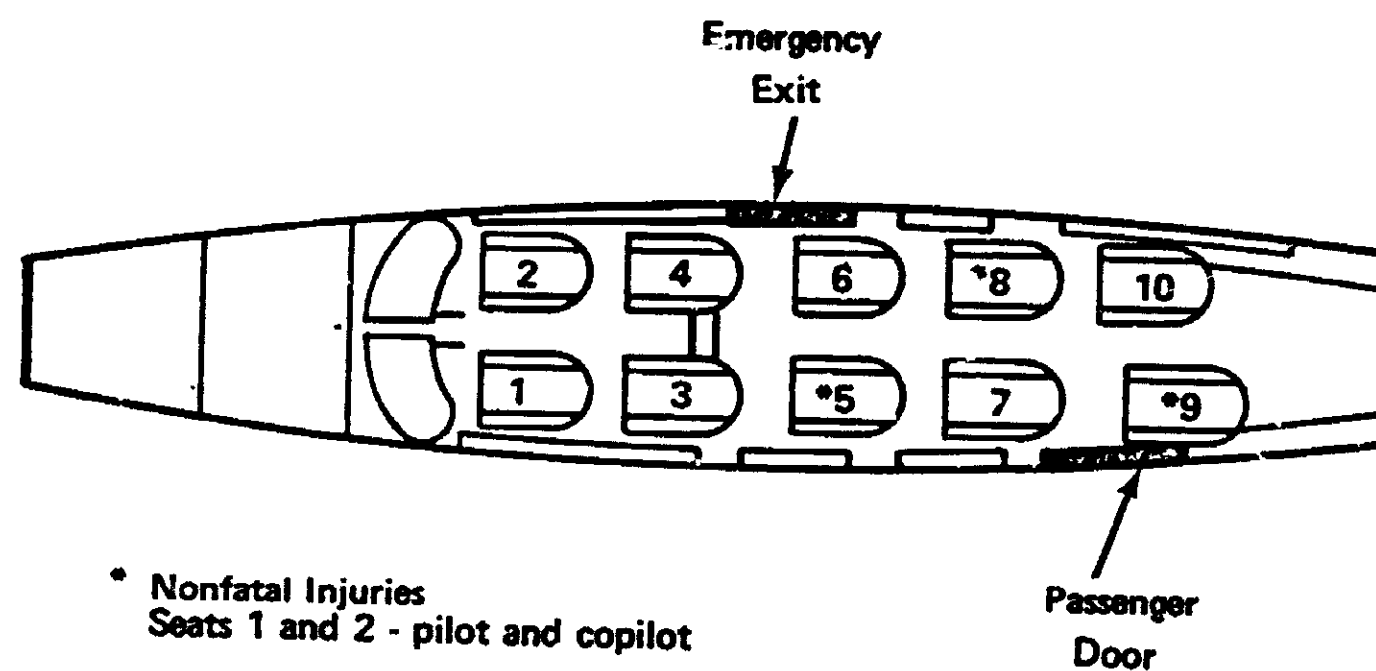
Figure 2--Seat diagram.

The structural damage to the aircraft seats indicated high downward vertical forces, which inflicted downward damage to the seat pans and leg structures of the two cockpit seats. In addition, they were displaced slightly to the right. The seat pans for seats 3 and 4 were separated from the leg structures, which were damaged severely. (See figure 2.) The inboard floor track was torn loose. The areas of attachment for both seat tracks had been displaced downward. Seats 5 and 7 remained attached to the floor, but had collapsed down and to the right. Seat 8 was attached to the rear outboard leg; the front legs had collapsed downward. Seat 10 was torn loose from the attachment plate. The inboard rear leg attach pin separated from the leg and remained in the floor plate while the other pins remained with the seat. The cabin floor was crushed downward about 3 in at the front leg position. Seats 6 and 9 were not found.

The occupants of seats 5, 7, 8, 9, and 10 survived the impact. The occupants of seats 5, 8, and 9 were able to escape by themselves, while the occupant of seat 10 was removed from the aircraft by persons at the accident site. He later died in the hospital. The occupant of seat 7 did not escape from the aircraft. However, the postmortem examination indicated that he received a nonfatal fractured skull injury and died in the postcrash fire.

Initially, five of the six occupants who were seated aft of the wing spar survived the impact, while all four occupants forward of the spar died. With the exception of two of the survivors' seats that exhibited slightly more seat leg deformation than the other seats, the examination of the cabin interior revealed that the areas on both sides of the wing spar received virtually identical damage. The distribution of the survivors in relation to the wing spar was probably caused by the slight nosedown attitude of the aircraft at the initial impact. The occupants forward of the spar would have received greater vertical deceleration loads than the rear occupants, who would have been protected by the absorption of energy in the forward fuselage and the continuing collapse of the fuselage structure aft of the spar. It is also likely that the engines and the wing spar were still absorbing energy after the forward occupants had received the peak vertical decelerative load. Finally, the rearmost occupants benefited from the upward slope of the fuselage beneath seats 7, 8, 9, and 10 which probably allowed more time for the decelerative forces to be absorbed.
