AIRCRAFT ACCIDENT REPORT

CONTINENTAL AIRLINES /
AIR MICRONESIA, INC.
BOEING 727-92C, N18479
YAP AIRPORT
YAP, WESTERN CAROLINE ISLANDS
NOVEMBER 21, 1980

NTSB-AAR-81-7

**CONTINENTAL AIRLINES/AIR MICRONESIA INC.
BOEING 727-92C, N18479
YAP AIRPORT
YAP, WESTERN CAROLINE ISLANDS
NOVEMBER 21, 1980**

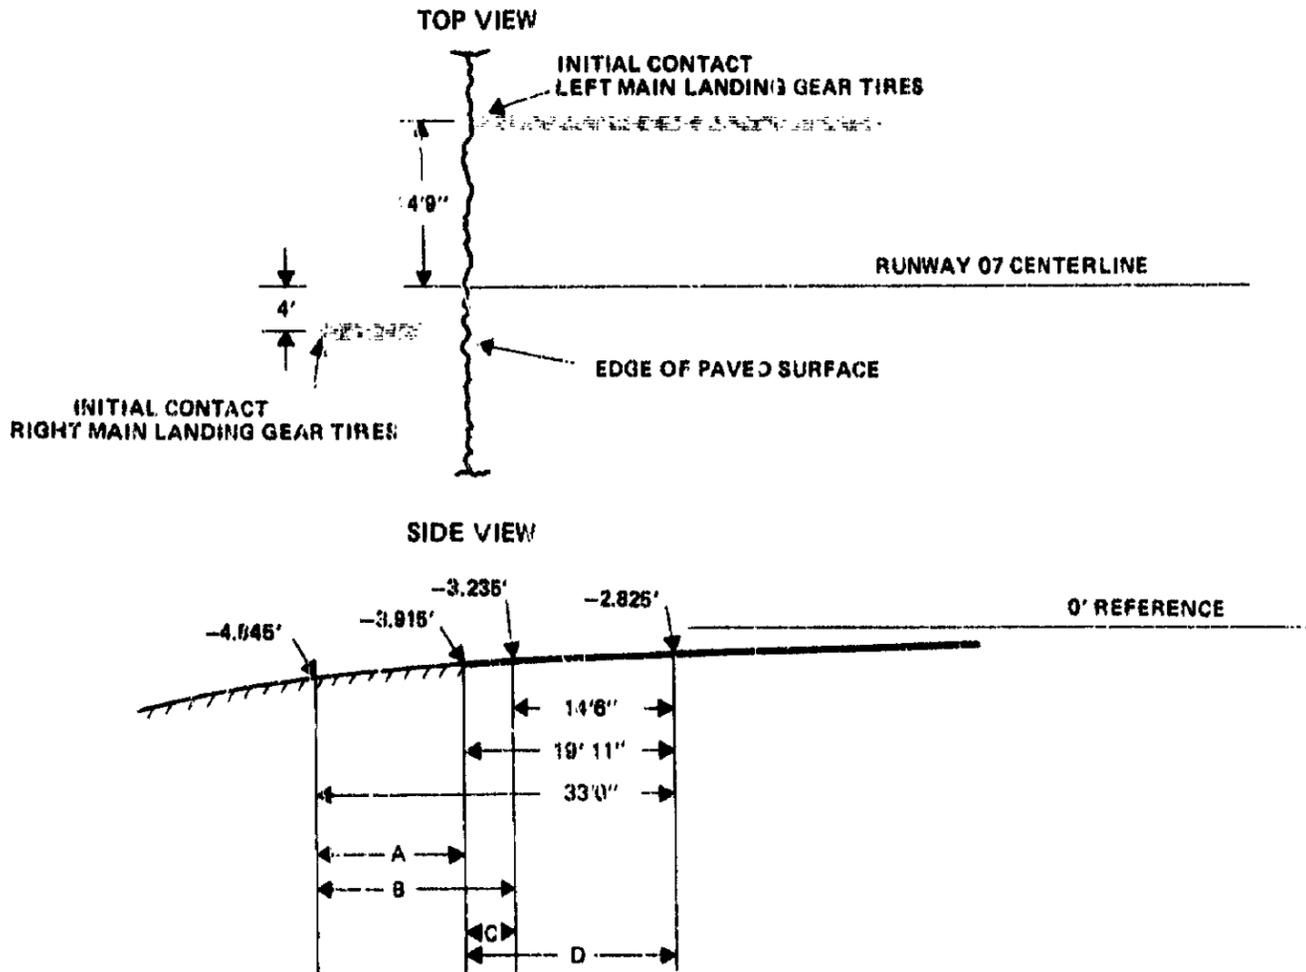
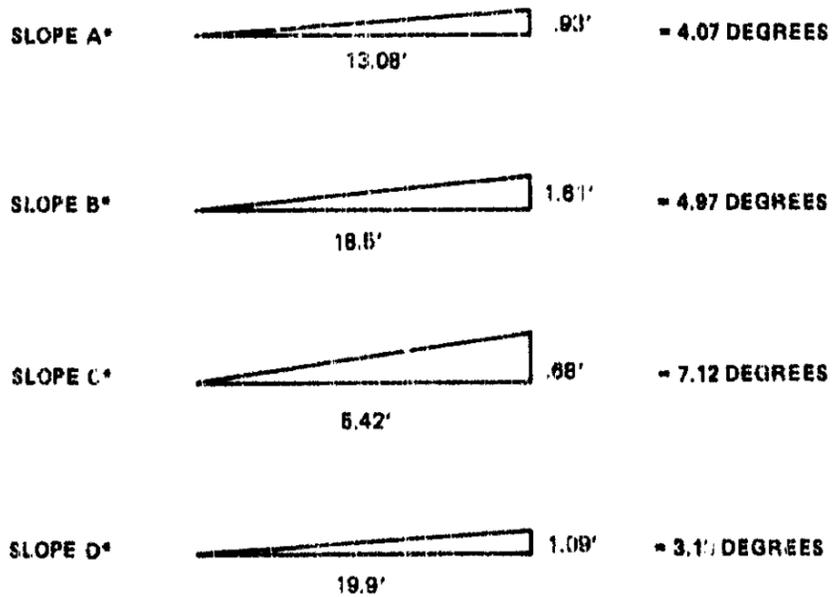
RUNWAY INFORMATION

Yap Airport has one runway oriented 070°/250° magnetic. The runway is 4,820 feet long and about 100 feet wide. The runway base is composed of compacted coral with an asphalt-treated seal covering a width of about 75 feet. The seal coat had deteriorated in many places and there were rutted areas in the touchdown zone. The runway edges were not distinct because of grass which had grown through the surface along the edges. The approach end of runway 7 was not clearly defined, because the surface gradually sloped downward from the runway level. (See appendix D.)

The first ground impact mark began 13 feet short of the runway threshold. (See appendix G.) This mark was made by the Nos. 3 and 4 tires on the right main landing gear. The left main landing gear tires touched down virtually on the threshold of the runway. A gouge made by the tail skid was found 2 feet short of the runway. Beginning about 100 feet beyond the threshold of the runway were several gouges and marks along the right side of the centerline made by the right wing inboard and outboard flap tracks. Heavy tire marks from the Nos. 1 and 2 tires began about 75 feet beyond the threshold of the runway and continued along the runway, gradually becoming lighter until the aircraft departed the runway surface. About 300 feet beyond the runway threshold, the left main gear tire marks and the scrapemarks from the right wing began a gradual turn to the right. The first evidence of nosewheel tire marks began about 600 feet beyond the threshold of the runway at the same point where the right wingtip began gouging the dirt and grass along the right edge of the runway. The left main tire marks departed the runway surface 1,000 feet from the runway threshold at the same time the right wingtip destroyed a bamboo A-frame touchdown zone marker located adjacent to the runway.

After the aircraft departed the runway surface, the right wingtip began digging into a 6- to 8-foot-high embankment about 1,150 feet from the runway threshold. The aircraft slid up over the embankment where the nose gear and left main gear assemblies broke loose. The right wing outer structure was destroyed by the embankment and fuel was spilled. The aircraft rotated to the right as it slid through dense jungle brush and it came to rest oriented 220° magnetic, about 1,700 feet from initial touchdown.
