AIRCRAFT INCIDENT REPORT

**NORTHWEST AIRLINES 79
McDONNELL DOUGLAS DC-10-40, N143US
LEESBURG, VIRGINIA**

JANUARY 31, 1981

NTSB-AAR-81-10

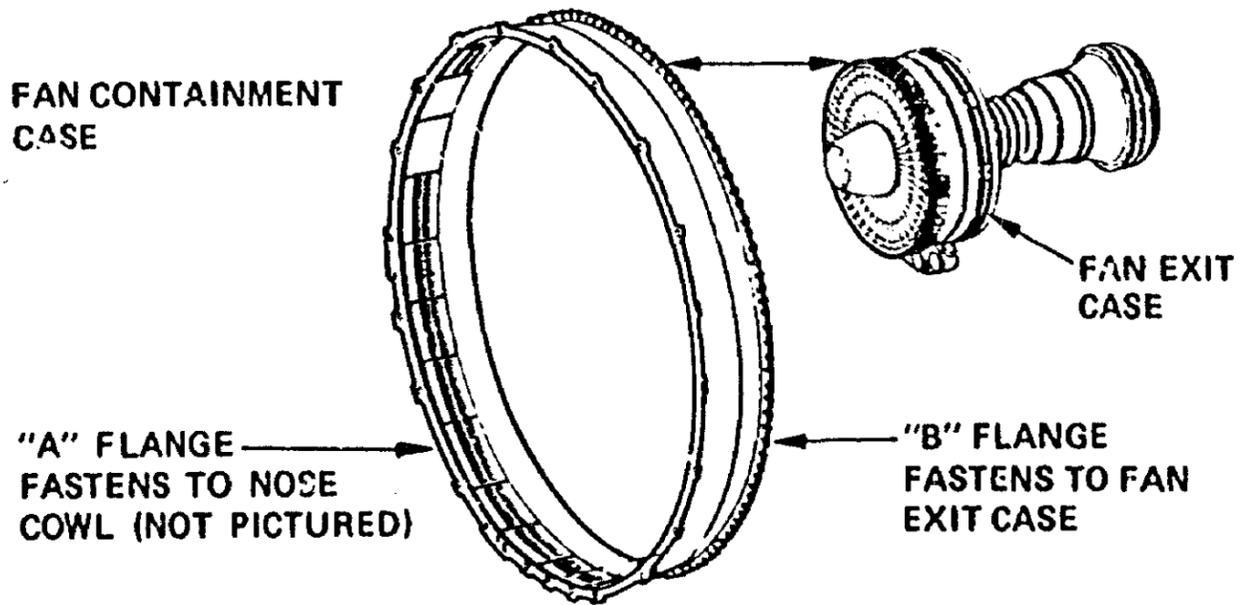
Figure 1.--No. 3 engine after incident.

The nose cowl assembly, the fan containment case forward of the B-flange, and their associated fixtures and components were missing from the aircraft. (See figure 1.) The rear of the nose cowl and the front of the fan case are mated at A-flange. The rear of the fan case and the front of the fan exit case are mated at B-flange. The fan exit case was torn and crushed around its leading edge. The compressor blades were damaged, all fan blades were damaged at the tips, and the No. 30 blade was missing.

NO. 3 ENGINE AFTER INCIDENT.
ARROW DENOTES SEPARATED
NO. 30 FAN BLADE.

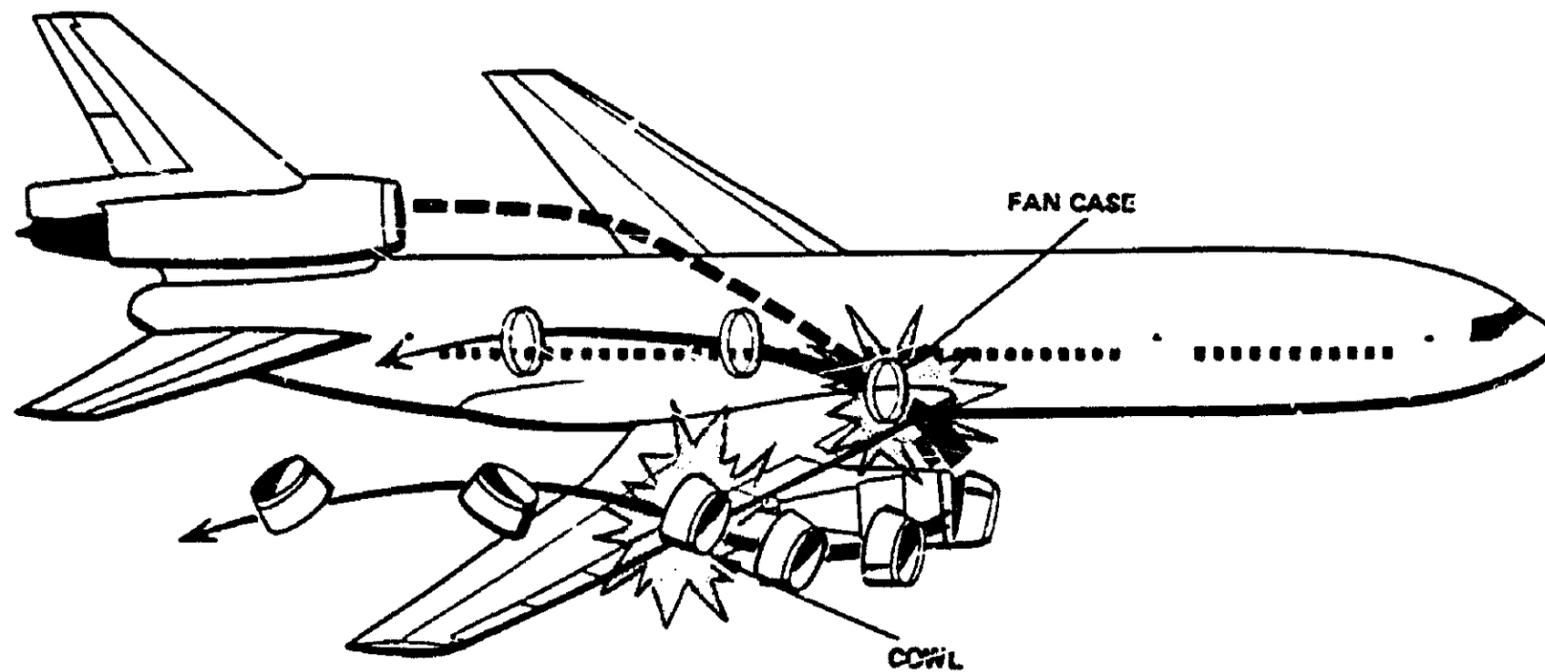
When the fan blade fractured, it struck the fan case and the inner nose cowl near the 10-o'clock position, causing the loss of two to five A-flange inlet cowl retention bolts in the area of the impact. The impact loads may have also caused the B-flange bolt

fractures or the flange breakout in an area corresponding to the A-flange failures. The engine dynamic imbalance and the aerodynamic loads on the engine nose cowl loaded the remaining A-flange fasteners beyond their tensile strength and the flange joint began to separate. The bolts sheared in a sequential circumferential (unzipping) manner until only fasteners between the 1- and 3-o'clock positions remained. Aerodynamic forces then lifted the cowl away from the engine, pivoting about the remaining bolts, stripping the bolts from their nut plates, and bending the flange backward and outboard. The cowl separated upward and outward and struck right wing slat No. 5. As the A-flange fasteners progressively separated, additional aerodynamic loading caused interaction between the fan blade tips and the fan case and caused increased loading on the B-flange. The torsional loads imposed by fan blade tips striking the fan case and the additional aerodynamic loading caused failure of the B-flange fasteners. The unrestrained fan case moved in and out of the fan exit case and struck the fan exit guide vanes at random locations. The fan case was driven forward and was radially swung away from the engine, striking the fan exit case. The impact caused the fracture of a small section of the fan exit case B-flange and bent it backward and inboard. The fan case departed upward and inward and struck the leading edge Nos. 1 and 2 slats on the right wing. (See figure 4.)

Figure 4.--Graphic analysis of the loss of the nose cowl and fan case.
