**NATIONAL  
TRANSPORTATION  
SAFETY  
BOARD**

**AIRCRAFT ACCIDENT REPORT**

**CASCADE AIRWAYS, INC.  
BEEHCRAFT 99A, N390CA  
SPOKANE, WASHINGTON  
JANUARY 20, 1981**

NTSB-AAR-81-11

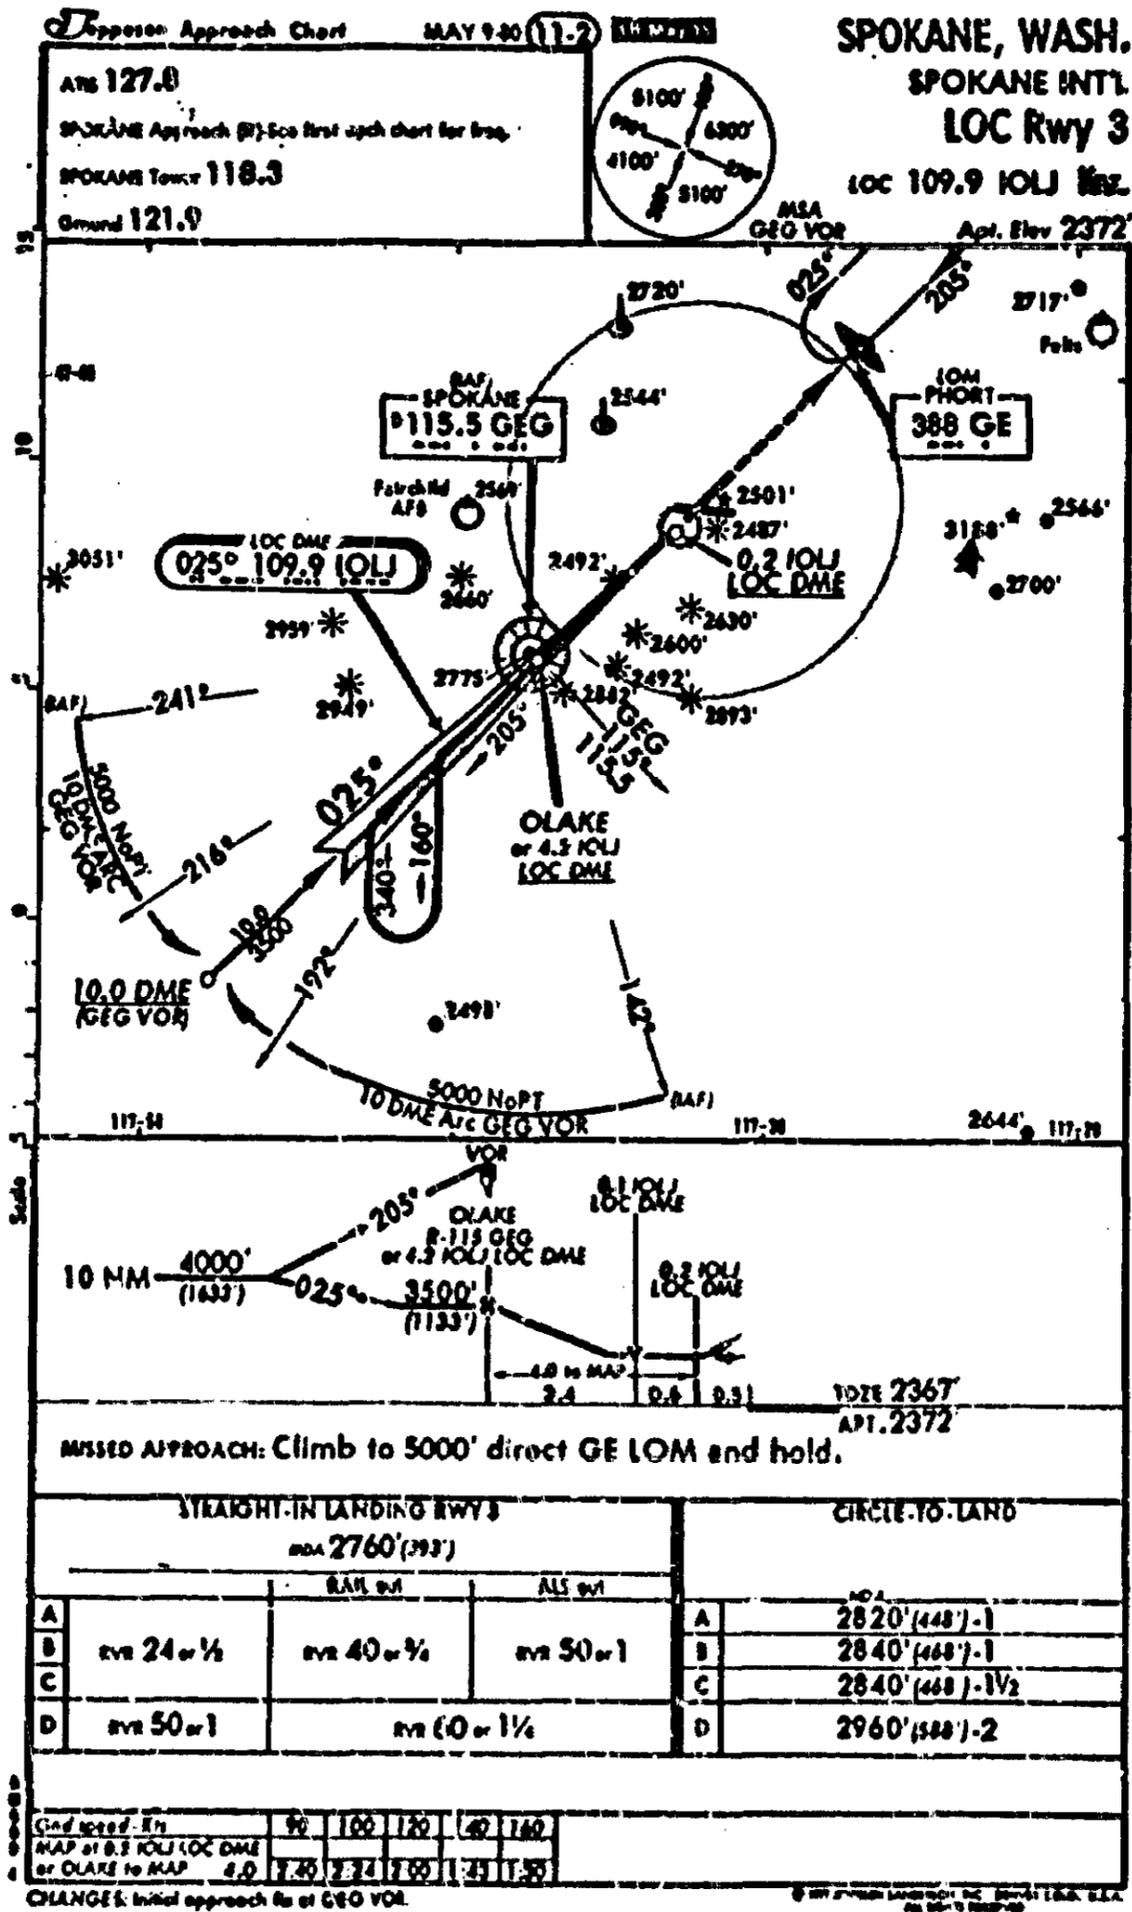
Figure 1.-- Localizer runway 3 approach chart.  
 (Not to be used for navigational purposes.)

11. The localizer 3 approach chart could cause confusion by portraying two DME frequencies without including a precautionary note to pilots about use of the correct frequency.

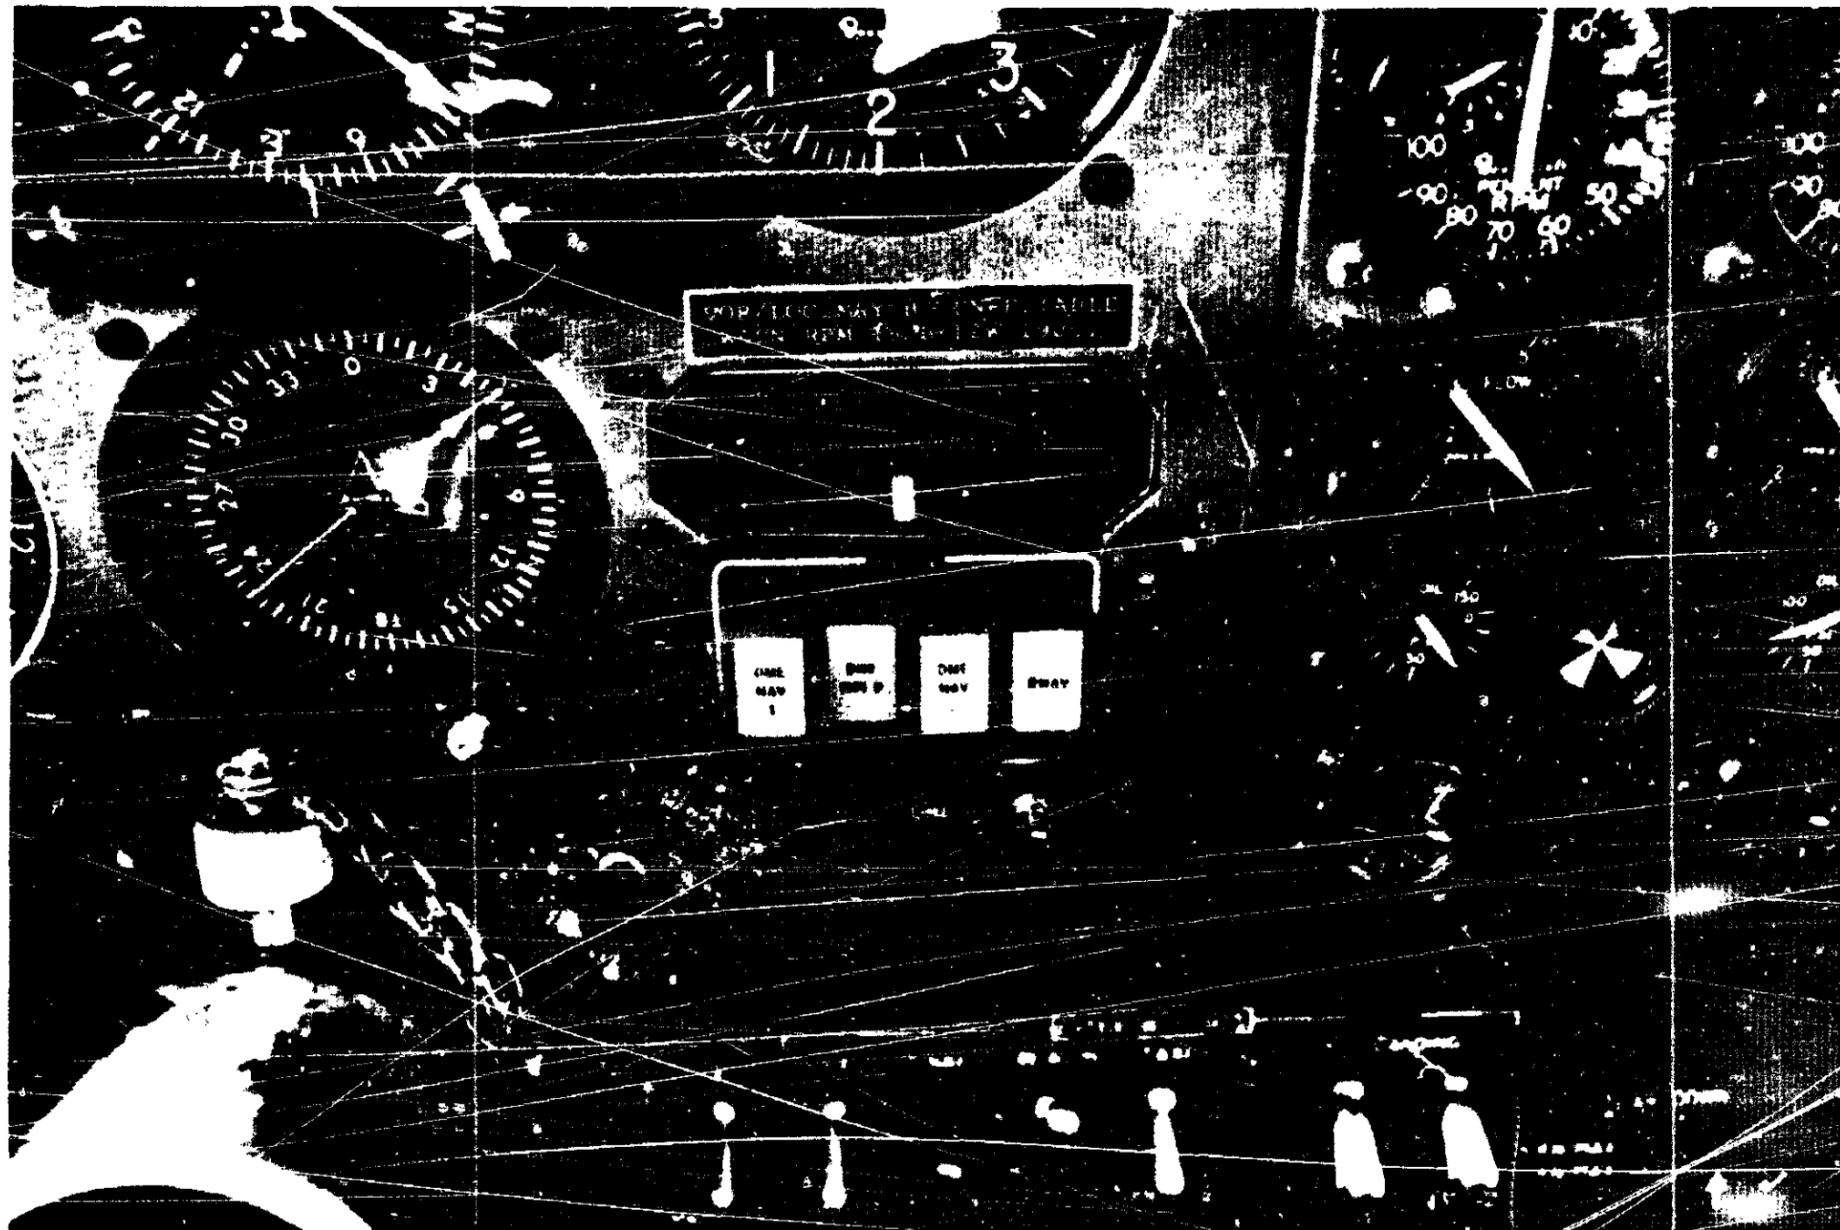
Figure 2.-- DME mode selector.

12. The flightcrew descended prematurely to the minimum descent altitude based on a 4.2 DME indication which emanated from the Spokane VORTAC.
13. The premature descent was a result of improper operation of the DME mode selector.
