AIRCRAFT ACCIDENT REPORT

AIR CALIFORNIA FLIGHT 336
BOEING 737-293, N468AC
JOHN WAYNE ORANGE COUNTY AIRPORT
SANTA ANA, CALIFORNIA
FEBRUARY 17, 1981

NTSB-AAR-81-12

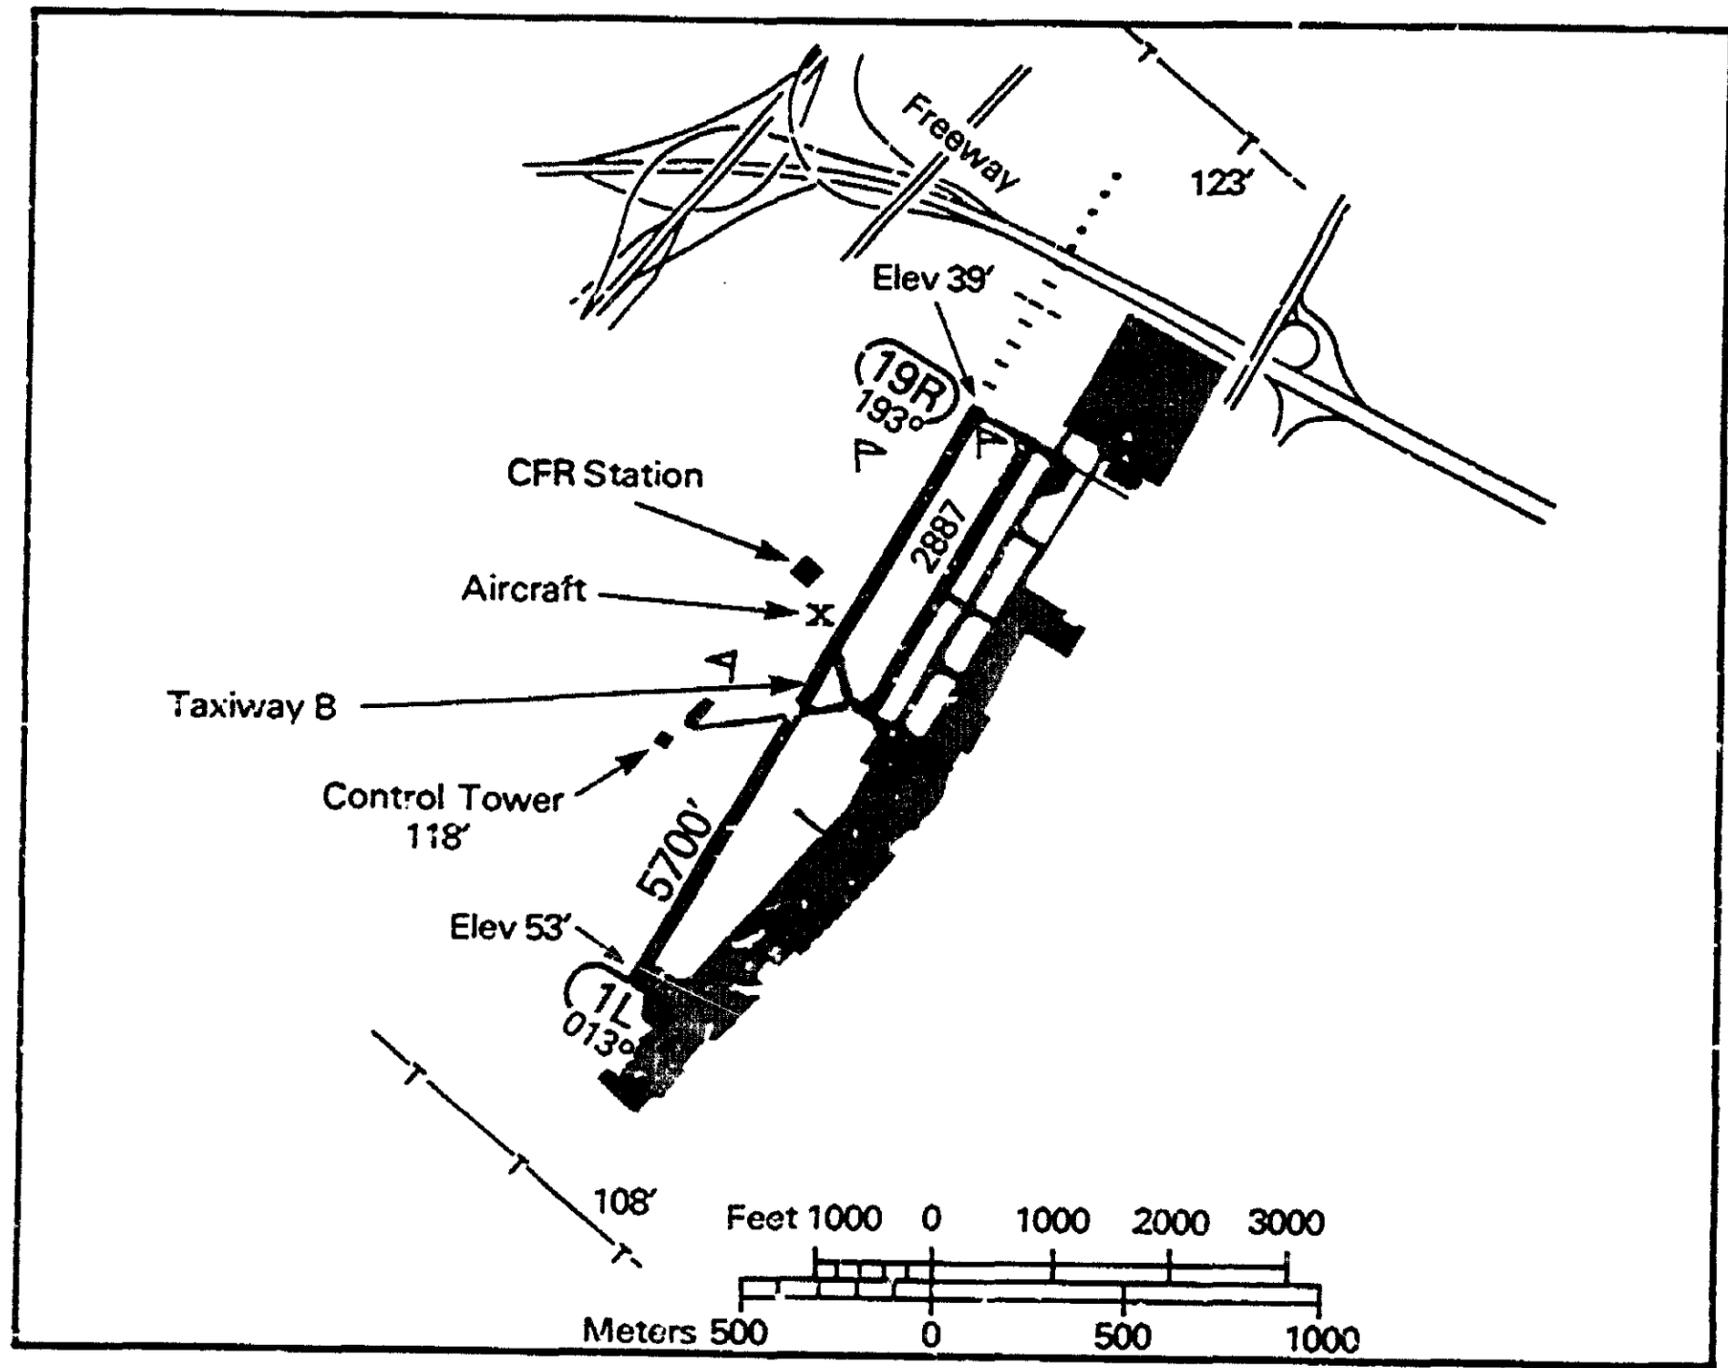
Figure 1.—Diagram of the John Wayne Orange County Airport at Santa Ana, California.

point, he observed that ACL336 appeared to have a high pitch attitude, was still in a descent, and was inside the freeway just approaching the end of runway 19R. (See figure 1.) The controller noted that ACL336 touched down on the right side of the runway, close to the approach end with gear down. As ACL336 touched down, the controller noted that ACL931 had aborted the takeoff and was almost abeam taxiway Bravo, taxiing slowly. He observed the right main gear of ACL336 go off the pavement, the right wing drop, and the aircraft slide and then pivot to the right. He stated that he saw a flash of fire under the left wing, which lasted for about 15 seconds and then "died down." The fire department arrived in less than a minute. He stated that all of the visible aircraft exits were opened 5 to 10 seconds after the aircraft stopped and that the passengers departed soon thereafter.

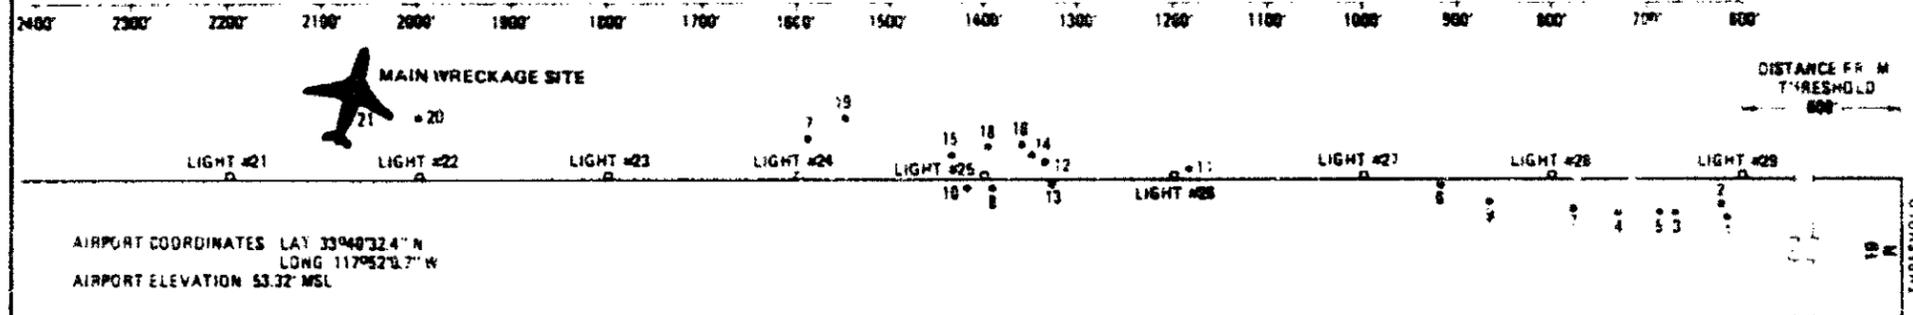
10. No. 2 tire mark ends 562' from point 9, 8' from edge of runway
11. Aerated ground comd. starts 14' from runway, 18' back of light #1-28
12. Aerated ground condition ends 18' from edge of runway

15. Ground scar ends 28' from edge of runway
16. Ground scar starts 37' from edge of runway
17. Ground scar ends from point 16
18. Portage of 90 inching plate flat

19. No. 2 ENGINE (S/N 866037) 65' from runway
20. No. 1 ENGINE (S/N 866101) 65' from runway
21. No. 1 ENGINE NOSE COWL AND THRUST REVERSE ASSEMBLY

1. SKID MARK FROM POINT 9 FOR 361 FT., THEN TIRE MARK FOR 131 FT
2. GREEN PAINT ON SIDE OF GROUND SCAR BETWEEN 14 AND 15
3. 5' TO 35' WIDE SCUFFED DIRT BETWEEN POINTS 15 AND 20.
4. LIGHTS # 24 AND 25 WERE BROKEN
5. ENGINE COMPONENTS, LOWER FUSCLAGE PANEL SECTIONS, AND FEW FLAP FAIRING SECTIONS WERE SLATTERED BETWEEN POINTS 17 AND 20.
