AIRCRAFT INCIDENT REPORT

**EASTERN AIRLINES
BOEING 727-25, N8140N
JOHN F. KENNEDY INTERNATIONAL AIRPORT
JAMAICA, NEW YORK
APRIL 8, 1981**

NTSB-AAR-81-14

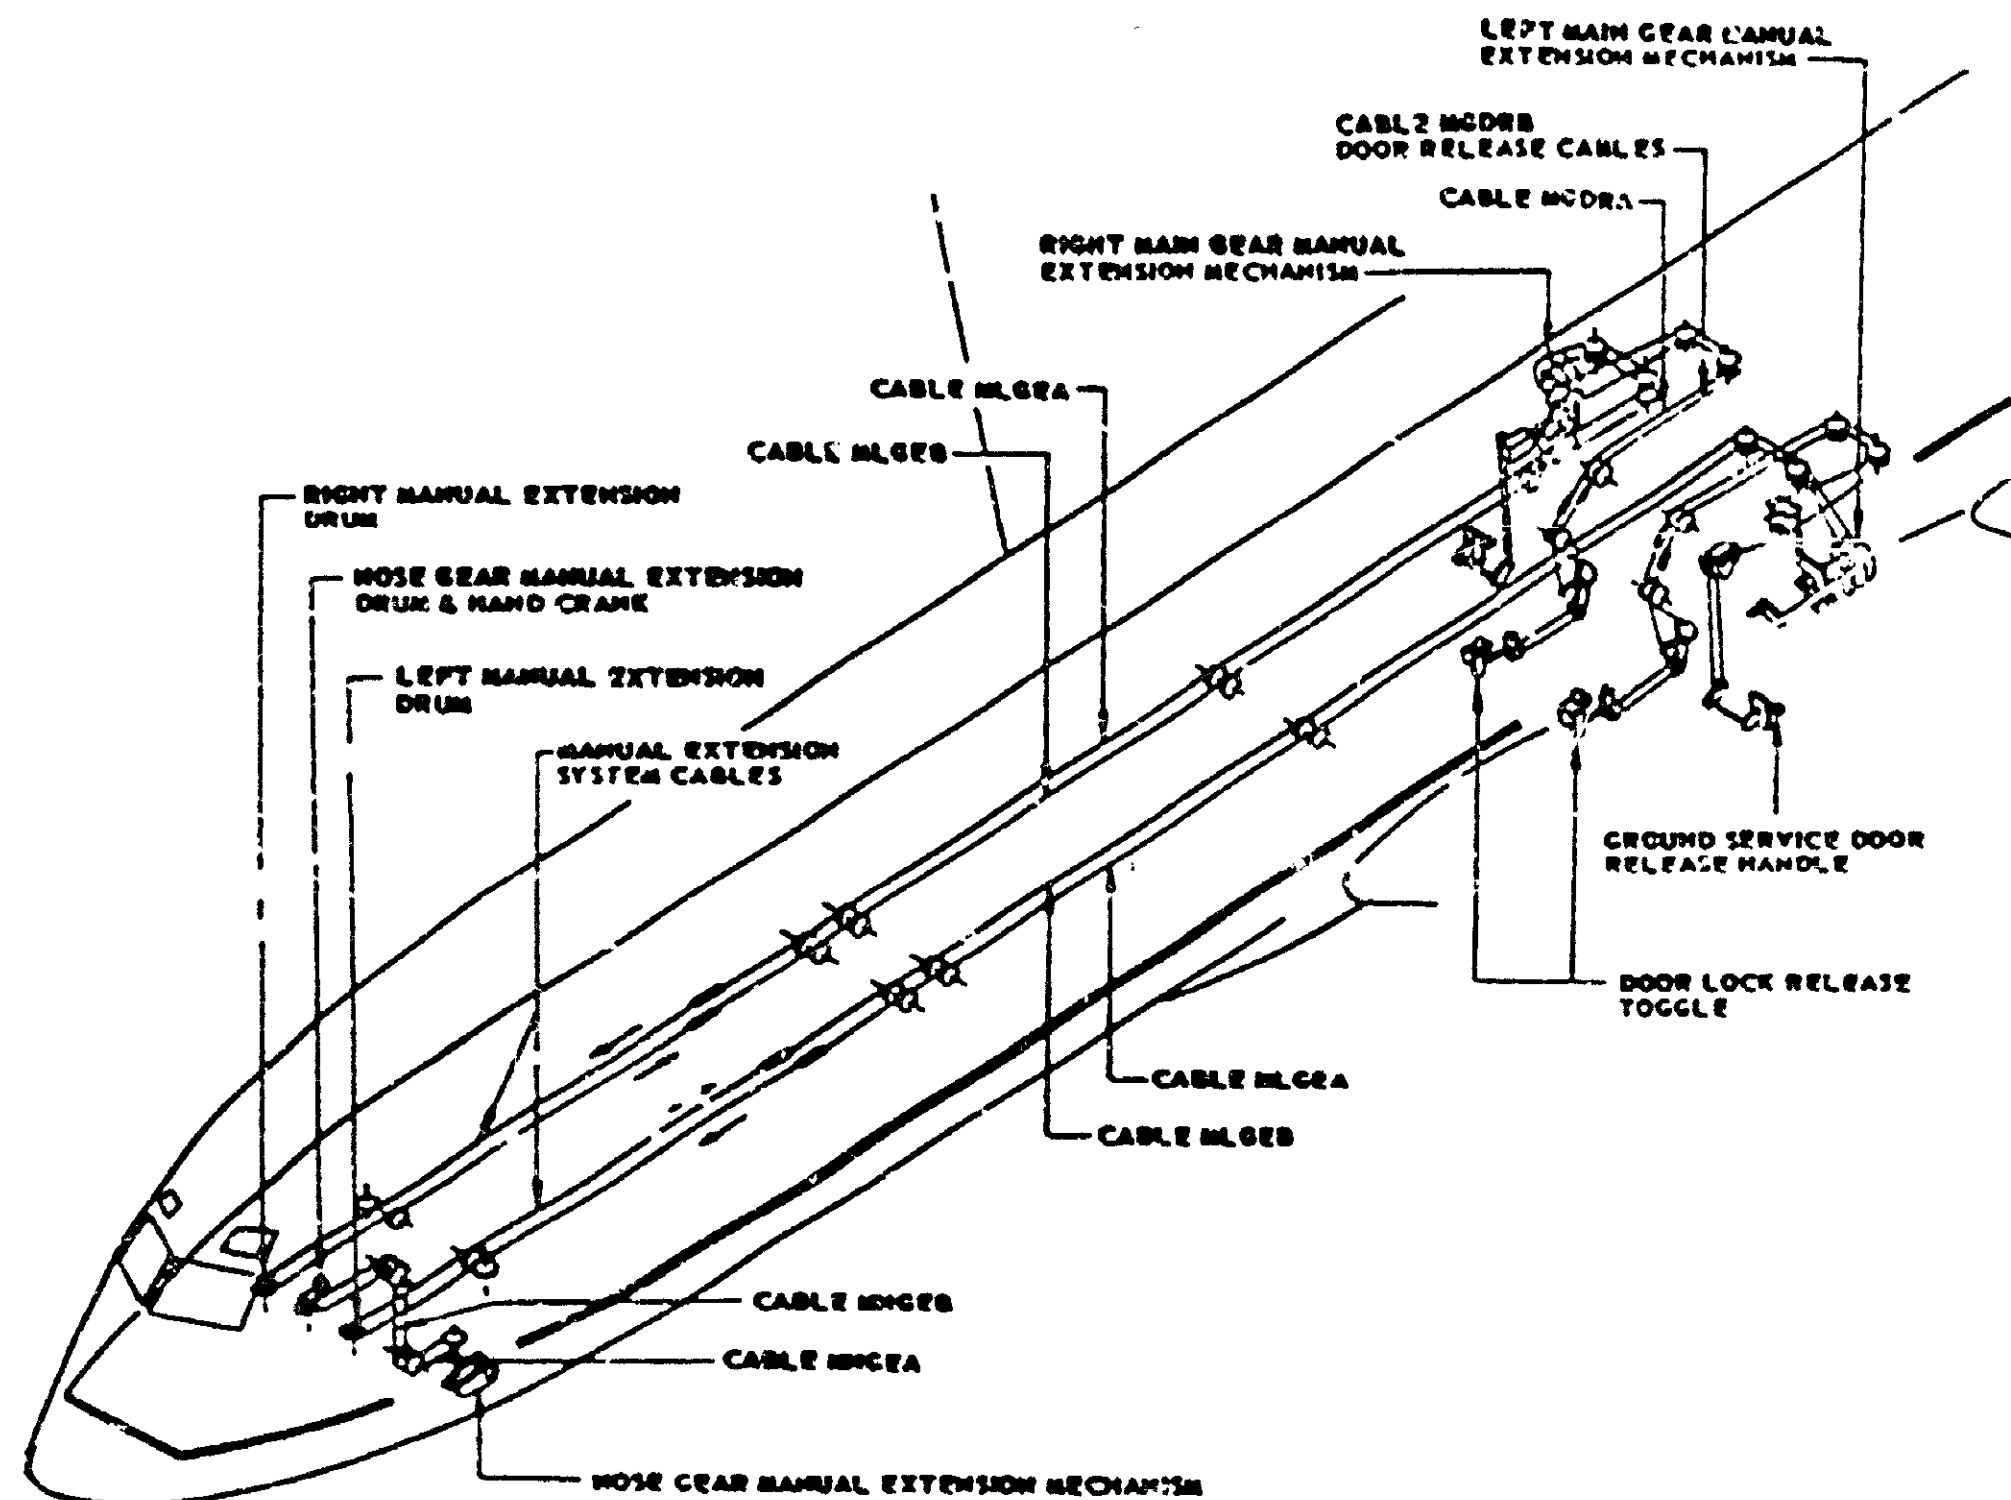
Figure 1.—Manual gear extension system.

The aircraft was lifted off the runway by cranes. Both inboard main landing gear doors were hanging by the attached actuators and sequencing push-pull rods. After the loose doors had been cleared, the nose and both main gears were extended manually by a Safety Board investigator and pinned in the down and locked position. (See figure 1.)

In normal manual operation, the handcrank must be rotated 3 turns clockwise (CW) to release the door uplock and gear uplock. When the door and gear fall free, the crank must be rotated 6 turns counterclockwise (CCW) to lock the gear down. When the aircraft was lifted from the runway, the Safety Board investigator rotated the left main gear manual extension handcrank in a clockwise direction to release the gear uplocks. The investigator said that he felt increasing resistance to rotation after about one turn, and after about 1 3/4 turns, he heard a "thud," the resistance eased, and the gear fell free from the retracted position. The crank rotated counterclockwise six turns without any resistance and the gear locked down normally.

After the aircraft was flown to Miami, the left main gear manual release system was functionally tested with the aircraft on jacks. It functioned normally with no unusual resistance to crank rotation. During the test, a scored and rubbed notch was found between two cable grooves on the cable drum. A worn and scored flat spot was found on the cylindrical cable guard above the drum. Based on the findings, tests were conducted to determine if the cable could move out of the groove and jam under the guard.

The tests were conducted with the gear down and locked and the inboard gear door removed. The gear uplock hook was placed in the locked position. The manual extension crank was rotated clockwise about 3 turns to unlock the hook, and force was continued in the same direction. The cable exiting the bottom side of the drum slackened slightly but not enough to allow it to move out of the groove.

The handcrank was rotated counterclockwise about 1 1/2 to 2 turns until the manual extension gearbox crank roller contacted the side strut cam. Resistance to the rotation of the handcrank increased, accompanied by slackening of the cable on the upper side of the drum, sufficiently to allow the cable to move out the groove and ride between the drum lands and the cable guard. When force on the handcrank was reduced, the cable tension caused the crank to spring back.
