NATIONAL TRANSPORTATION SAFETY BOARD

AIRCRAFT ACCIDENT REPORT

AIR U.S. FLIGHT 716, HP-137, N11360,
AND SKY'S WEST CESSNA TU-206, N4862F,
MIDAIR COLLISION
FT. COLLINS/LOVELAND MUNICIPAL AIRPORT
LOVELAND, COLORADO
APRIL 17, 1981

NTSB-AAR-81-18

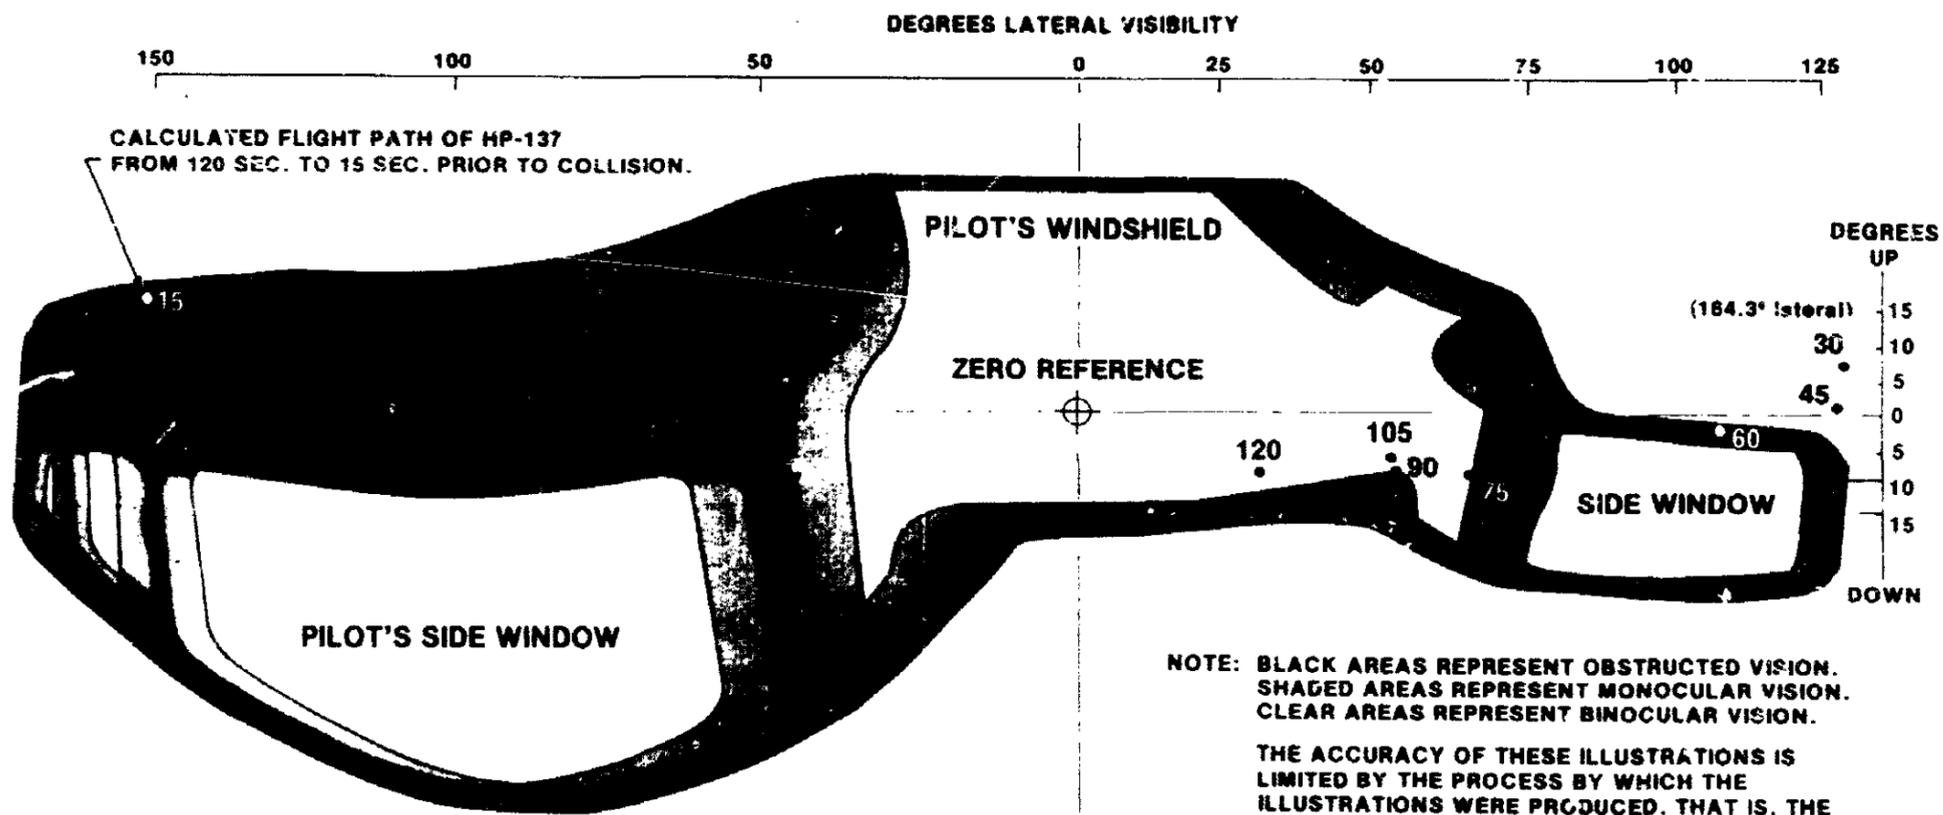
VISIBILITY FROM LEFT SEAT ONE INCH ABOVE DESIGN EYE REFERENCE POINT

Examination of the photographs taken from the pilot's position indicate that the view of the Jetstream would have been unobstructed and within the binocular vision envelope of the windshield. If the pilot's eyes were in a position 1 inch above the design eye reference point, the Jetstream target would have been present within that vision envelope in the lower right hand corner very near the glare shield for a period of at least about 120 to 75 seconds before the collision. The pilot's seat was found adjusted to the full-up position. Had the pilot's seat been adjusted forward of the reference point, the over-the-nose visibility would have been increased. Conversely, if the seat was located aft and/or below the reference point, the visibility near the lower edge of the windshield would have been less, due to the position of the instrument panel glare shield.

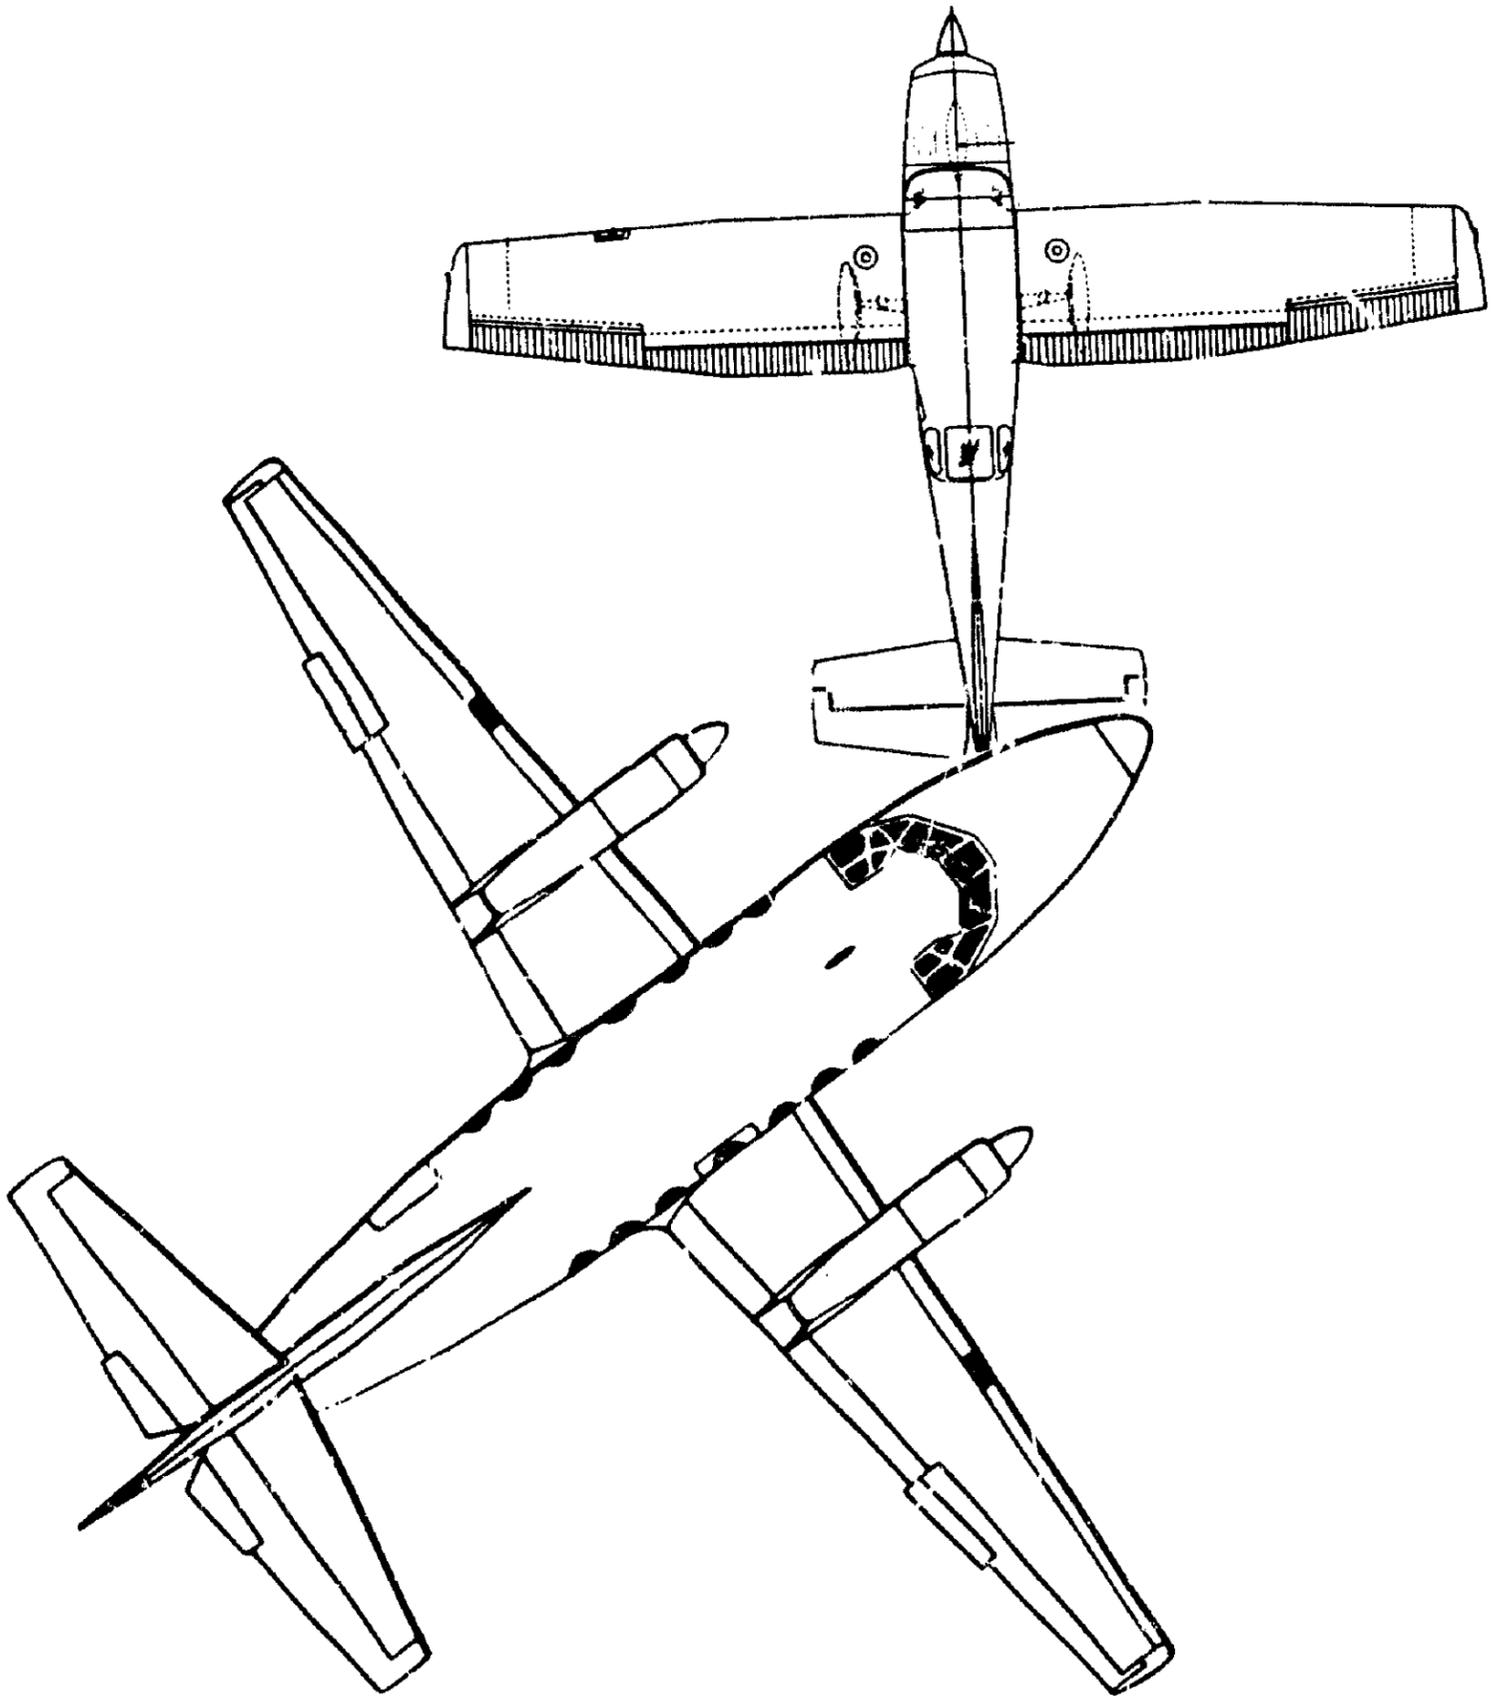
APPENDIX F
SKETCH OF ACCIDENT POSITIONS

The Cessna was in a climbing left turn on a northwesterly heading and Flight 716 was in level flight on a northerly heading. The left wing tip and fuselage nose section of the Jetstream (Flight 716) collided with the left side of the Cessna. The No. 1 propeller of the Jetstream cut through the aft fuselage section of the Cessna resulting in immediate loss of control to both aircraft. (See sketch appendix F.)
