# **NATIONAL TRANSPORTATION SAFETY BOARD**

## **AIRCRAFT ACCIDENT REPORT**

**WORLD AIRWAYS INC., FLIGHT 32,  
MCDONNELL DOUGLAS DC-10-30CF, N112WA,  
OVER NORTH ATLANTIC OCEAN  
SEPTEMBER 20, 1981**

**NTSB-AAR-82-1**

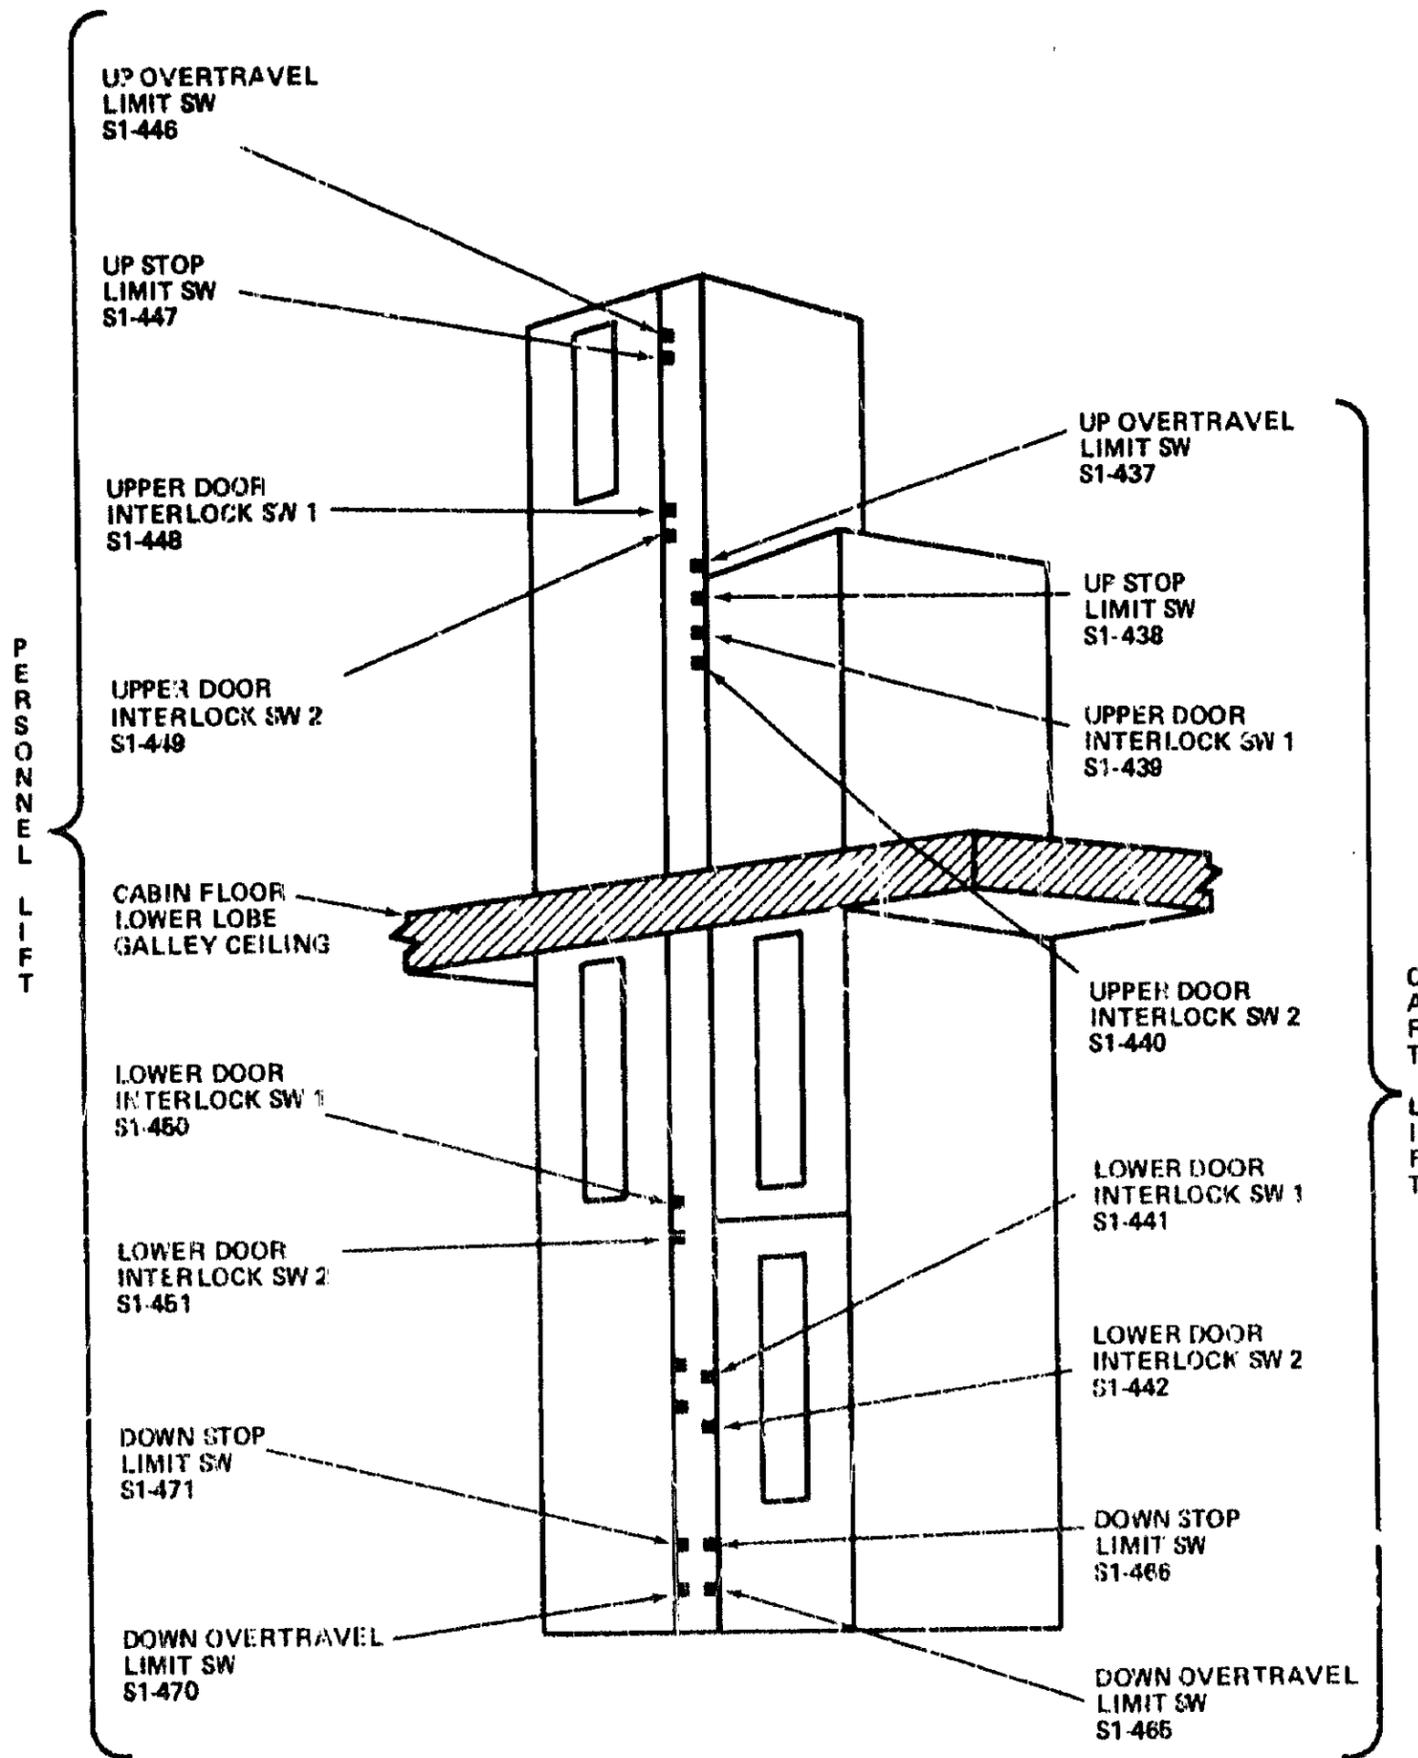
Figure 1.--Galley lift system with electrical switch locations.

Limit Switches - The range of travel of the lifts is controlled by limit switches installed within the wire duct attached to the forward side of one of the vertical lift tracks. There are two sets of two limit switches for each lift; one set located in the service center and one set in the lower galley. One switch is a normal stop switch and the other limit switch is for overtravel in the event the normal switch fails to operate. The limit switches are actuated by a cam plate mounted on the side of the lift. The cam plate has a machined offset to prevent actuation of the overtravel limit switch unless the normal switch fails to operate. In addition to the limit switches, mechanical stops are installed in the vertical lift tracks to stall and shut off the gear motors if both limit switches malfunction. (See figure 1.)

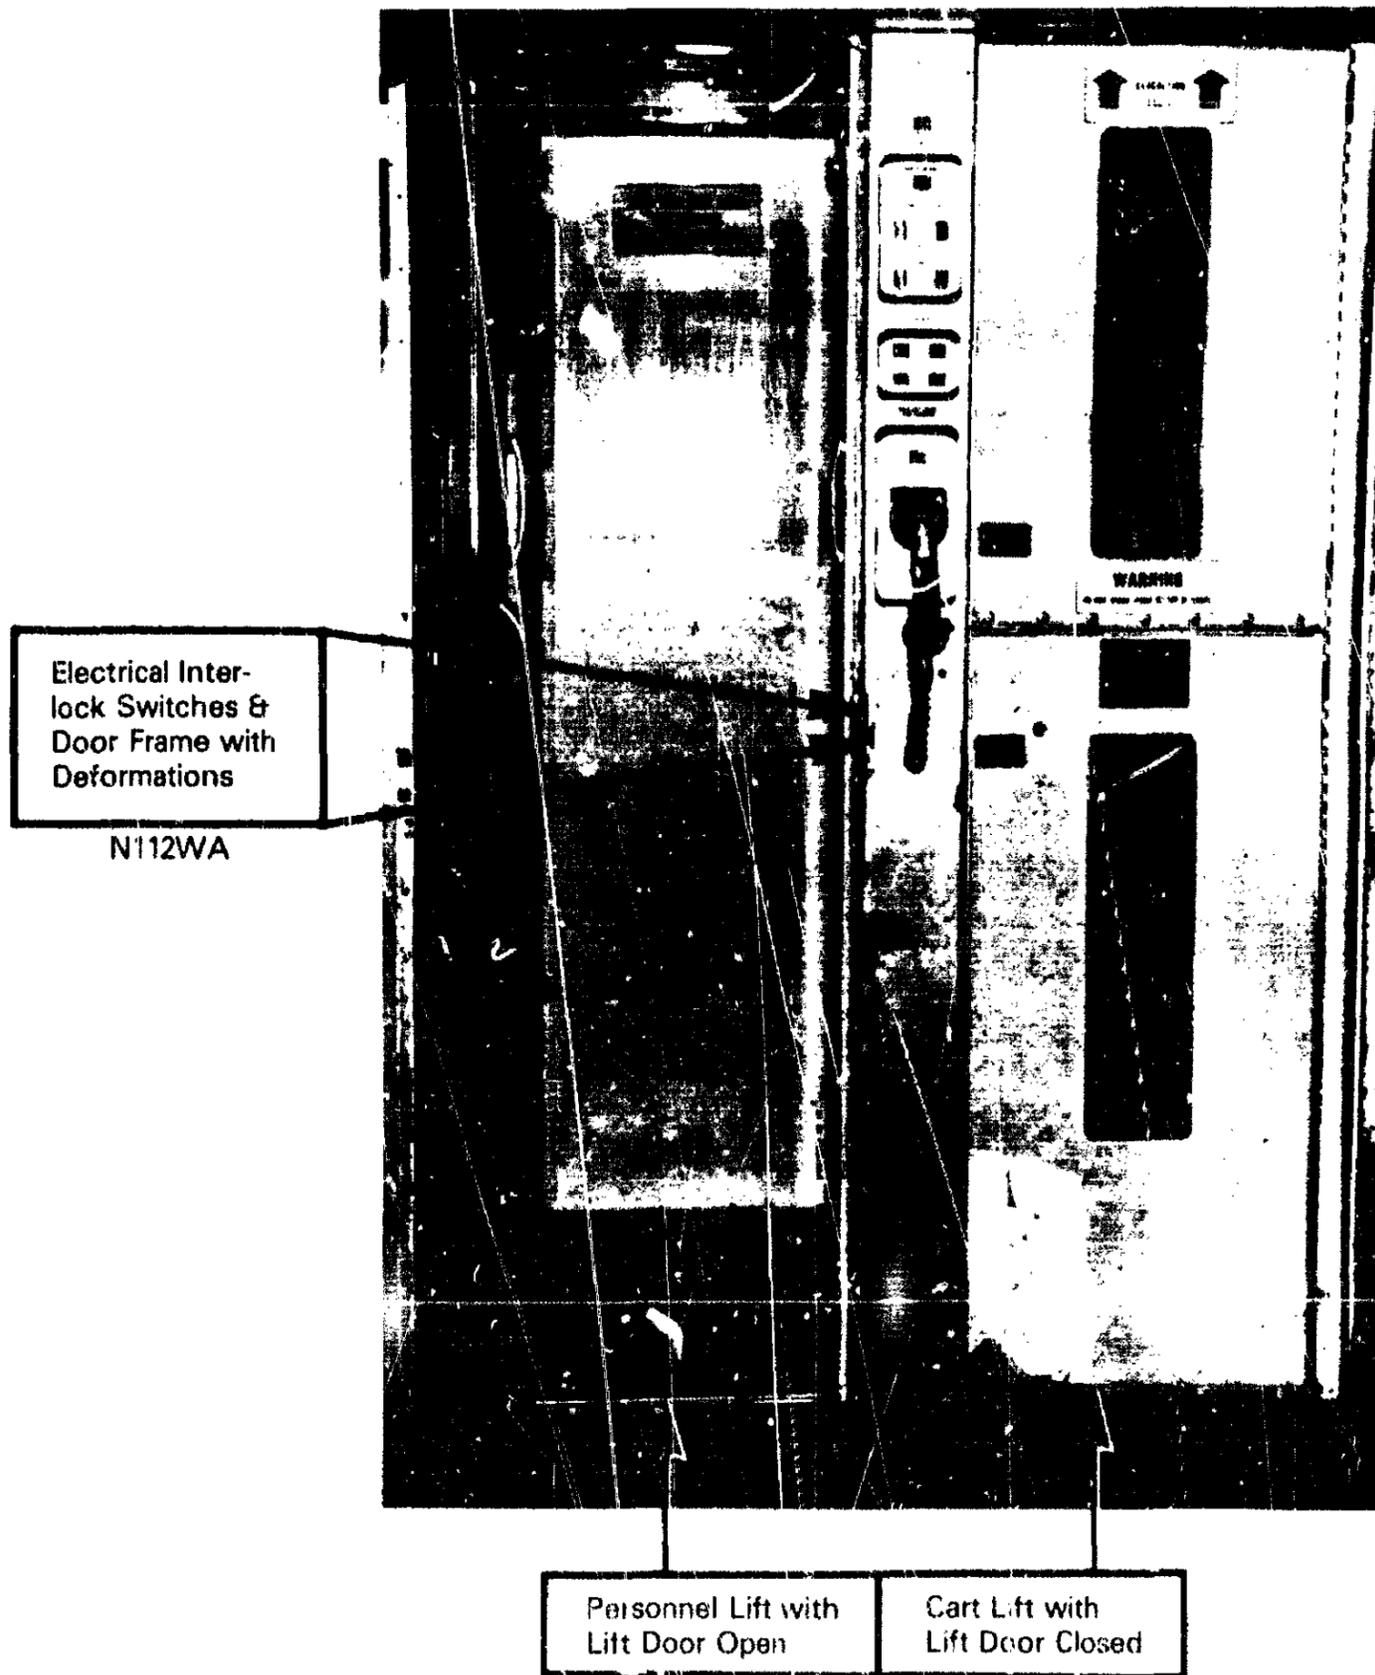
Figure 2.--Personnel and cart lifts.

The lower galley personnel lift door frame was deformed and battered in the area where the electrical interlock switches are mounted (see figure 2). The uppermost electrical interlock switch on the lower galley personnel lift door, S1-450 (see figure 1), was found with the switch roller assembly twisted and the roller striker arm jammed in the depressed (switch closed) position. The damage to the lower galley lift door frames was the result of repeated bumping by food and liquor carts.

Require a redesign of the DC-10 aircraft galley personnel and food cart lift doors and door frames to relocate the interlock switches to a position where they will not be susceptible to damage by food service carts, to inadvertant contact by personnel attempting removal of food service carts, and to contamination by foreign substance. (Class I, Urgent Action) (A-81-126)
