# **NATIONAL TRANSPORTATION SAFETY BOARD**

## **AIRCRAFT ACCIDENT REPORT**

**AIR FLORIDA AIRLINES, INC.  
McDONNELL-DOUGLAS, INC.,  
DC-10-30CF, N101TV  
MIAMI INTERNATIONAL AIRPORT  
MIAMI, FLORIDA  
SEPTEMBER 22, 1981**

**NTSB-AAR-82-3**

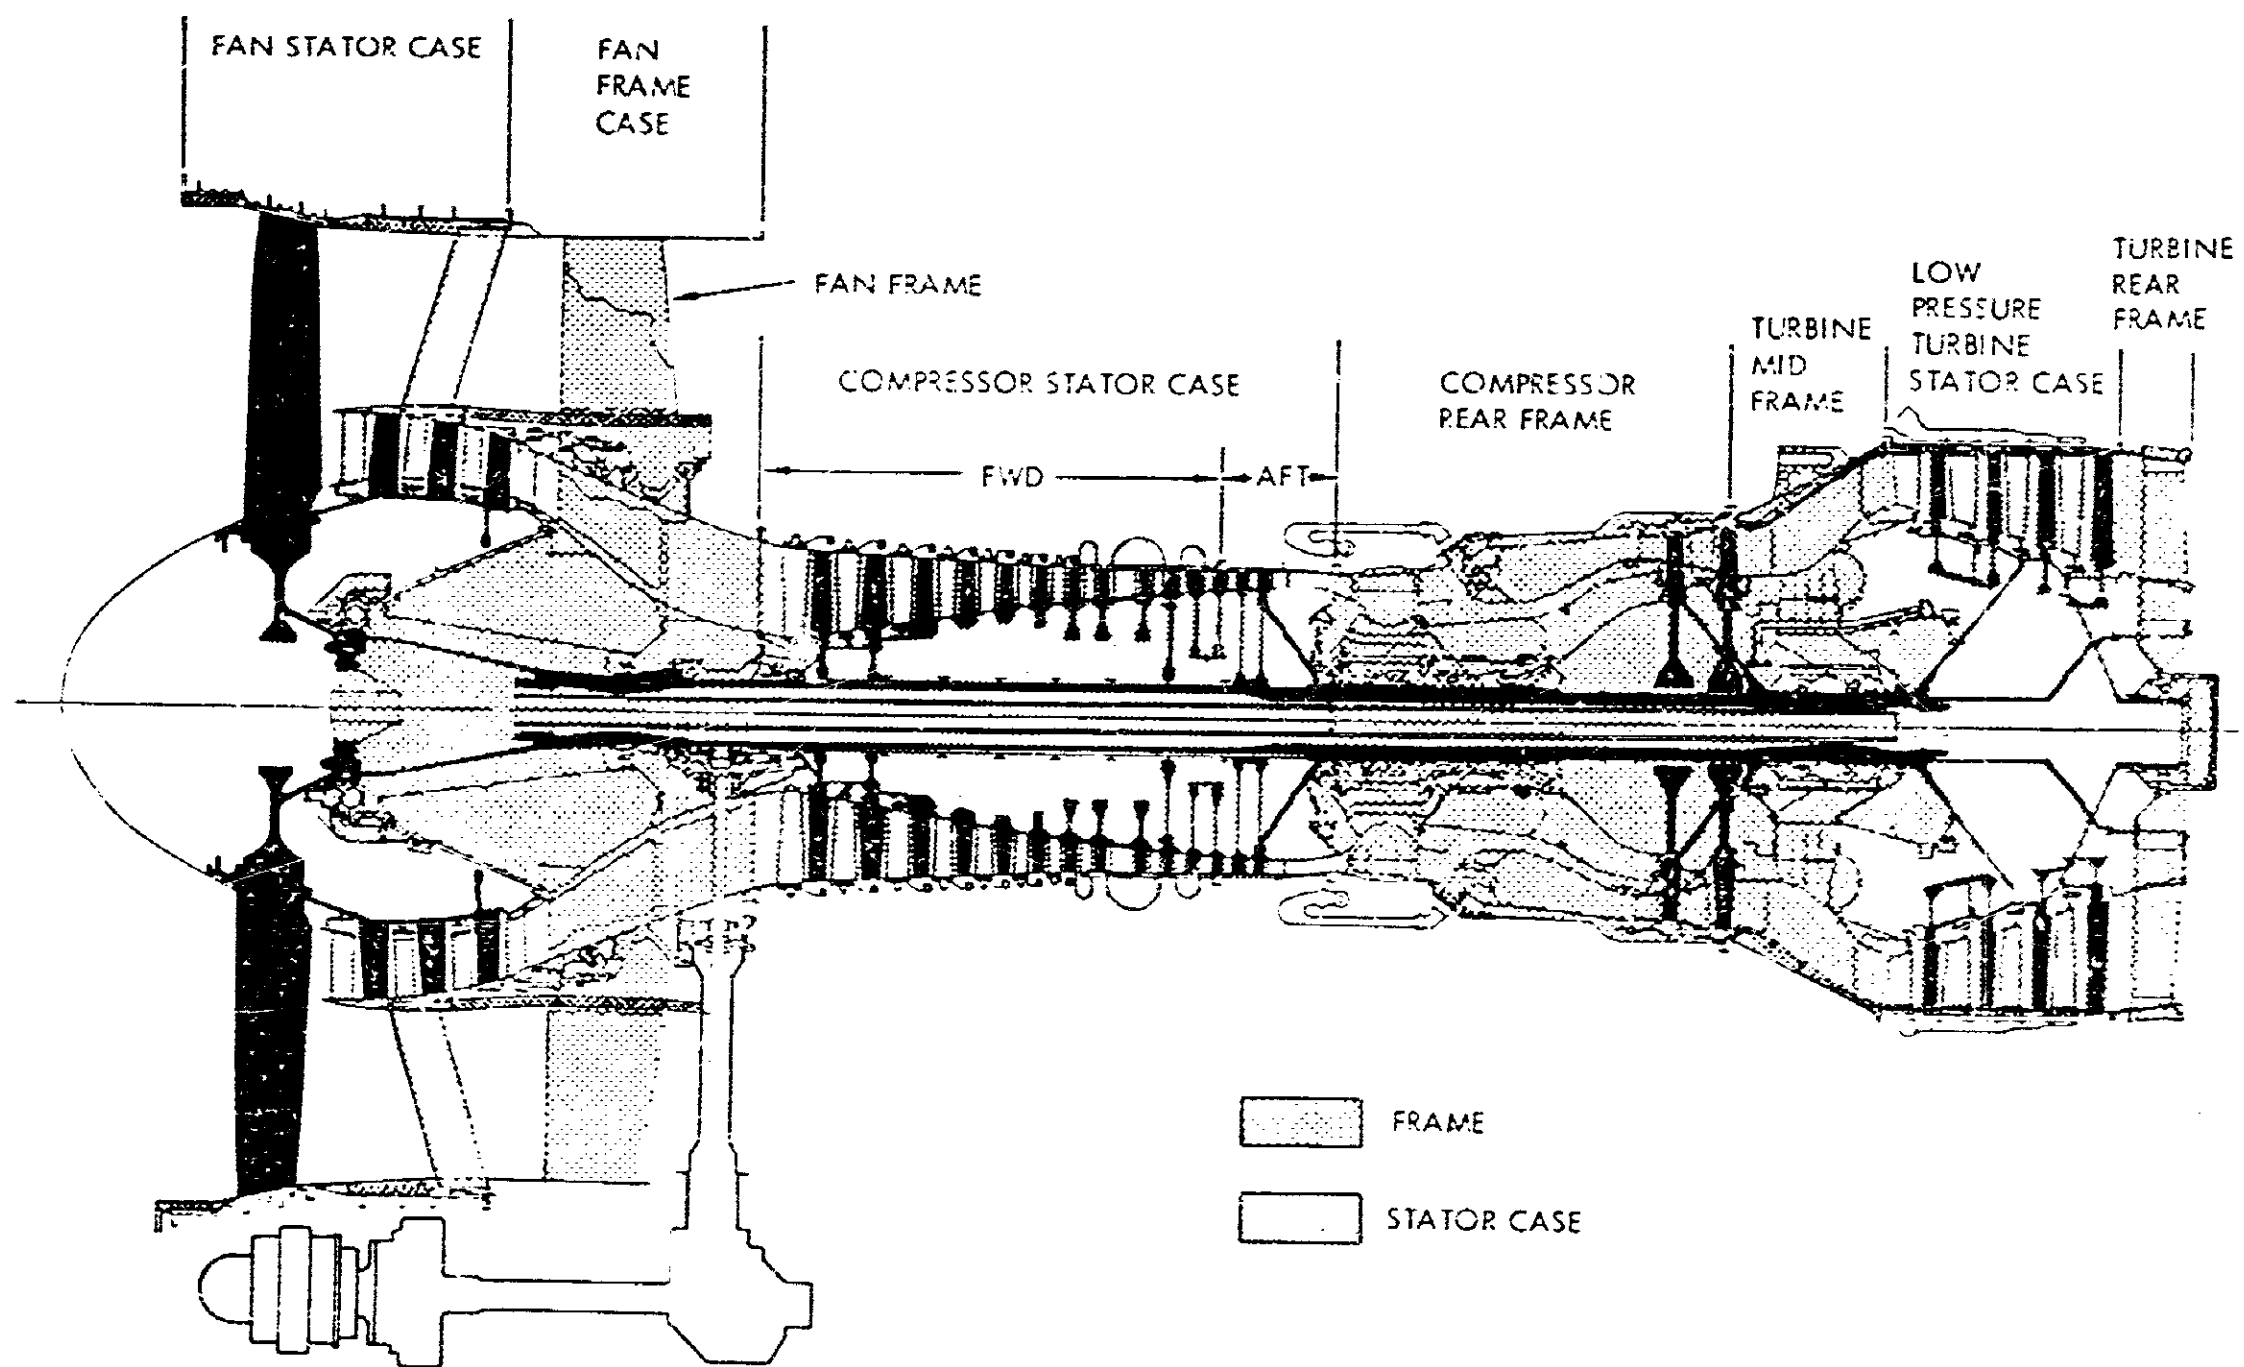
The examination showed that the major damage to the engine was incurred aft of the high pressure turbine section. The low pressure turbine stator assembly case had separated circumferentially along the flange attaching its forward end to the turbine mid-frame housing. This separation, located at engine station (ES) 294, was just forward of the plane of rotation of the stage 1 low pressure turbine rotor. The stator case separated fore and aft along the top of the engine; it tore horizontally above its outboard split flange and the forward one-third of the inboard split flange had separated. The stator assembly case had split into three large segments and numerous smaller segments which separated from the engine and fell to the runway. (See figure 3.)

Figure 3.--CF6-50/-45 frames and stator assemblies.

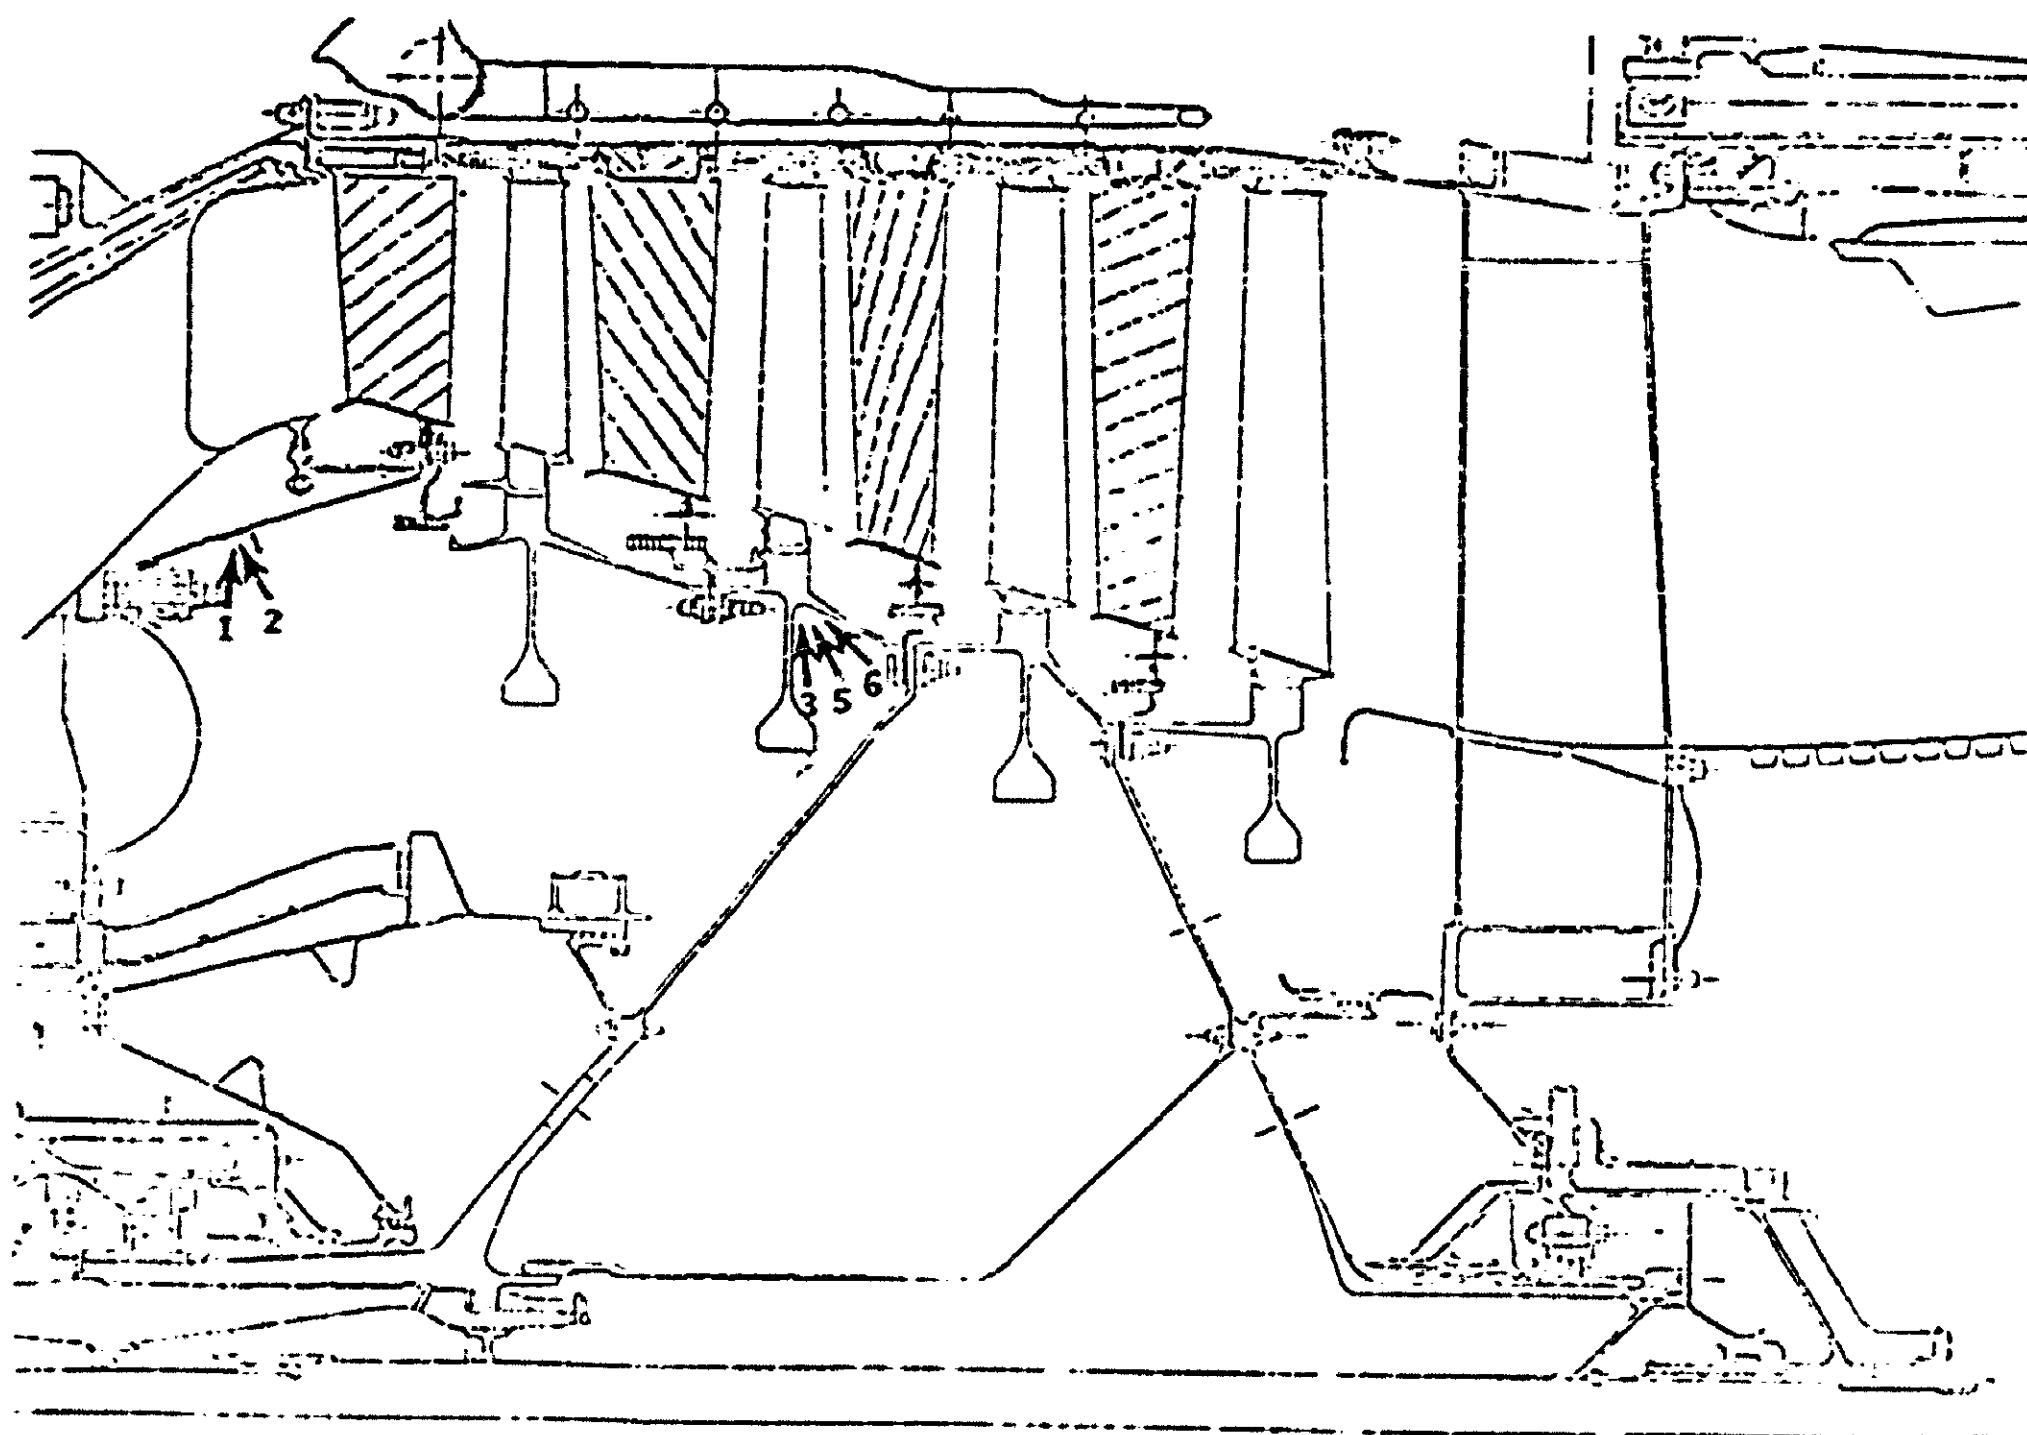
Figure 4

Six additional pieces of ferro magnetic material were found: one piece was found on the runway; three pieces were found in the low pressure turbine stage 2 rotor cavity; and two pieces were found in the low pressure turbine's stage 1 toroid cavity. EDAX analysis identified the material as M-50 alloy steel. All six pieces were severely battered and oxidized. Five of the six pieces were measured for thickness. One piece was too battered for thickness determination. The thickness of one piece ranged from 0.140 to 0.150 inches; one piece was 0.148 inches thick; and three pieces were 0.149 inches thick. (See figure 4.)

Sketch of the low pressure turbine portion of CF6-50 engine S/N 455-123. After the low pressure turbine failure of this engine, six pieces of foreign material were recovered and submitted for examination. For identification purposes these six pieces were arbitrarily assigned numbers - #1 thru #6. Pieces #1 and #2 were found near the turbine mid frame stiffener (see arrows #1 and #2). Pieces #3, #5, and #6 (see arrows #3, #5, and #6) were found in the cavity formed by the Stage 2 low pressure turbine disk and the forward low pressure turbine shaft. Piece #4 was recovered from the runway near the location where the engine failure occurred.
