NATIONAL TRANSPORTATION SAFETY BOARD

AIRCRAFT ACCIDENT REPORT

EASTERN AIRLINES FLIGHT 935
LOCKHEED L-1011-384, N309EA,
NEAR COLTS NECK, NEW JERSEY,
SEPTEMBER 22, 1981

NTSB-AAR-82-5

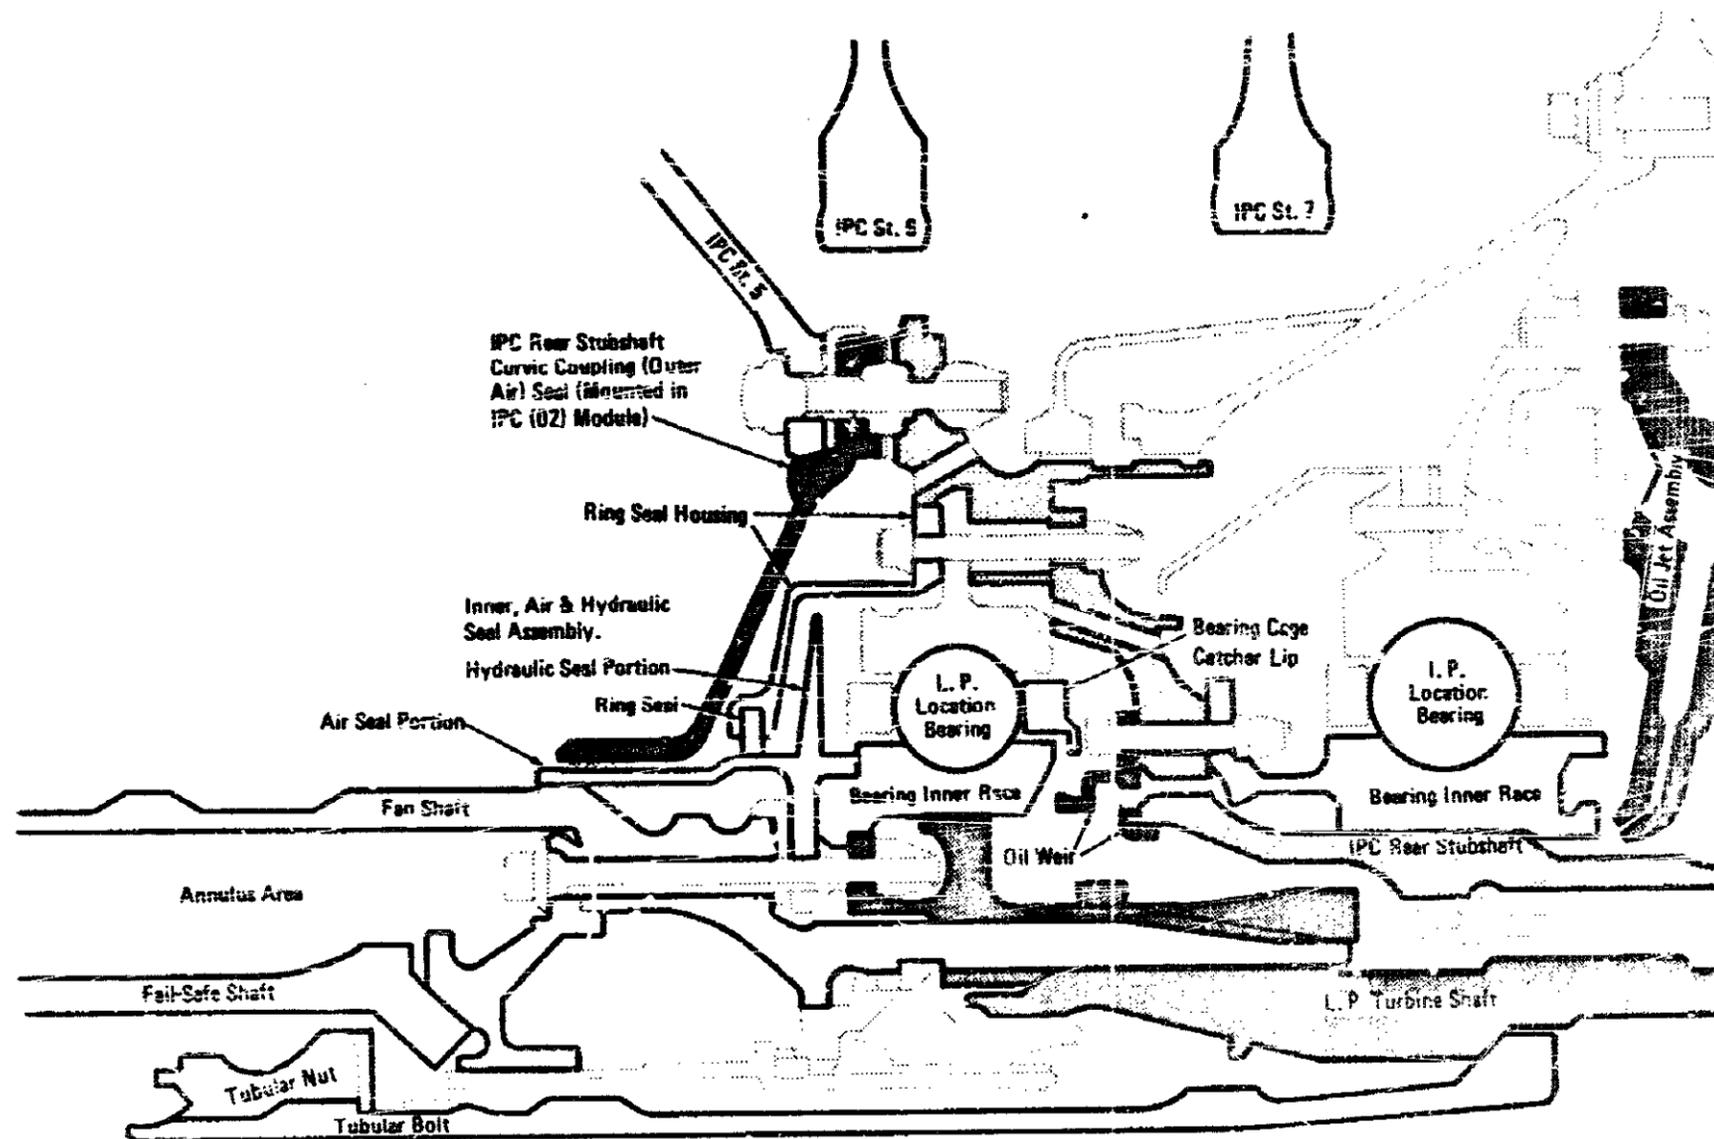
Figure 5. --- Installed Position of Components Associated with LPLB Failure.

The low-pressure location bearing had deteriorated from intermittent spalling of the bearing's outer race that encompassed 250° of its circumference. The area of apparent fatigue spalling was biased toward the rear side of the bearing's race track. The profile of the LPLB's inner race track was worn heavily and was elongated axially to a width of 1.250 to 1.375 inches; the forward and rear lands of the inner race adjacent to the track profile were also heavily worn. The bearing cage was extensively overheated. The bearing location lands were worn and the bearing cross grooves were filled with debris. The front half of the bearing cage was heavily rubbed on its front face from contact with the base of the hydraulic seal fin. Molten material produced from the inner track/ball wear and breakup had been deposited onto the front half cage bore for 180° of its circumference. The cage ball pockets were heavily worn. The rear oil catcher lip was distorted rearward from wear and rearward movement of the inner race; it had come in contact with the retention bolt heads of the low pressure location bearing oil weir. The main surface areas of the location bearing balls showed minor primary skidding type damage with wear ranging between 0.007 to 0.012 inches on the diameter of the ball. The individual ball's wear pattern was uniform and the balls generally maintained their sphericity. None of the balls had any visual appearance of secondary fatigue. All of the balls had randomly located sliding flats, some of which were reoriented. The flats' approximate diameter ranged from .125 of an inch to .75 of an inch; these flats could be related to the inner race movement in the fore and aft thrust directions.

The LPLB contained massive mechanical damage which allowed excessive axial and radial movement within the bearing assembly. Rubbing of associated components was consistent with the excessive axial and radial movement produced by the failed bearing assembly.

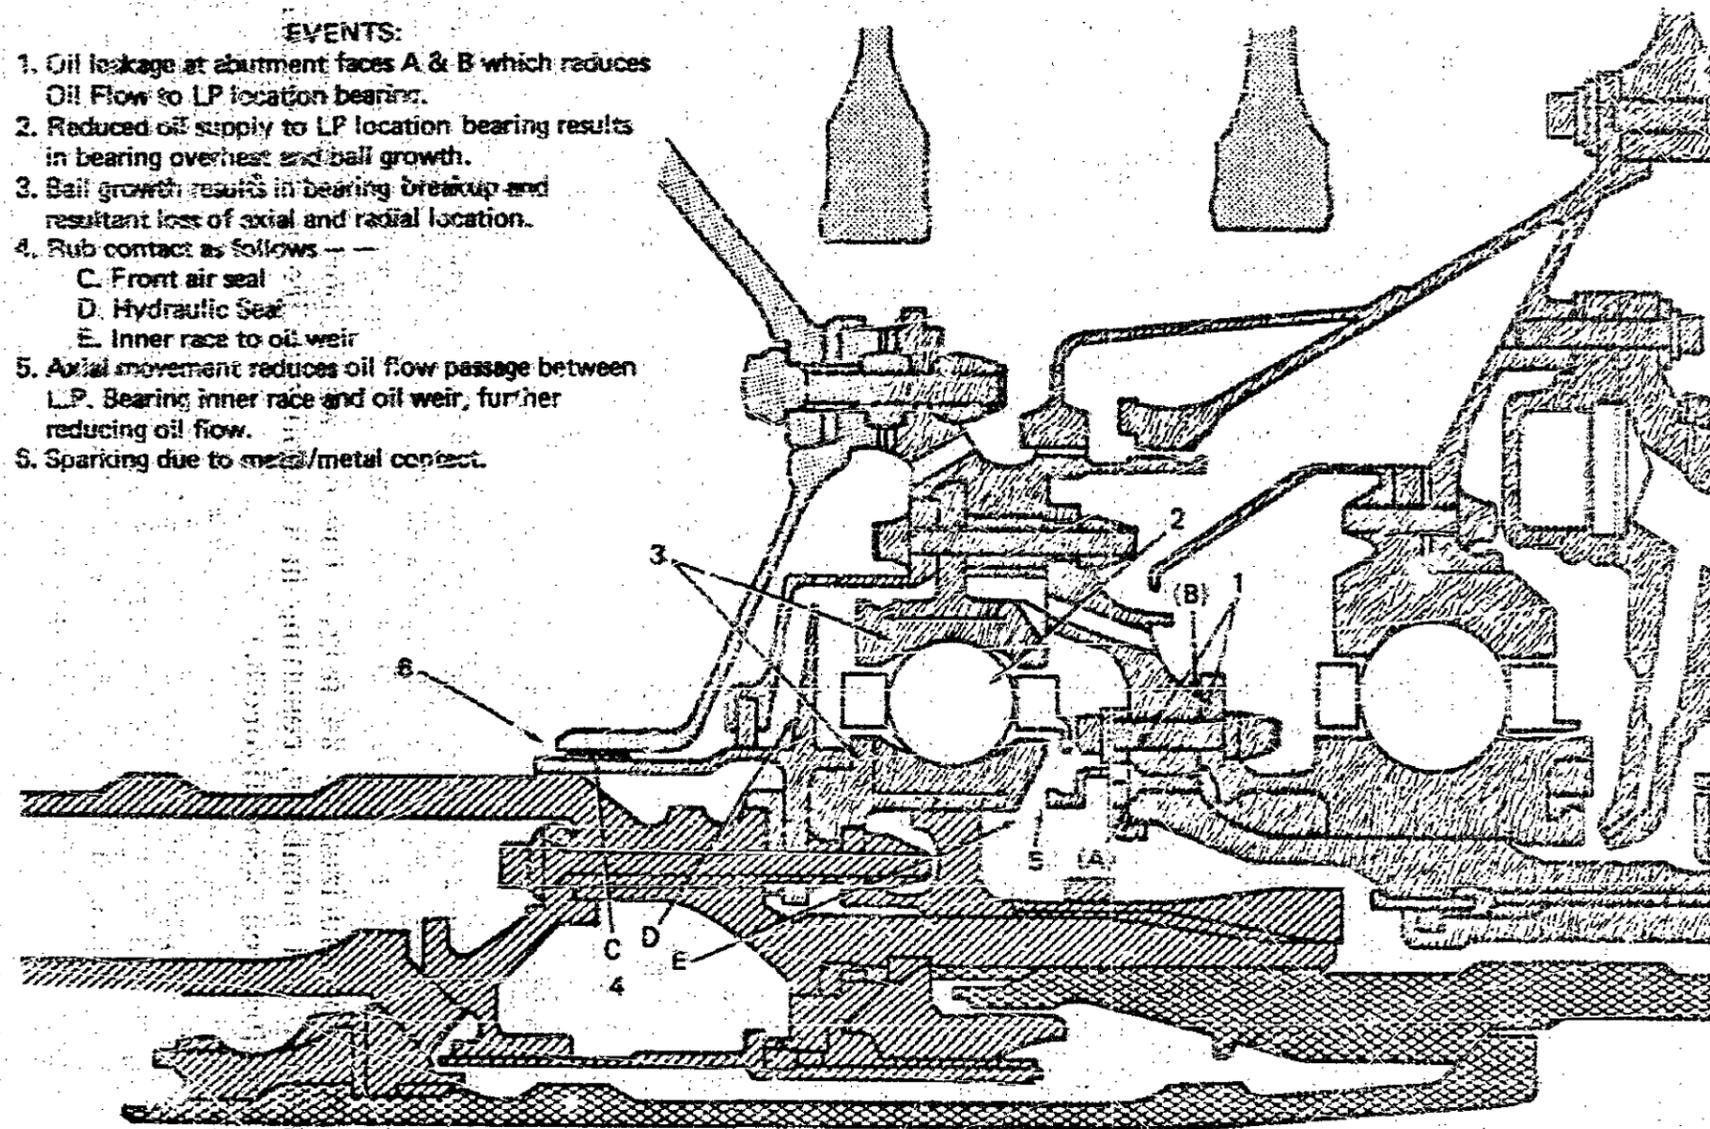
Figure 7. -- Initial Failure Sequence.

The initiating event in the LPLB failure was an inadequate oil supply to the bearing because of oil leaks between abutment faces of the IPC rear stubshaft and the LPLB oil weir and leaks between the abutment faces of the LPLB inner race locating flange and the IPC rear stubshaft. Each of these interfaces had evidence of oil leakage path stains and foreign debris entrapment. (See figure 7.) The LPLB oil supply system does not provide a positive oil feed to the bearing, but rather a "slinger" type is used to lubricate the bearing. Since the oil supply jet was not positive and since leaks occurred across the flanged abutment faces, probably as a result of poor mating of these surfaces following overhaul, the LPLB inner race flange may have become distorted at high power settings. The Safety Board believes that the "slinger" oil supply and oil leaks at the abutment faces are major factors in LPLB distress situations.

The inadequate supply of oil allowed the LPLB assembly to overheat and provided a temperature high enough to induce bearing outer race fatigue spalling, which in turn would have induced ball tightening and rubbing in the bearing cage pockets. The

1. Oil leakage at abutment faces A & B which reduces Oil Flow to LP location bearing.
2. Reduced oil supply to LP location bearing results in bearing overheating and ball growth.
3. Ball growth results in bearing breakup and resultant loss of axial and radial location.
4. Rub contact as follows --
 - C. Front air seal
 - D. Hydraulic Seal
 - E. Inner race to oil weir
5. Axial movement reduces oil flow passage between LP Bearing inner race and oil weir, further reducing oil flow.
6. Sparking due to metal/metal contact.

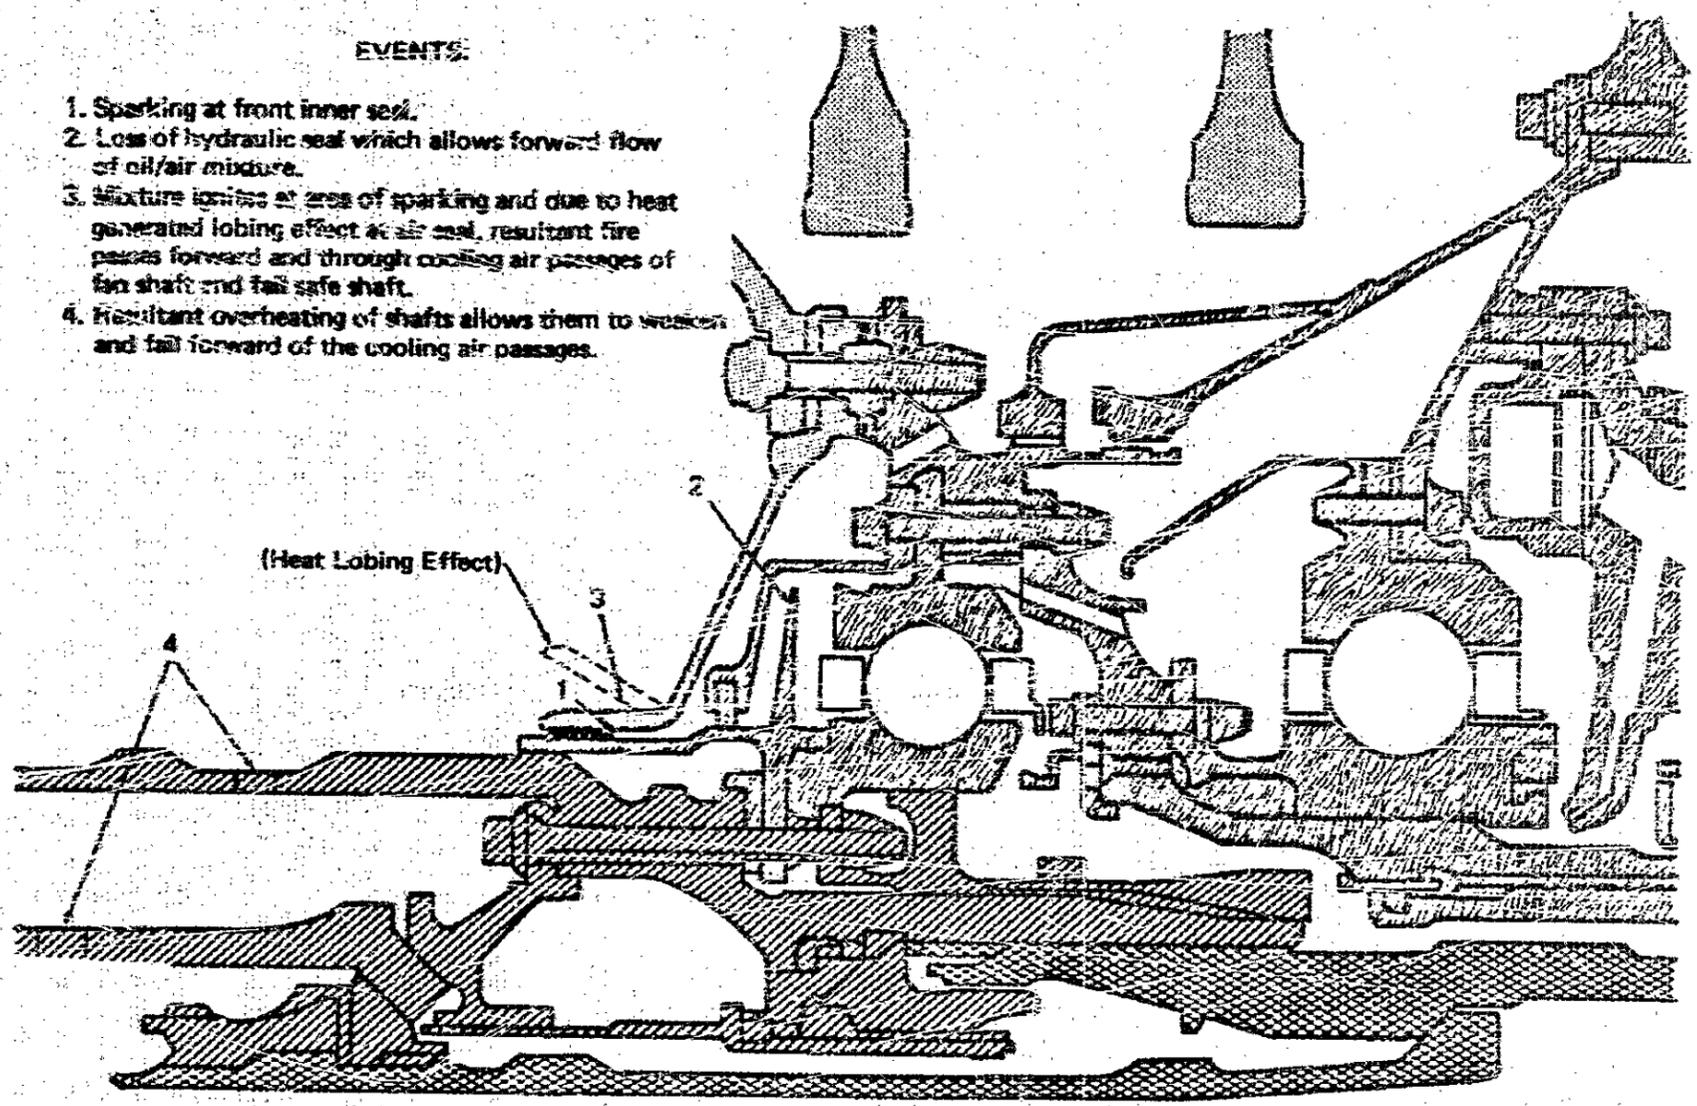
The ring (piston) seal housing and the ring (piston) seal which is adjacent to the hydraulic seal fin were also rubbed heavily. Oil level-type marks present on the rear face of the ring seal housing arm suggest that different levels of oil were present in the ring seal housing/hydraulic seal cavity. The differences in oil levels indicated that the normal capillary-type seal between the hydraulic seal and the ring seal housing had been compromised, thus allowing LPLB oil to eject into the fan shaft area. The oil that escaped was mixed with pressurized air from two sources and was injected into the fan shaft annulus area. The first source was the oil scavenge cavity, located between the LP and IP location bearings, which is pressurized by 7th stage compressor air to 39 psig with the engine operating at climb power. Additional pressurized air is provided from the IPT pressure seal; it is pressurized to 24 psig. The oil was vaporized and was ignited by contact with the hot seal members, resulting in a stabilized fire in the fan shaft and the fail-safe shaft annulus area. (See figure 8.)

1. Sparking at front inner seal.
2. Loss of hydraulic seal which allows forward flow of oil/air mixture.
3. Mixture ignites at area of sparking and due to heat generated lobing effect at air seal, resultant fire passes forward and through cooling air passages of fan shaft and tail shaft.
4. Resultant overheating of shafts allows them to weaken and fall forward of the cooling air passages.
