AIRCRAFT ACCIDENT REPORT

RONSON AVIATION
BELL 206B, N27670 AND
SEMINOLE AIR CHARTER
PIPER PA-34-200T, N8110R
MIDAIR COLLISION
EAST RUTHERFORD, NEW JERSEY
SEPTEMBER 23, 1981

NTSB-AAR-82-6

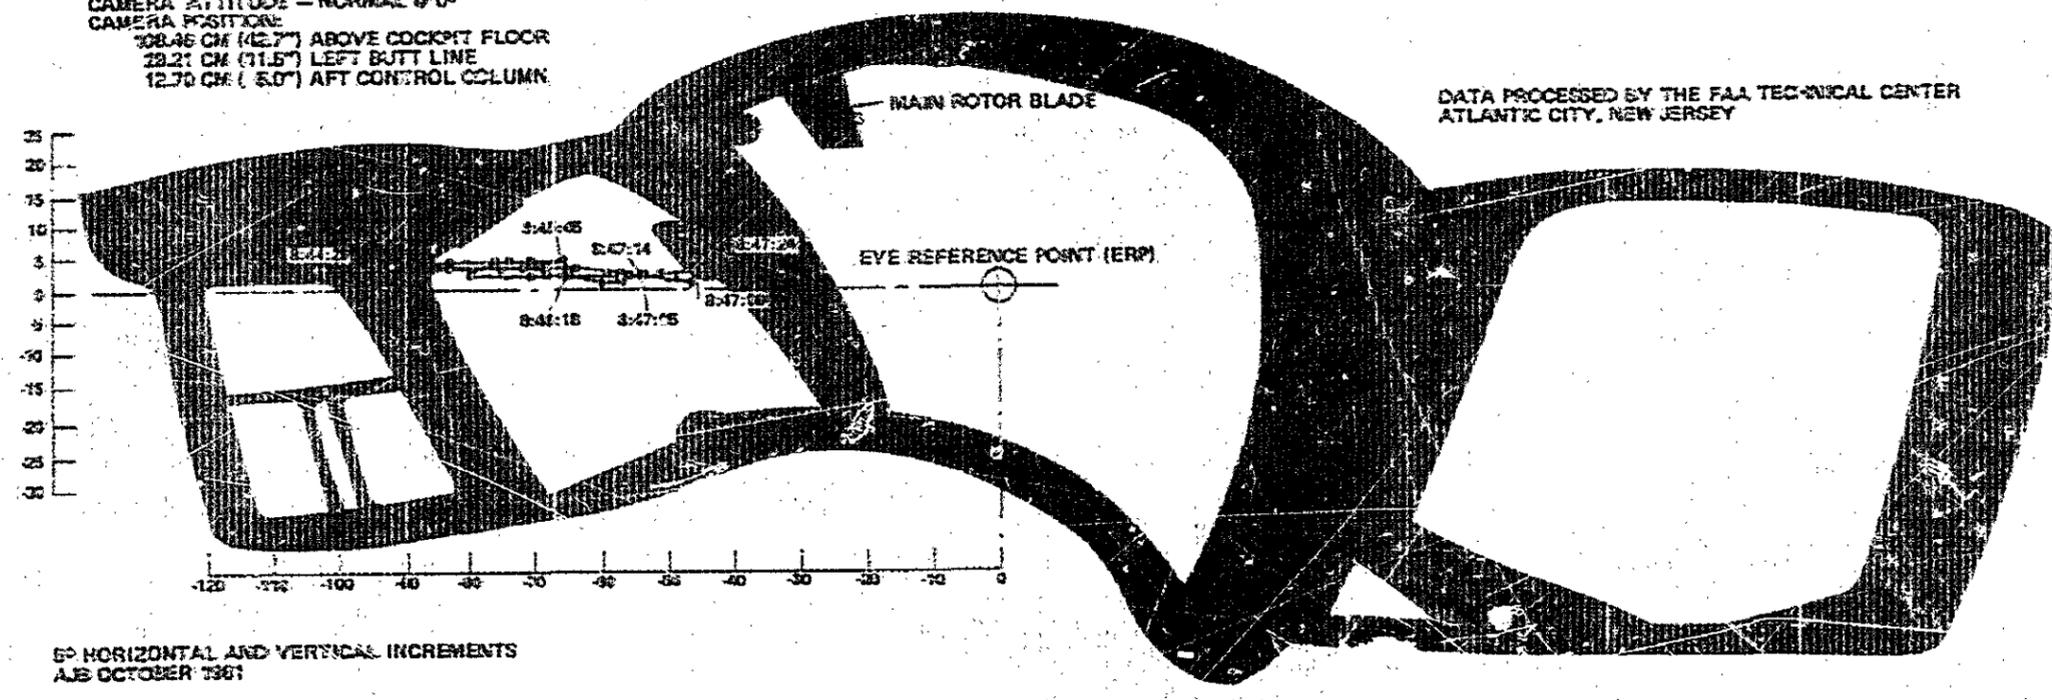
BINOCULAR PHOTOGRAPHS

A plot of the helicopter viewing angles on the binocular photograph from the pilot's position shows the airplane just slightly above the zero elevation position of the copilot's windshield moving alternately from left to right, but always in view. The only potential obstruction to the pilot's view of the airplane are the left and center windshield posts. A plot of the viewing angles as viewed from the copilot's seat placed the airplane in the left side window slightly above the zero elevation line until approximately 1 minute 38 seconds before the collision when the left windshield post would have blocked it from view. The airplane remained partially obscured by the windshield post for the next 83 seconds, until it entered the copilot's upper left windshield for the remainder of the angles plotted.

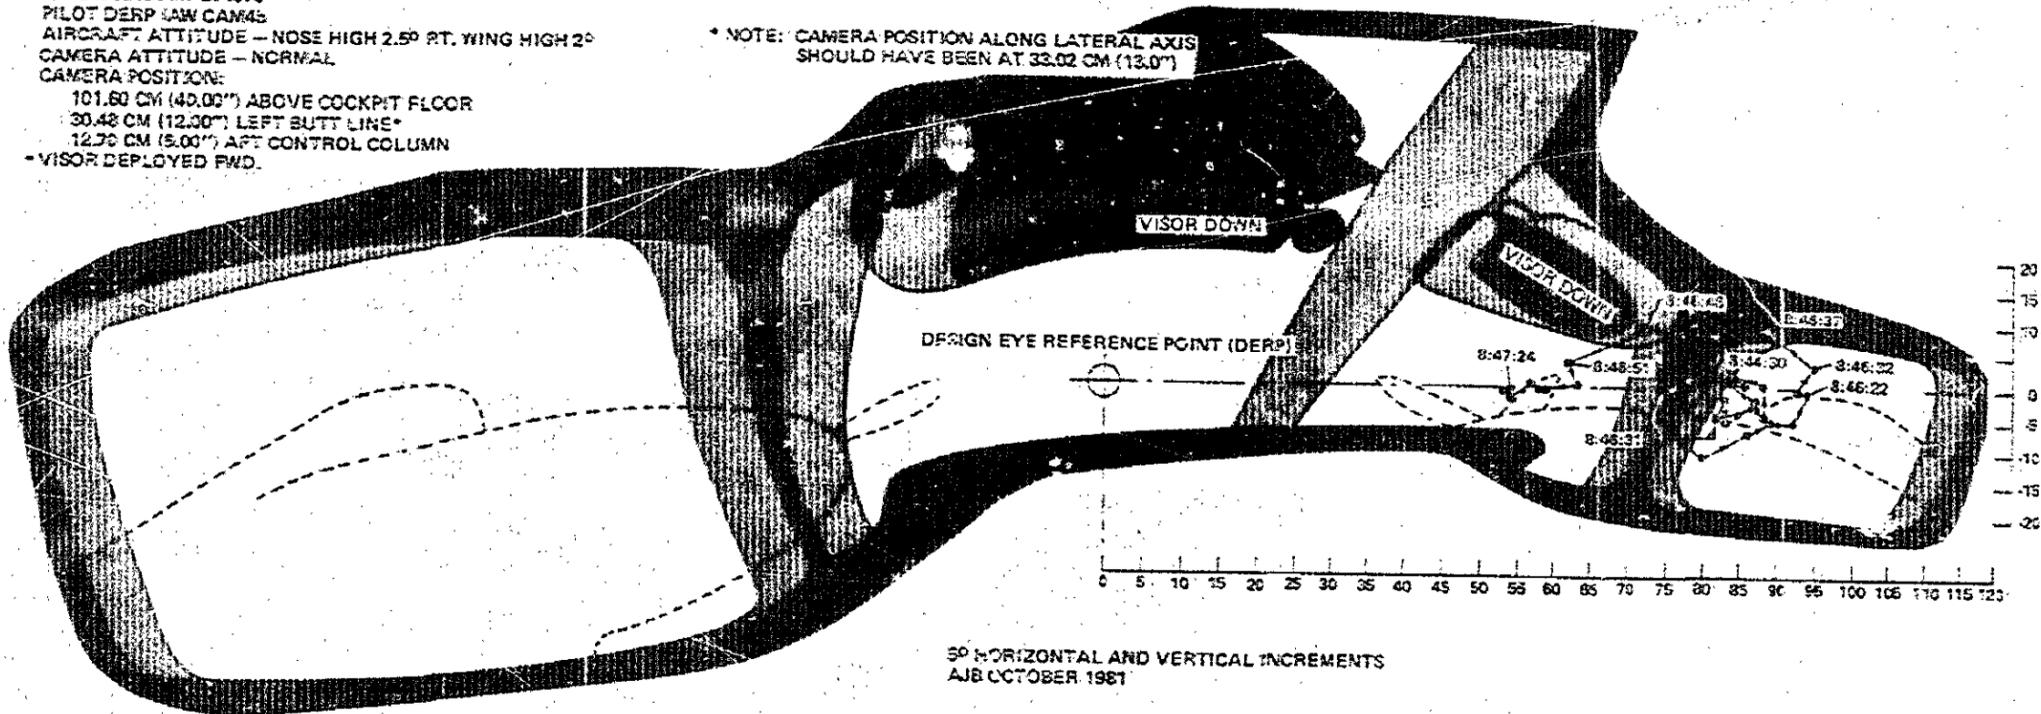
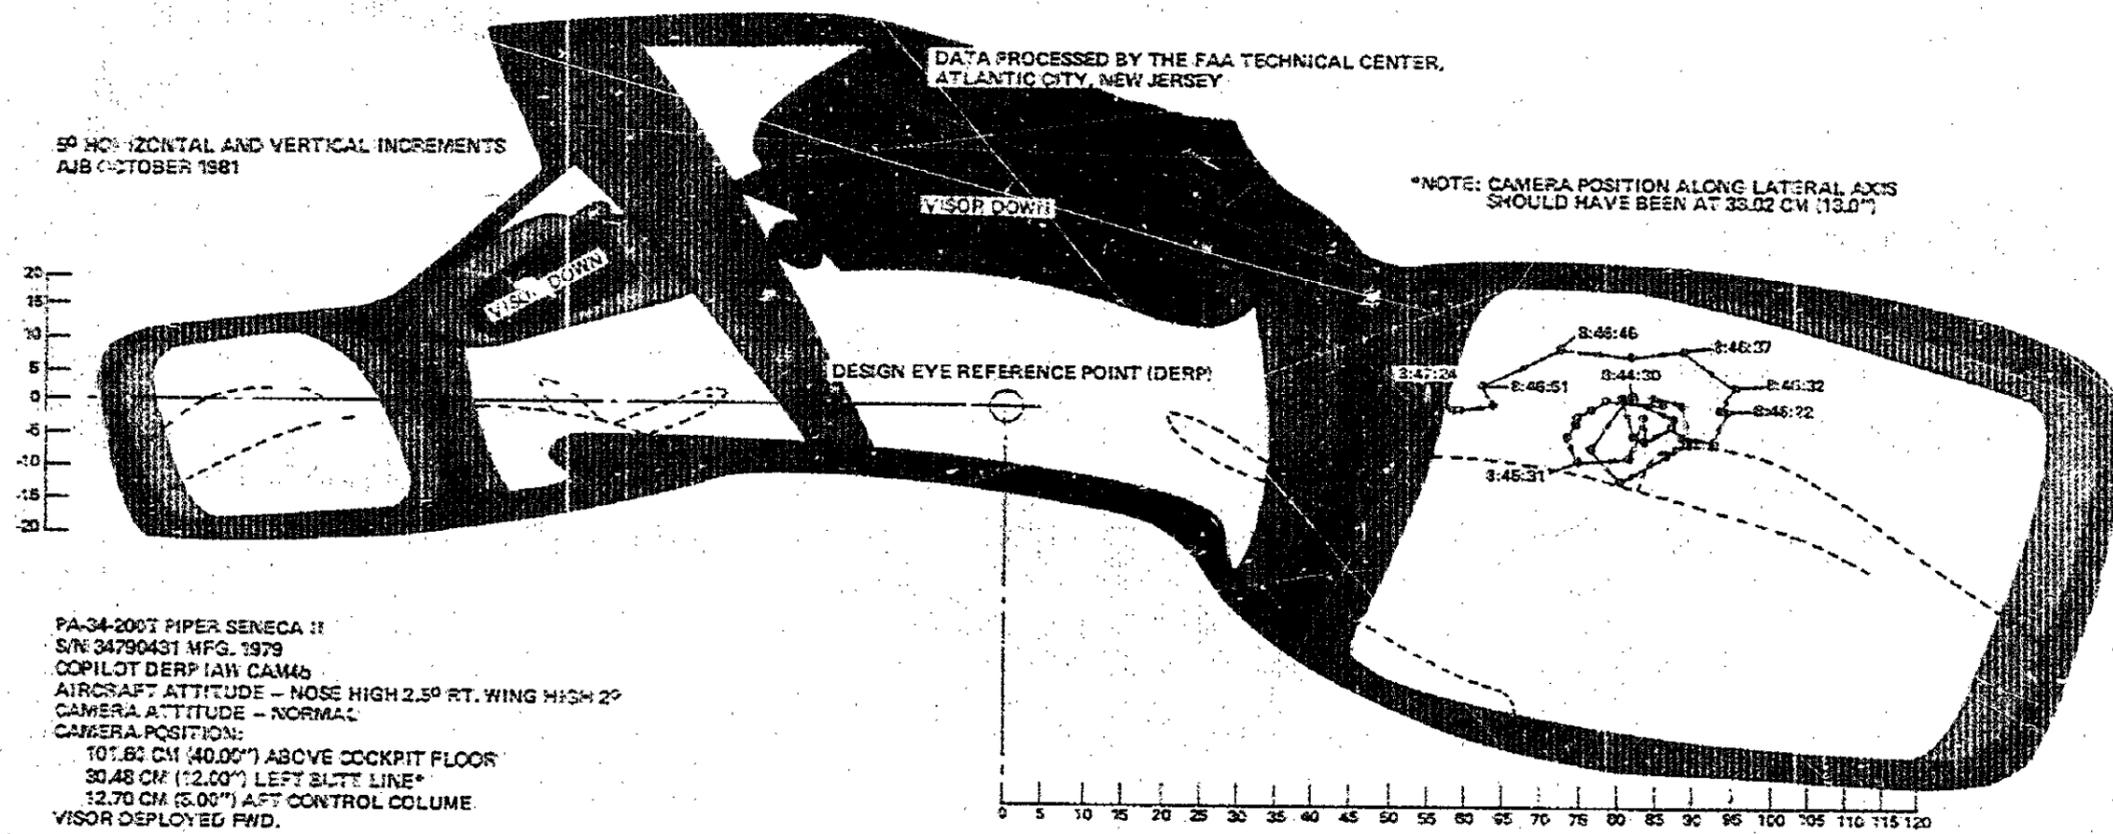
BINOCULAR PHOTOGRAPHS

The airplane viewing angles when plotted on the binocular photographs from the pilot's position placed the helicopter in the right front cabin window for the first 122 seconds starting 183 seconds before the collision. During this period the helicopter would have been obscured about 50 percent of the time by the wing, nacelle, or windshield side post. The turn to base caused the helicopter to move up and into the cabin overhead for about 15 seconds. When the wings were again leveled during the base leg, the helicopter moved down to just above the zero elevation line in the copilot's windshield just above the right engine for the 30 seconds of plotted data. The final point plotted occurred approximately 9 seconds before collision.

The view from the right seat of the airplane would have placed the helicopter nearly in the center of the right front cabin window forward of the wing and above the nacelle for nearly two thirds of the 122-second time period prior to turning base. During the turn to base, the helicopter would have moved up and forward for 30 seconds and then down as the wings were rolled level. The helicopter continued to move forward during the remaining points staying within the right-side window.

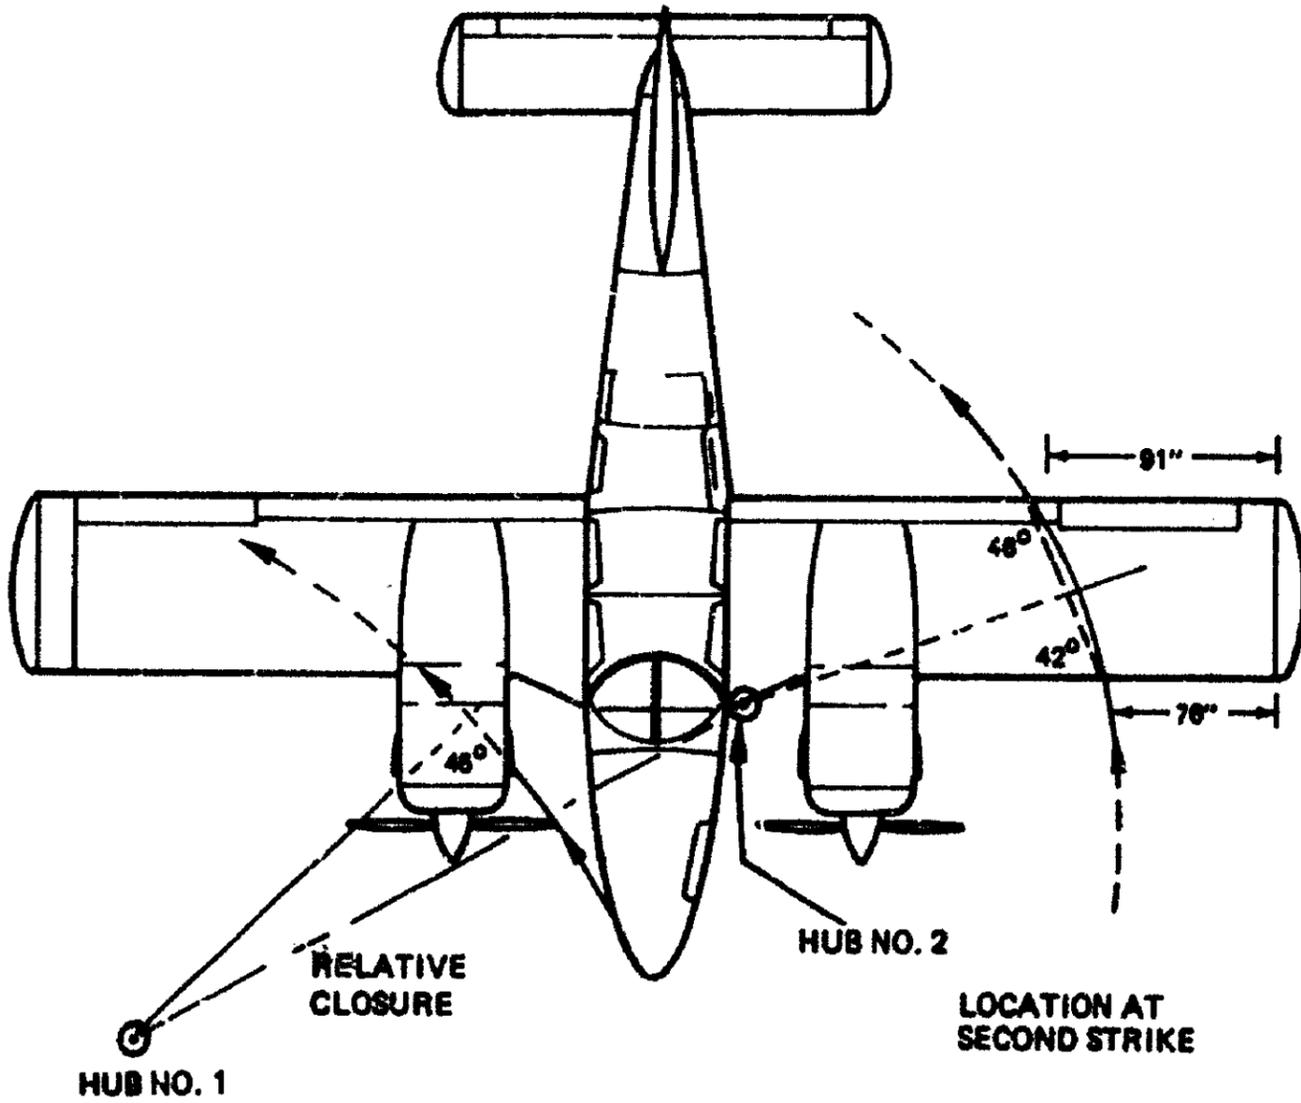
COLLISION DIAGRAM

Witnesses said that the two aircraft converged at an angle of nearly 90°, with the helicopter approaching from the right of the airplane. Several witnesses said that the helicopter appeared to bank to the right immediately before the collision. Both persons in the airplane said that they never saw the helicopter before the collision.

Several witnesses stated that the two aircraft converged at an angle of nearly 90°, with the helicopter approaching from the right of the airplane. Some of these witnesses described a sudden bank to the right by the helicopter immediately before the collision. The angles and directions of separation of the airplane's right engine and left wing, taken together with the damage and marks on the helicopter main rotor blades,

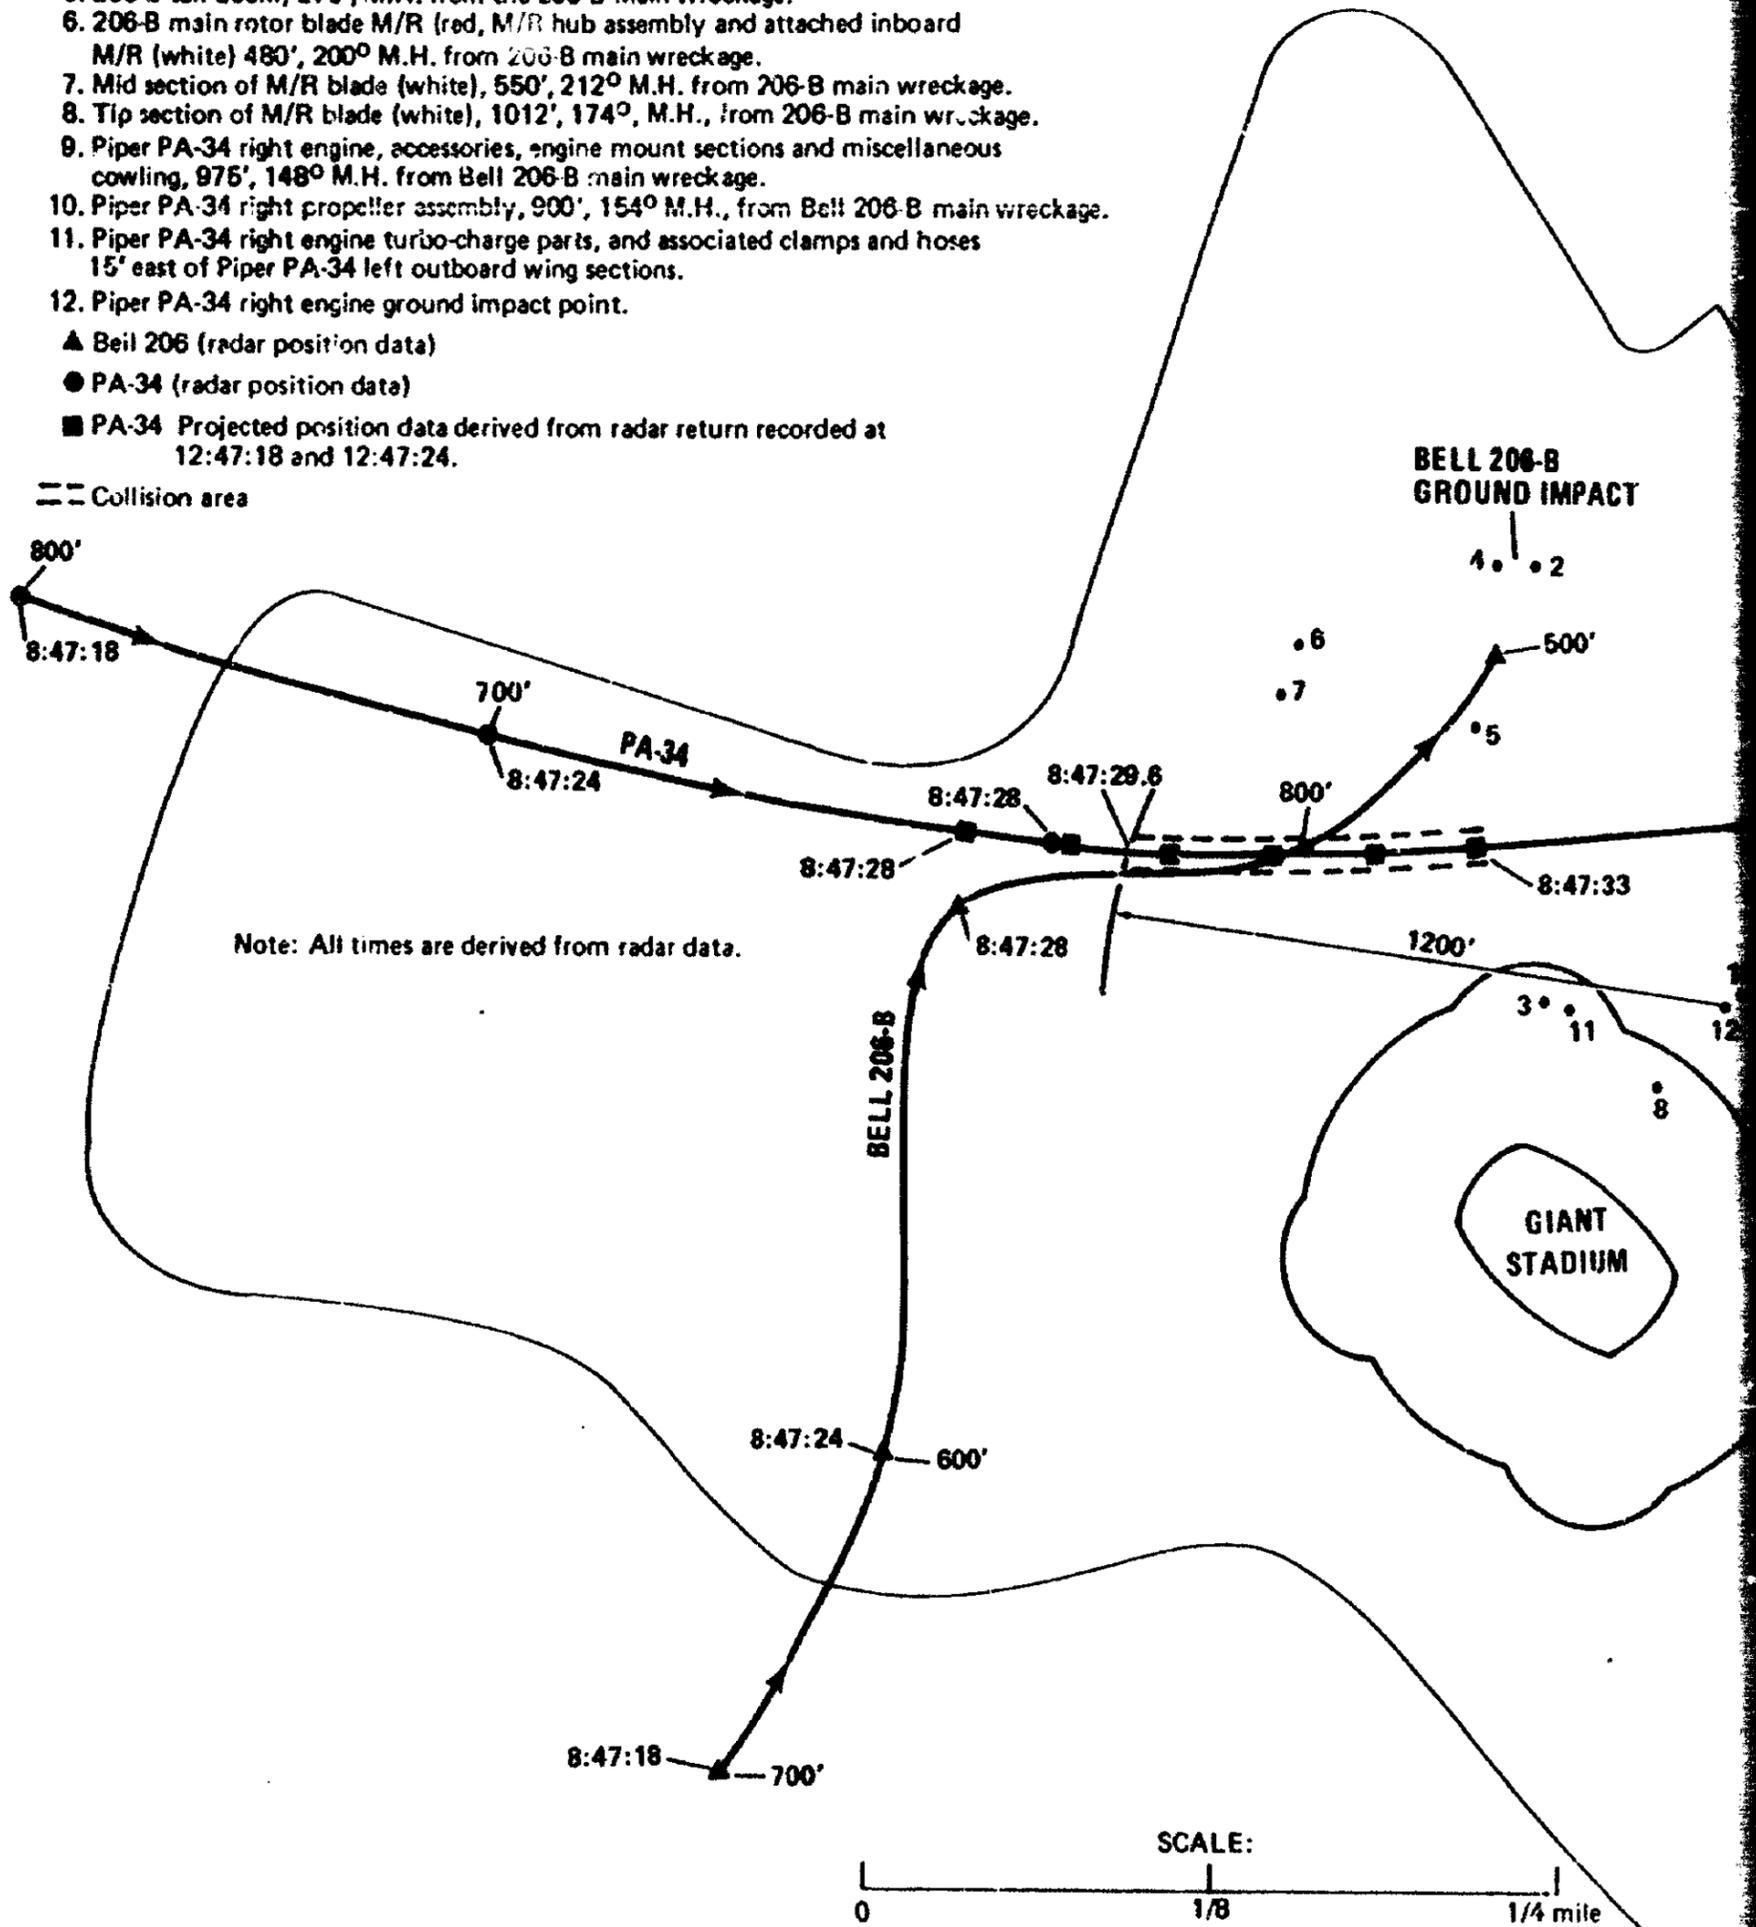
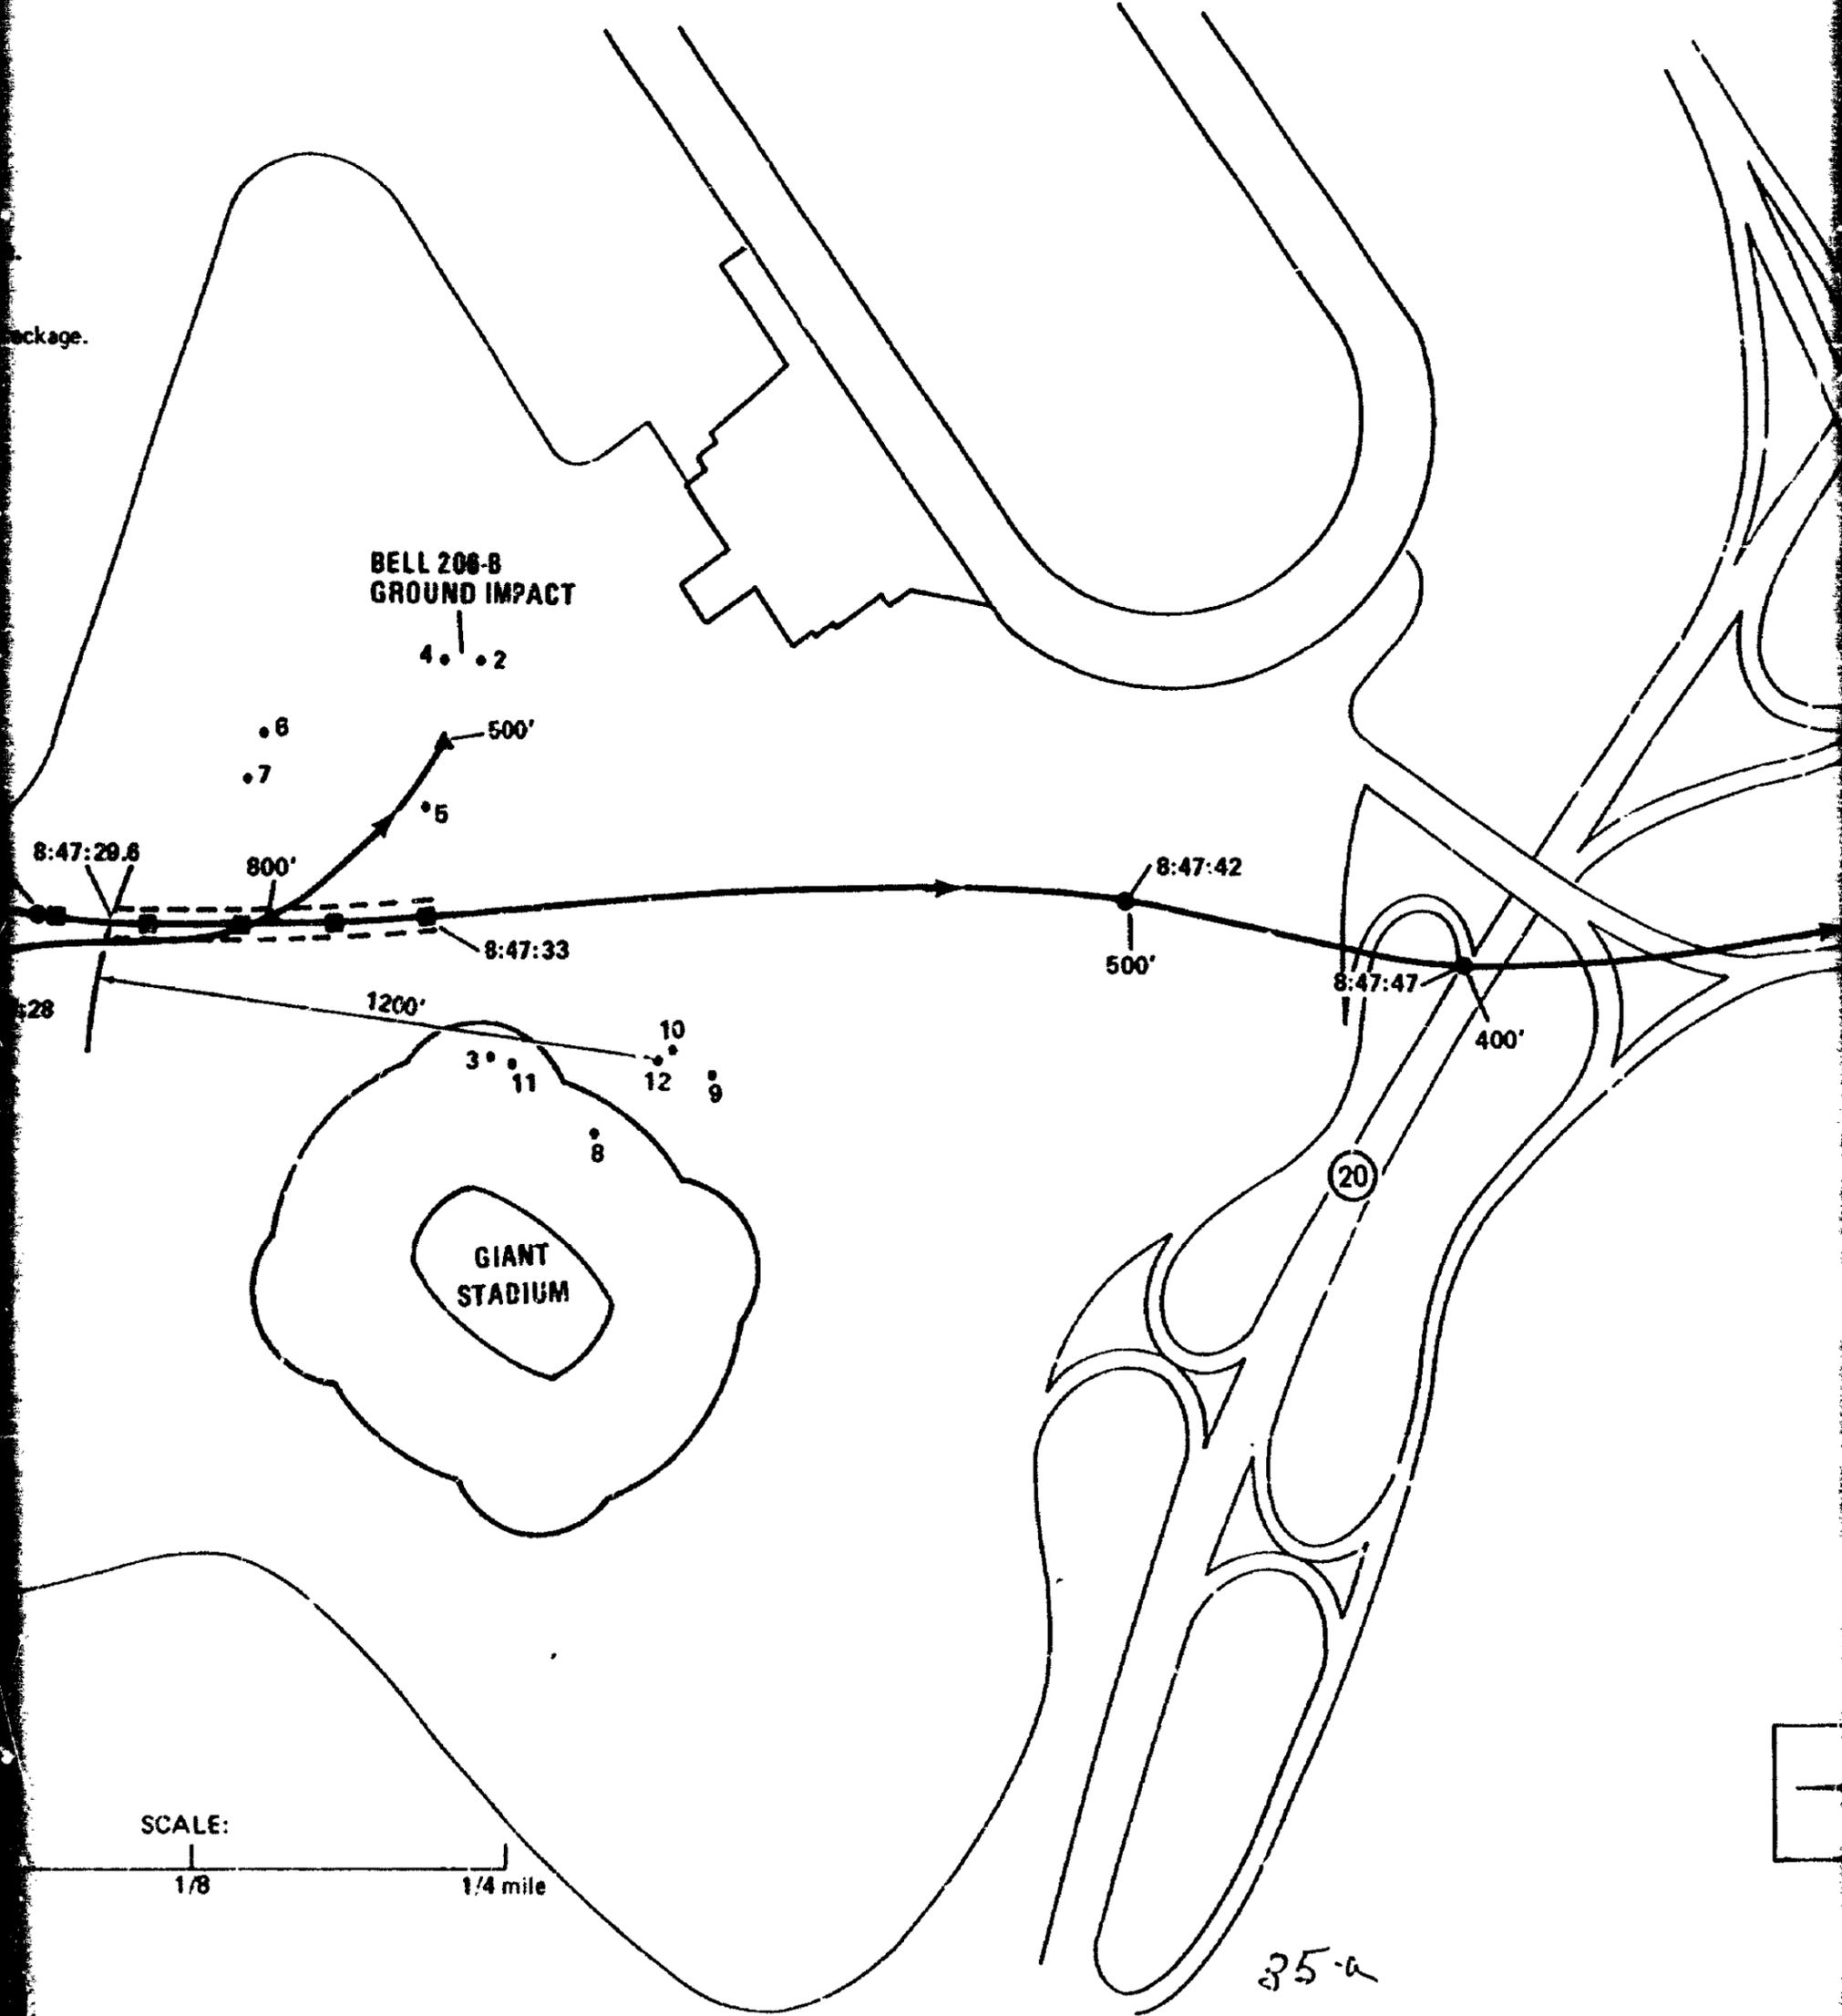
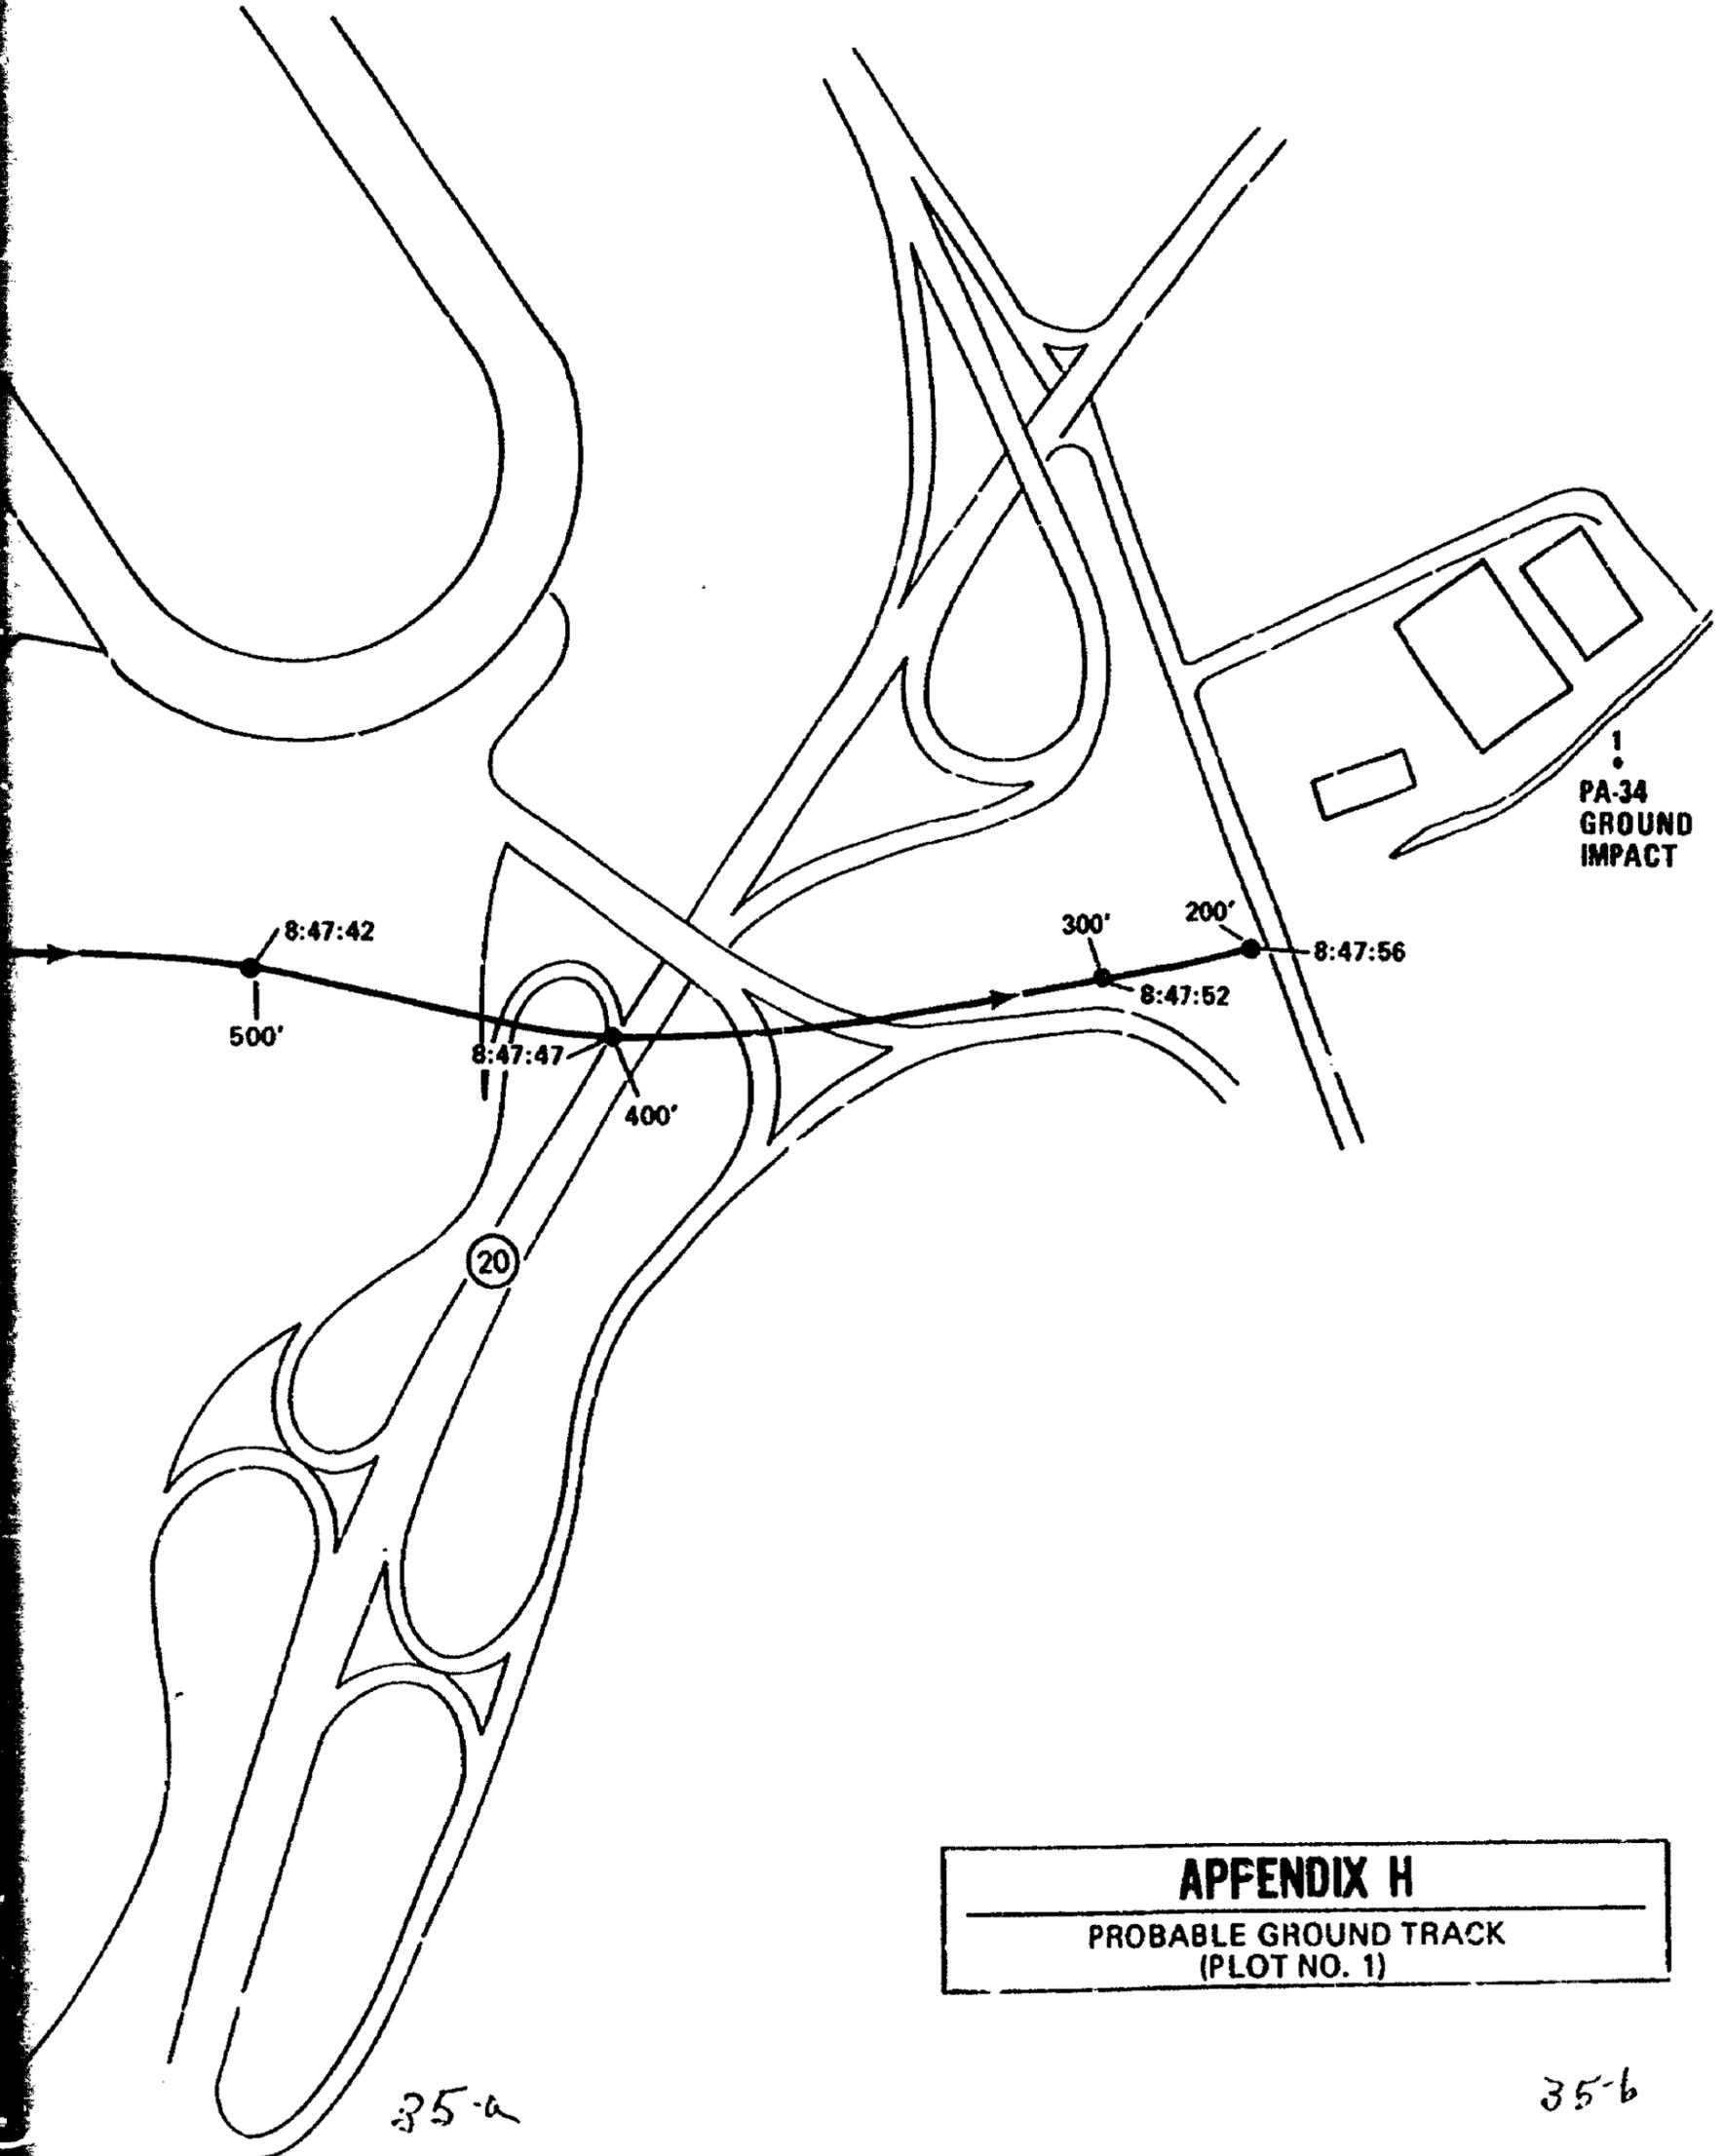
APPENDIX H
PROBABLE GROUND TRACK
(PLOT NO. 1)

The ground tracks showed that after crossing over Newark airport and leaving the control zone at an altitude of 1,300 feet, the helicopter maintained an essentially constant northerly heading toward Teterboro Airport and descended gradually to about 650 feet. The airplane tracked inbound on the Teterboro runway 6 ILS, just slightly left of centerline, for about 2 1/2 minutes, descending from 1,900 feet to 1,000 feet. At 0846:36, the airplane turned right to an easterly heading and continued to descend. This heading was maintained until the collision. At the time of collision, the transponder returns from both aircraft indicated about 650 feet.
