AIRCRAFT ACCIDENT REPORT

**PILGRIM AIRLINES FLIGHT 458
deHAVILLAND DHC-6-100, N127PM
NEAR PROVIDENCE, RHODE ISLAND
FEBRUARY 21, 1982**

NTSB-AAR-82-7

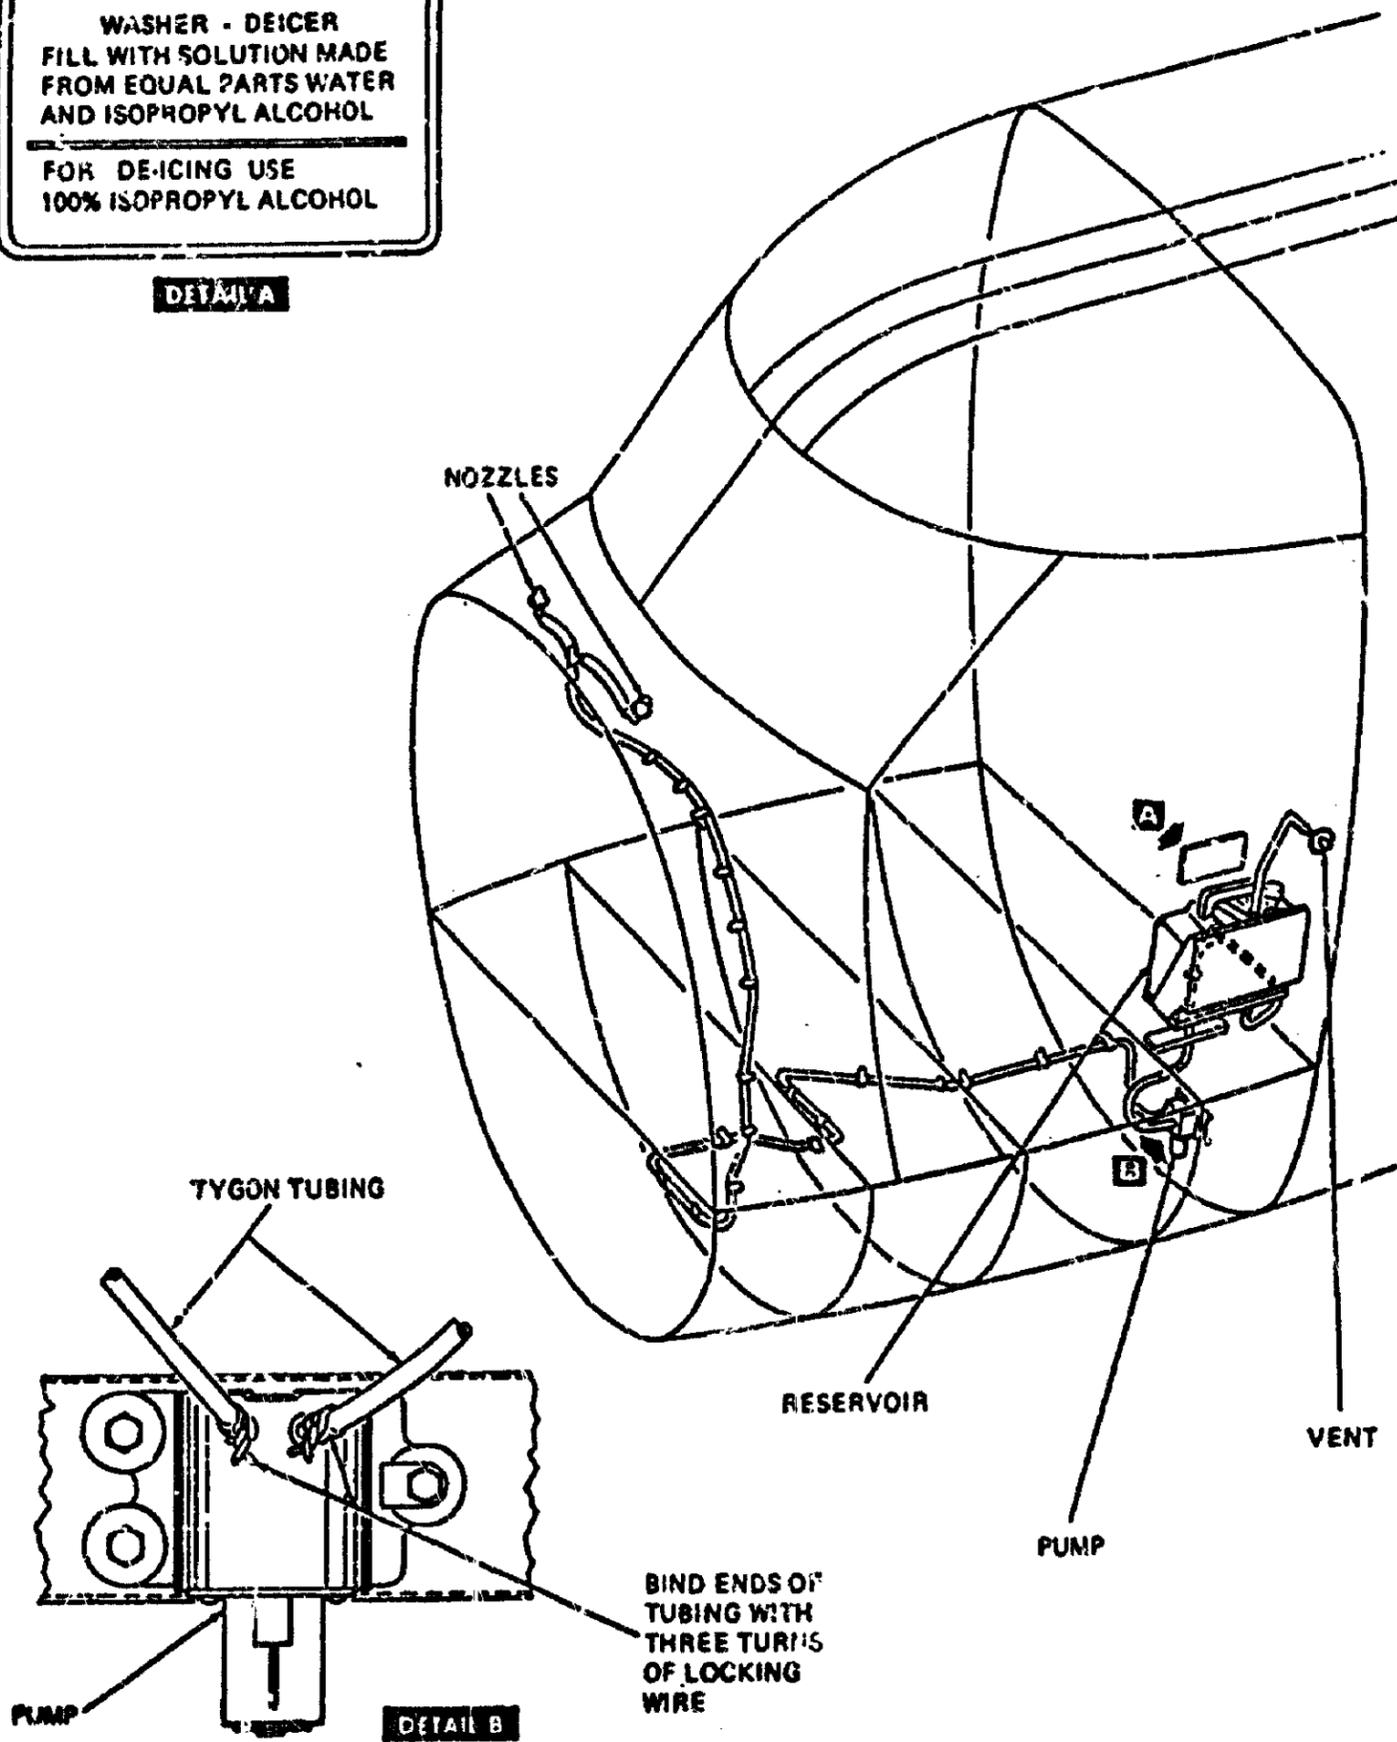
Figure 1.--Diagram of the windshield washer/deicer system installed on the accident aircraft.

Investigators determined that the Tygon tubing hardens when it comes in contact with alcohol and becomes misshaped at its connection points, often resulting in leaks. To correct the leaks, the hardened, misshaped ends of the tubing are cut off and the tubing reattached. After successive cuts, a splice is required to make the tubing long enough for an unstrained connection. Maintenance procedures approved by deHavilland allows the connection to be secured with three wraps of safety wire.

The bottom of the reservoir opposite to the filler neck was found in the burned cockpit area during the postaccident inspection. The edges were melted and deformed from heat and fire. No other deicer system components (pump and lines) were found.

The tests demonstrated that with the tubing not properly fastened on the outlet pressure side of the pump, isopropyl alcohol could have leaked through the pump and accumulated in the compartment beneath the cockpit floor without the washer/deicer system having been activated, and once the system was activated, alcohol would have been sprayed from the pump outlet forward into the compartment area which contained numerous ignition sources.

The deHavilland practice of securing the tube connections with three wraps of safety wire is not as positive as other common methods in preventing tubing disconnects, especially on the outlet pressure side of the pump. Although clamps are the better method of securing the tubing, even they do not insure a leak-free, disconnect-free environment that is critical since the system down to the pump is gravity fed. Any leak or disconnection at any point between the reservoir and the outlet side of the pump will cause a complete loss of fluid unless the leak is detected and stopped.

The pressure tubing probably disconnected from the pressure side of the pump at some time before the first officer activated the windshield washer/deicer system. Fluid could have accumulated beneath the cockpit floor as small amounts of alcohol leaked through the pump when it was not running. When the windshield deicing system was activated twice, about 20 minutes after the aircraft departed Groton, alcohol probably was sprayed from the discharge side of the pump into the compartment beneath the cockpit floor. The fire probably originated within the compartment and spread to the forward cabin area by burning into and through the left fiberglass heating duct.

Issue an Airworthiness Directive to require a redesign and modification of isopropyl alcohol windshield deicing systems installed on DHC-6 aircraft to eliminate the potential for alcohol leakage or, if practicable, to require replacement of these systems with the electrically heated windshields offered by the manufacturer as an alternative installation. (Class II, Priority Action) (A-82-56)

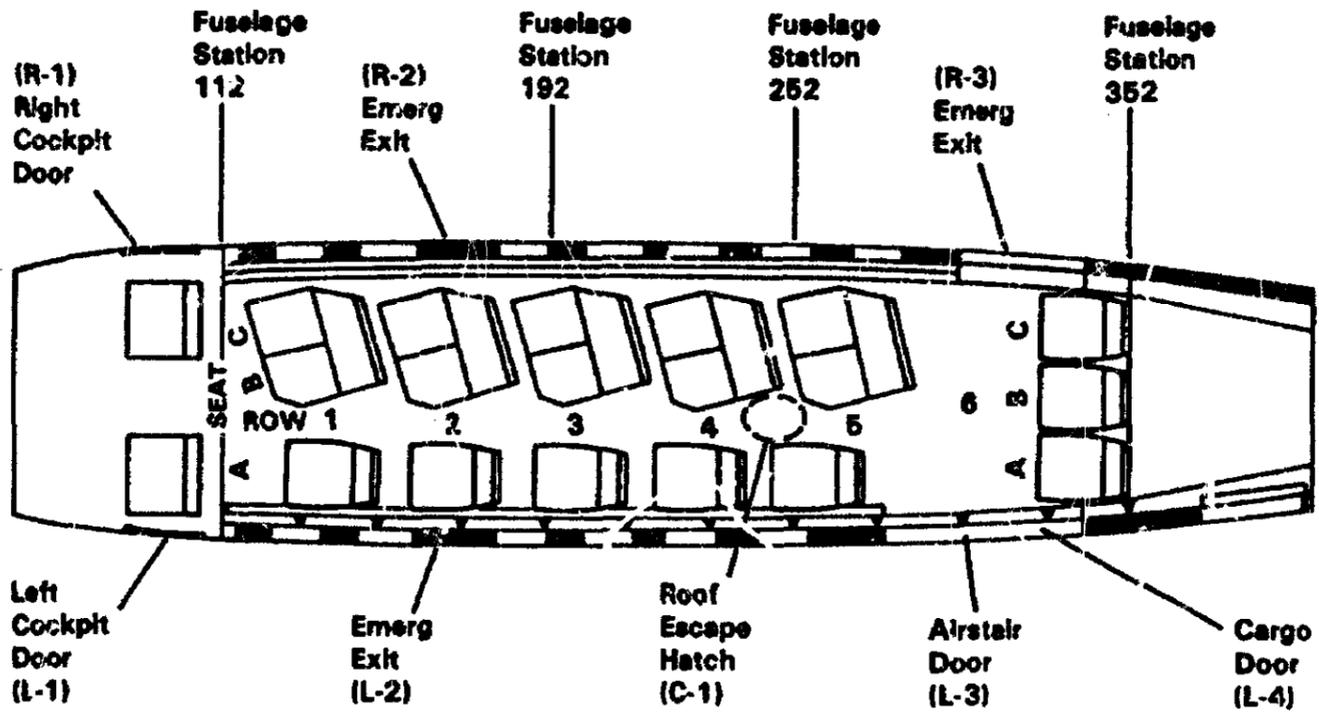
APPENDIX D
SEATING DIAGRAM

SEAT	OCCUPANT	INJURY	OCCUPANT EXITED VIA
LEFT COCKPIT	T. PRINSTER	SERIOUS	L-1 (THROUGH WINDOW IN DOOR)
RIGHT COCKPIT	L. HOGG	SERIOUS	R-2 (OPENED R-2)
ROW 1 SEAT A	UNOCCUPIED		
SEAT B	UNOCCUPIED		
SEAT C	UNOCCUPIED		
ROW 2 SEAT A	ADULT MALE, 51	MINOR	L-4*
SEAT B	16-YEAR-OLD BOY	SERIOUS	R-2 (TRIED TO OPEN EXIT)
SEAT C	ADULT FEMALE, 46	SERIOUS	R-2 (ASSISTED FROM AIRCRAFT)
ROW 3 SEAT A	ADULT FEMALE, 59	FATAL	
SEAT B	UNOCCUPIED		
SEAT C	UNOCCUPIED		
ROW 4 SEAT A	ADULT MALE, 47	SERIOUS	L-4* (TRIED TO OPEN L-3)
SEAT B	UNOCCUPIED		
SEAT C	ADULT MALE, 35 (UNOCCUPIED) AT IMPACT	SERIOUS	L-4*
ROW 5 SEAT A	ADULT FEMALE, 26 (BLIND)	SERIOUS	L-4* (ASSISTED FROM AIRCRAFT)
SEAT B	UNOCCUPIED		
SEAT C	ADULT MALE, 26	SERIOUS	L-4* (THROUGH "HOLE") (TRIED TO OPEN L-3)
ROW 6 SEAT A	9-YEAR-OLD GIRL	SERIOUS	L-4* (PULLED FROM AIRCRAFT)
SEAT B	UNOCCUPIED		
SEAT C	17-YEAR-OLD BOY	SERIOUS	L-4* (PULLED FROM AIRCRAFT)

*It is not clear from passenger interviews whether the "hole" referred to by the occupant of 5-C and others was a hole in the side of the cabin or the partially opened/damaged cargo door, L-4
