NATIONAL TRANSPORTATION SAFETY BOARD

AIRCRAFT ACCIDENT REPORT

MIDAIR COLLISION
UNITED STATES AIR FORCE, F111-D,
BUILDING CONTRACTORS, INC., CESSNA TU-206G,
CLOVIS, NEW MEXICO
FEBRUARY 6, 1980

NTSB-AAR-82-10

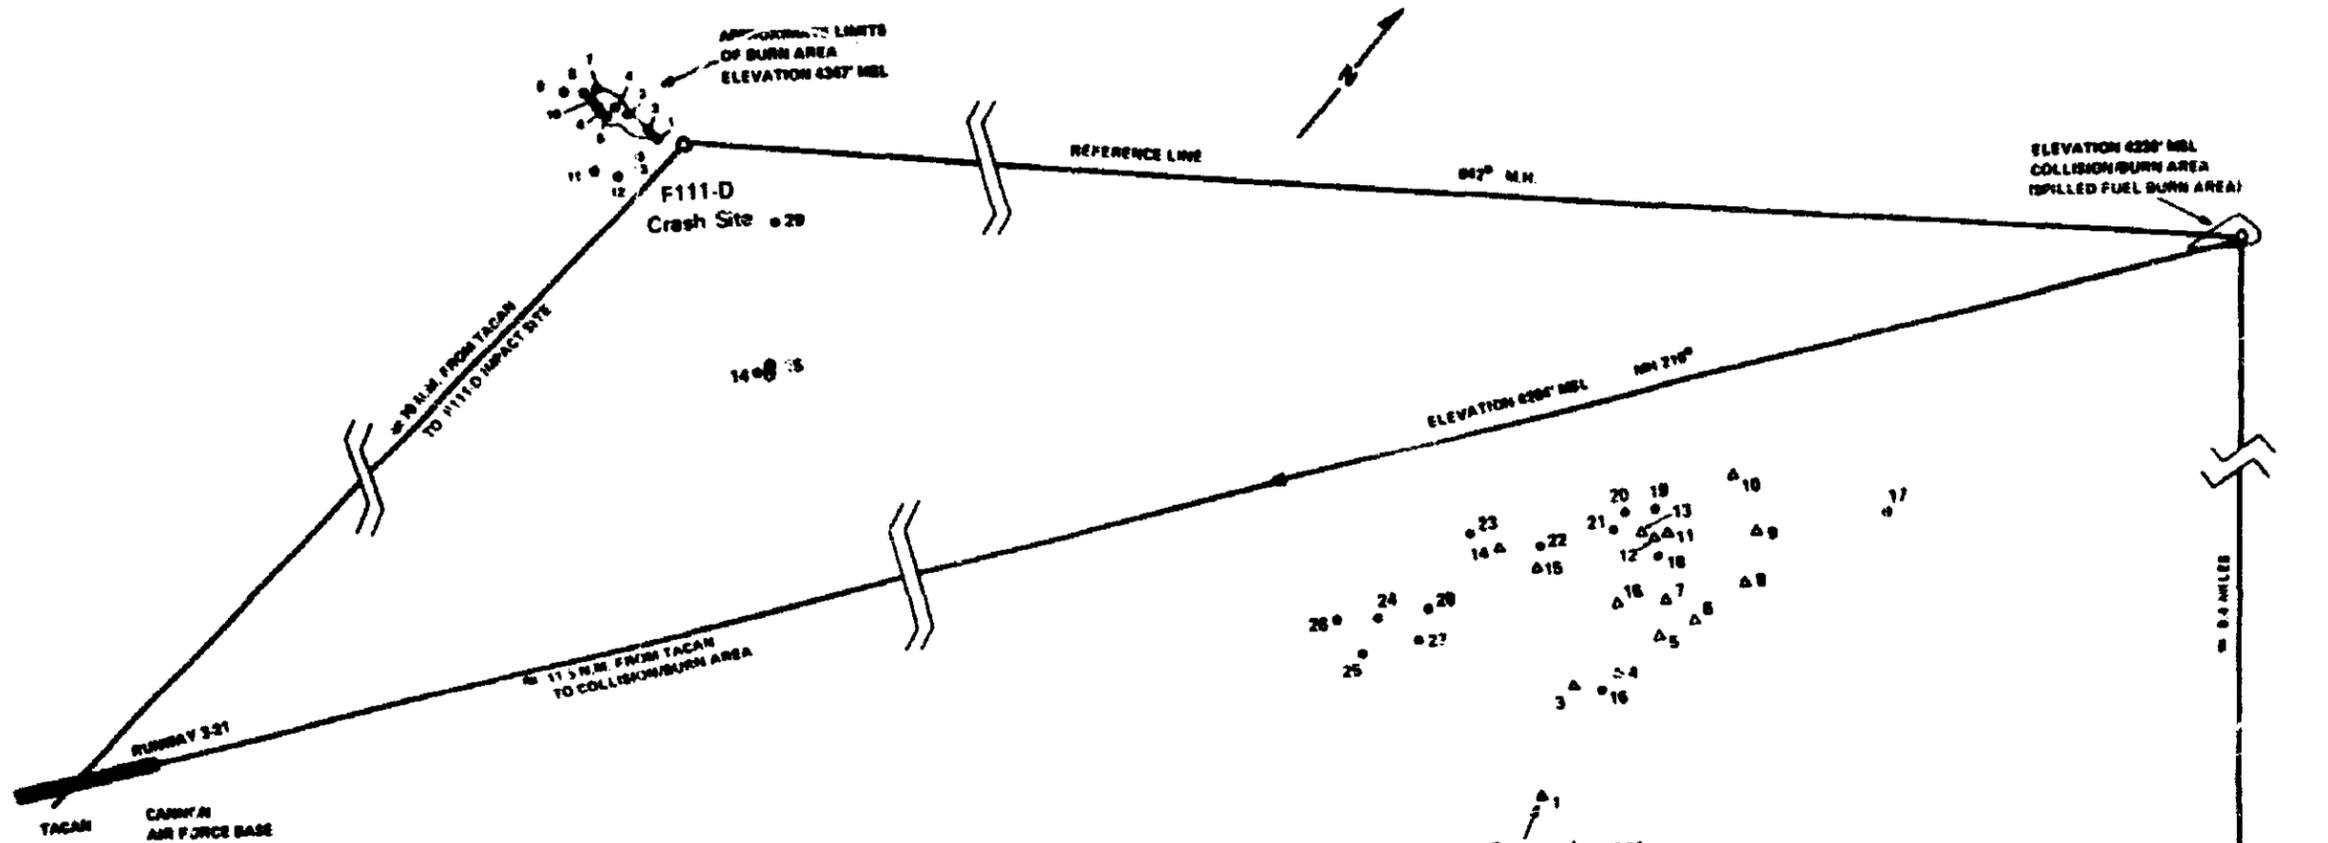
APPENDIX C
 Wreckage Distribution Chart

The collision impact markings and gougings were used to determine the collision angles of each aircraft. The initial contact of the two aircraft was between the F-111D's right wing bomb rack and the wing tip of the Cessna's left wing. After the initial impact, the Cessna struck the F-111D's bottom right fuselage engine nacelle. Scratches and gouge marks, which were imprinted with white and blue paint, were found on the bottom of the F-111D's right engine. The impact damage indicated that the Cessna collided with the F-111D about 22° right of the F-111D's centerline axis. Impact markings on the Cessna indicated that the Cessna collided with the F-111D about 82° to the left of the Cessna's axis centerline. The evidence further indicated that there was no relative vertical motion between the two aircraft, which also indicates that at the time of impact both aircraft were in level flight.

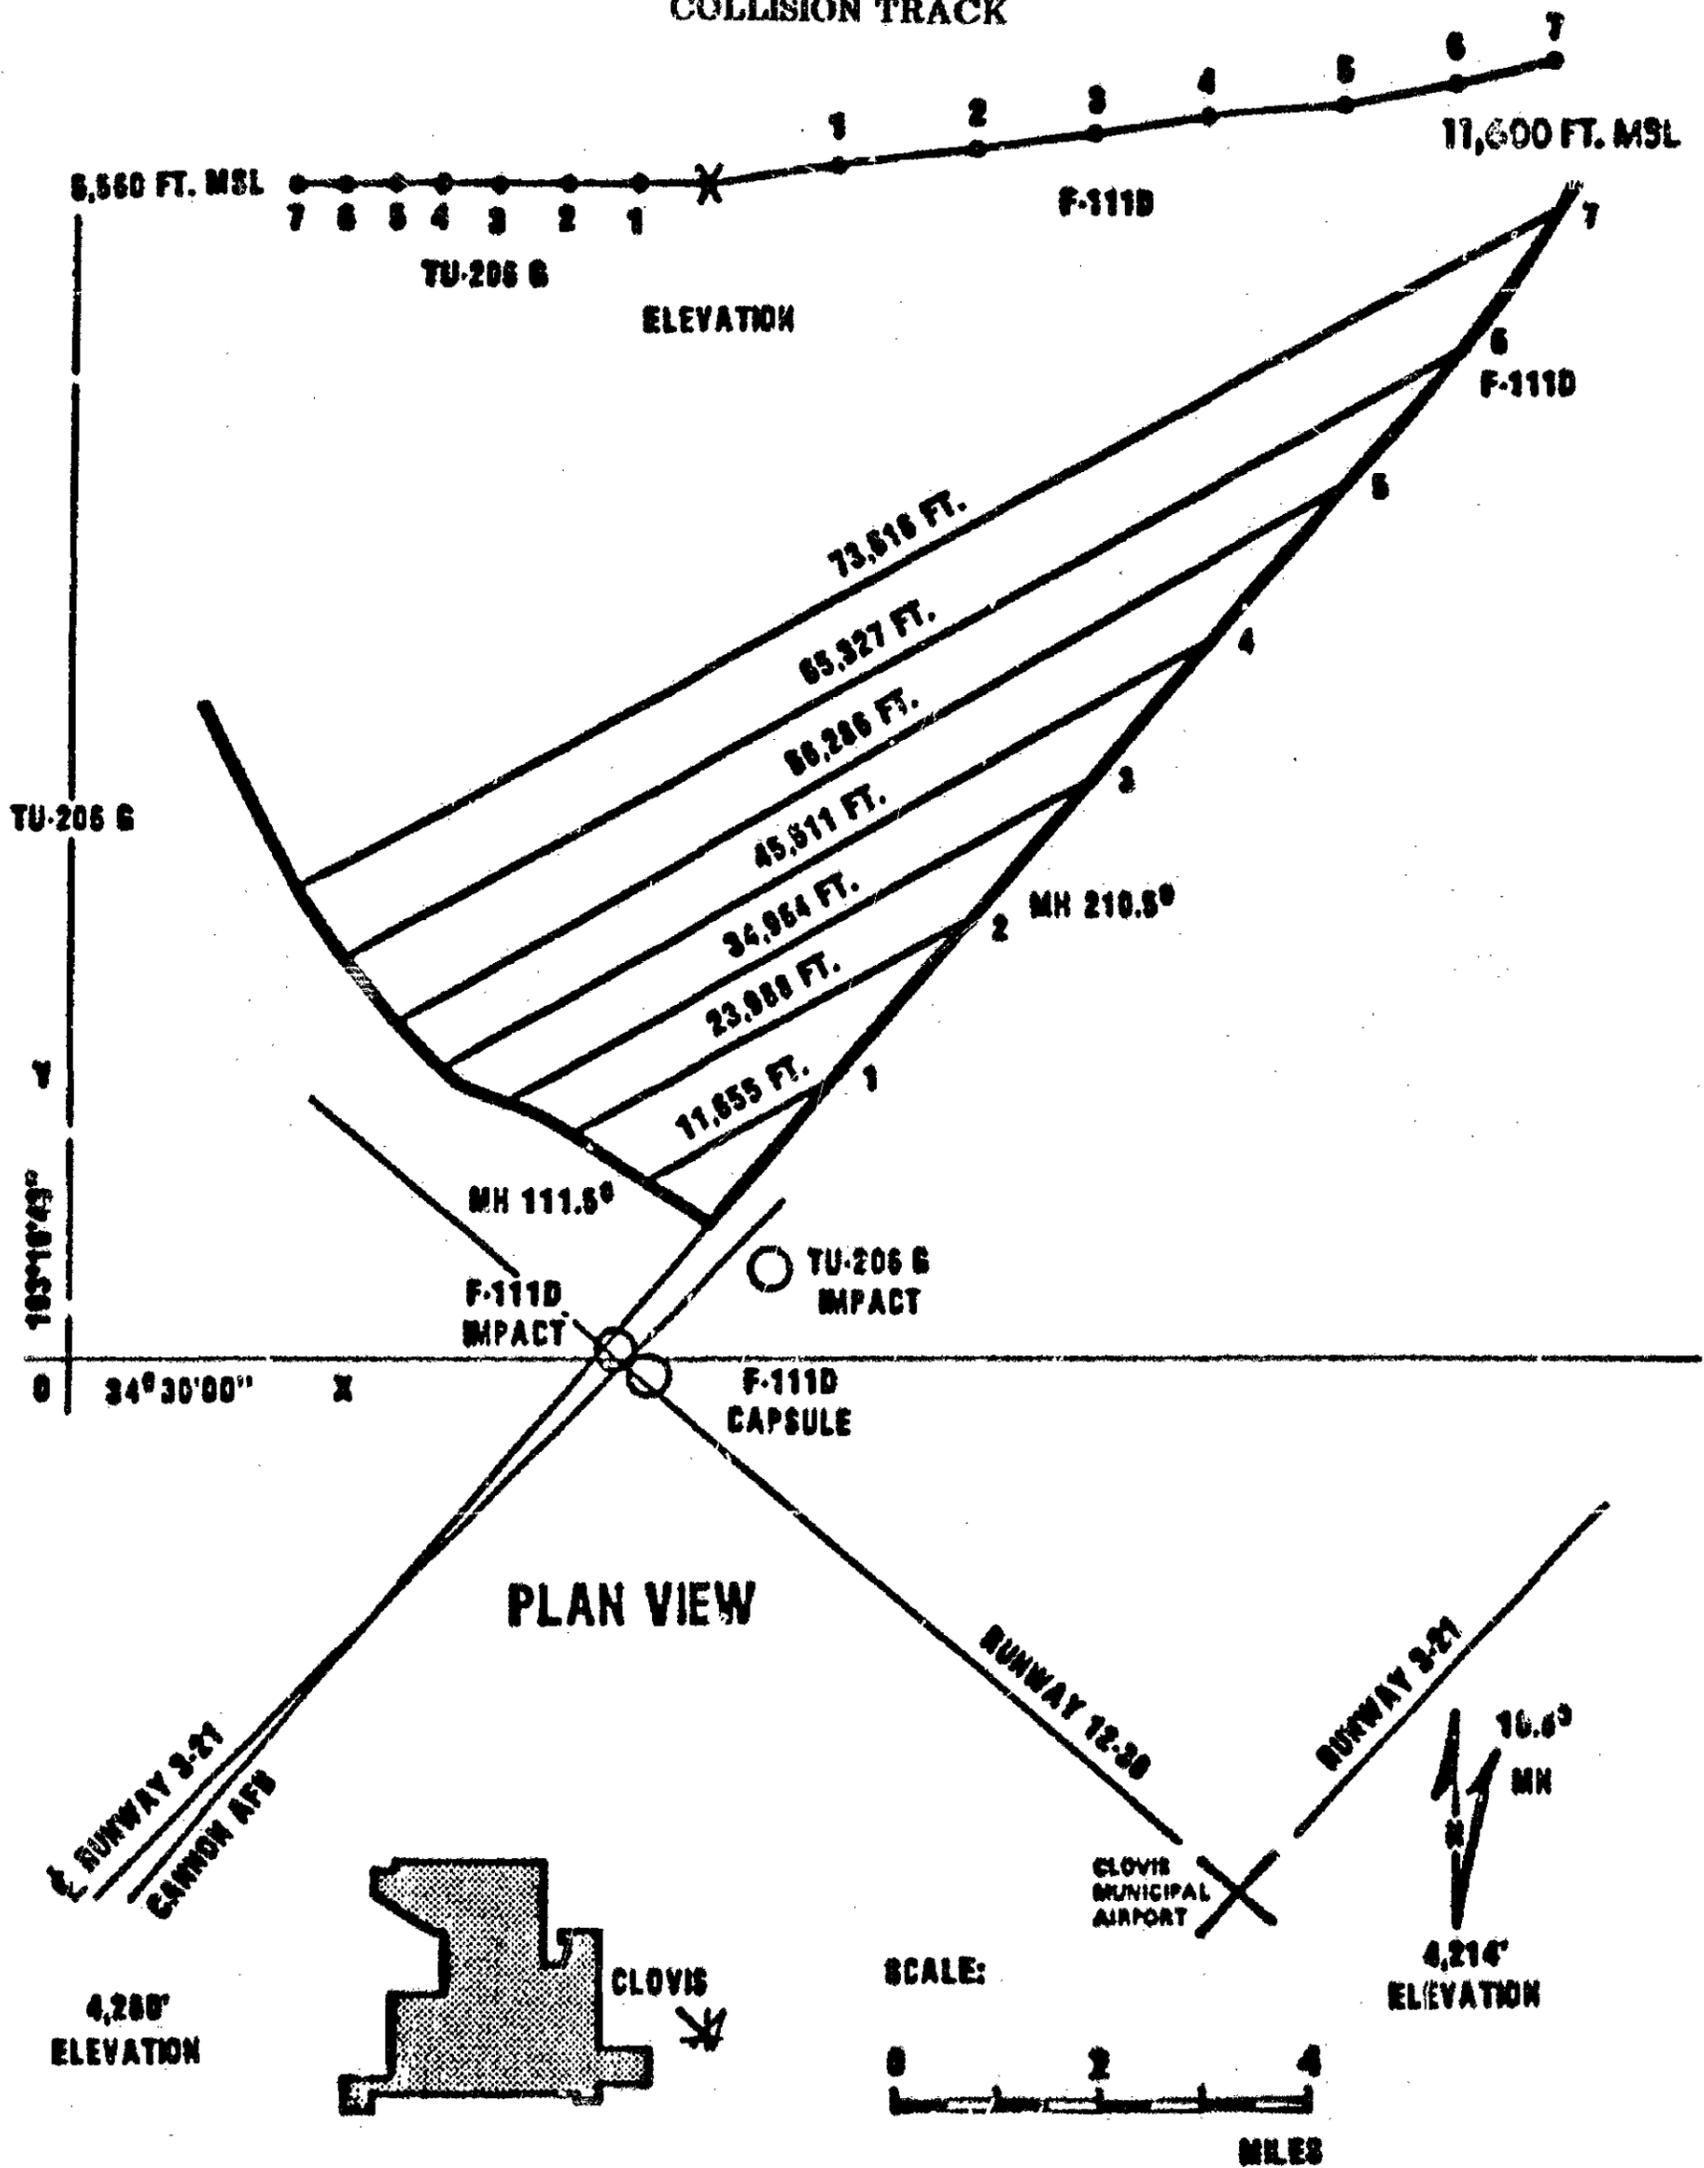
APPENDIX D COLLISION TRACK

airspeed. The collision geometry and slant range between the two aircraft for the 105-second period before the collision have been calculated and plotted on binocular photographs. (See appendix D.) It is to be noted that the accuracy of a photo depiction of visibility is inherently limited because of the basic assumptions necessary in its construction.

The ABQ ATC radar track recording was smoothed to provide the average ground speed during the last 105-second period before the collision. This information in combination with the collision angles determined from impact markings provided an average closure rate. Further, as the radar track recording did not provide information below 6,400 feet and after the aircraft descended below 6,400 feet, and the collision occurred 14 seconds later, the recommended AILA approach profile and the instrument readings from the crew escape module at the time of module ejection were used to estimate the altitude and indicated airspeed at the time of collision.

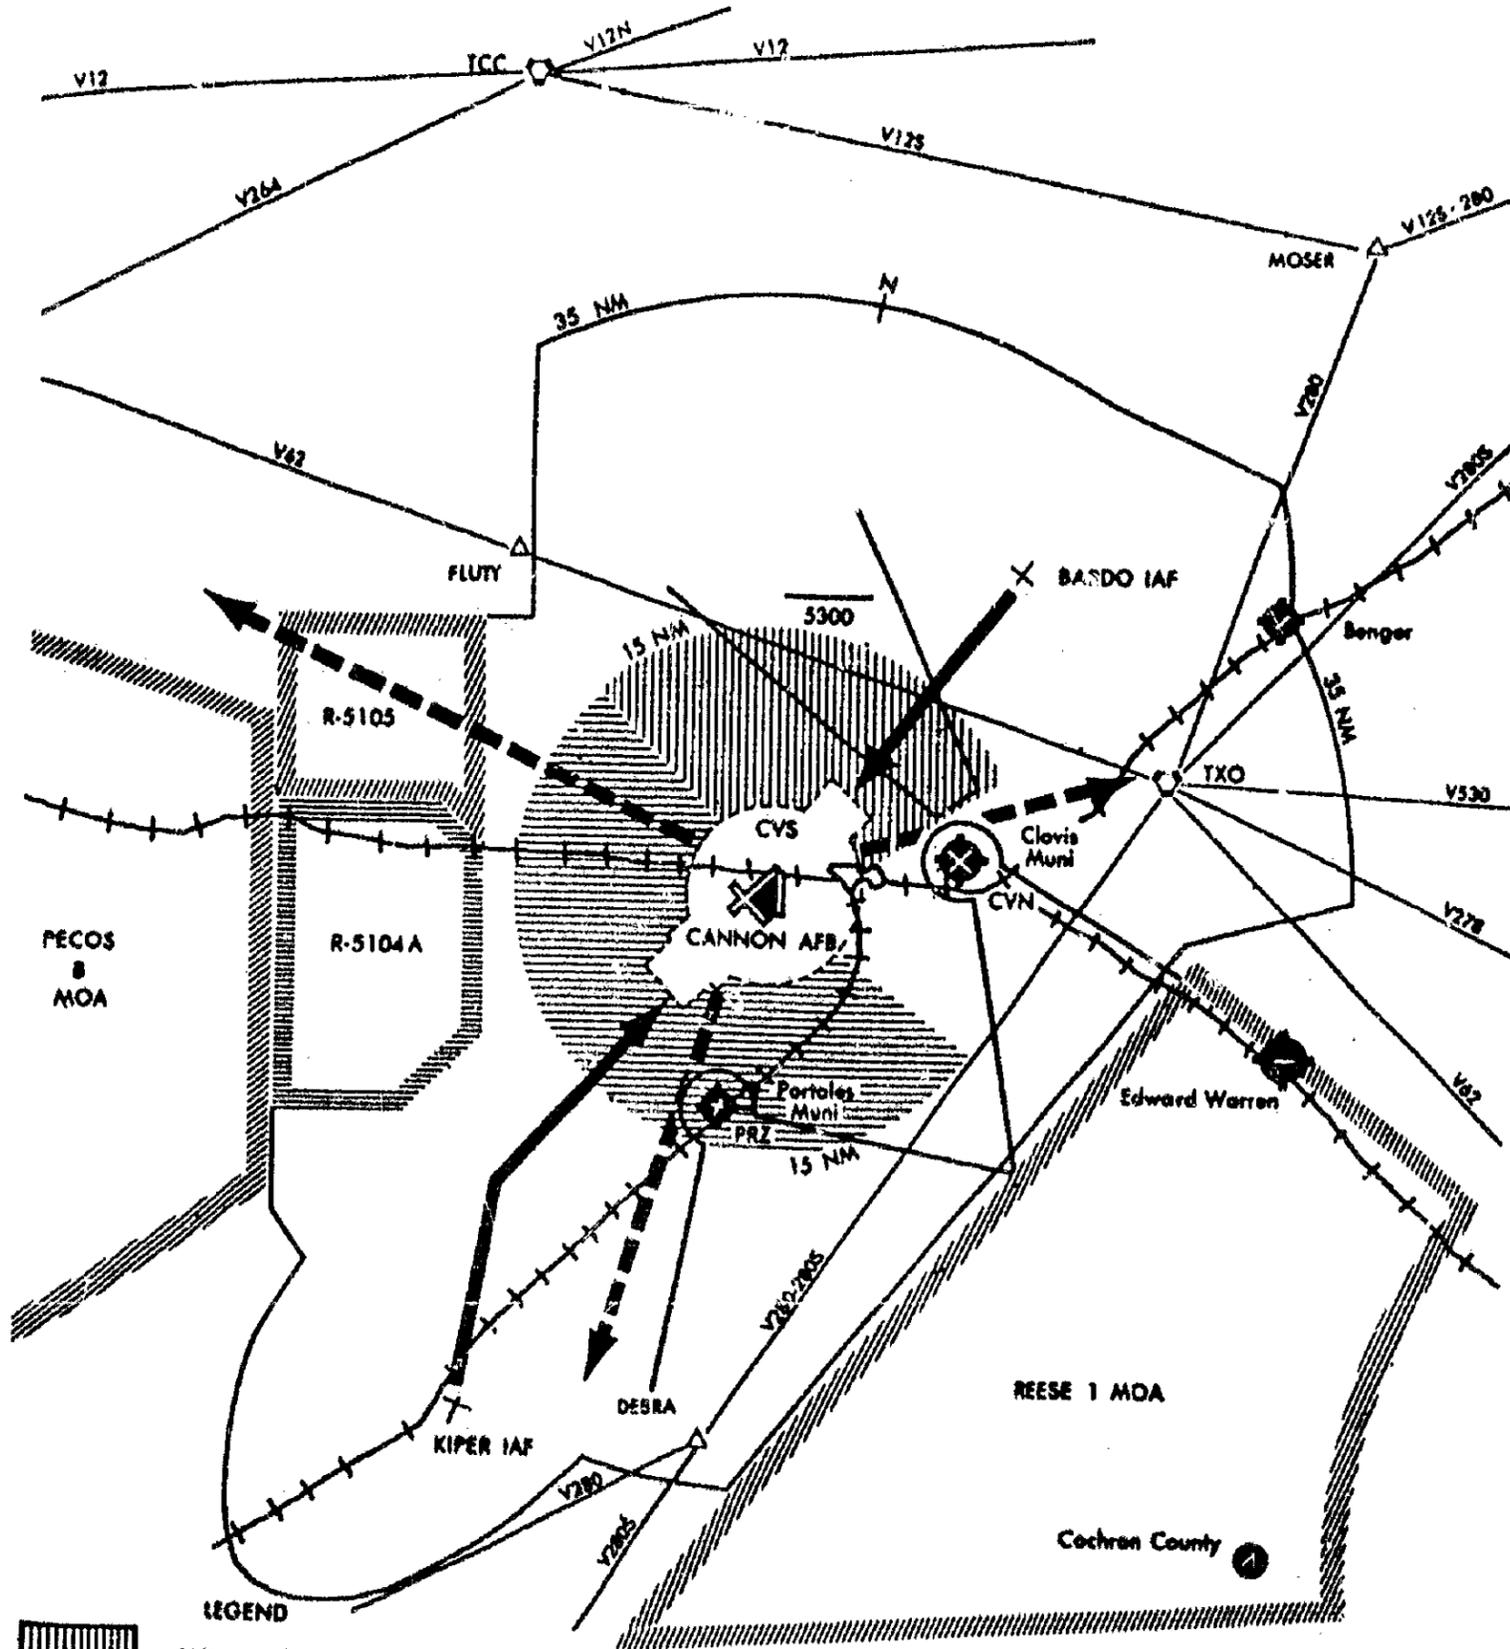
TERMINAL AREA GRAPHIC NOTICE, CHART DATED FEBRUARY 22, 1979

On this particular chart, dated February 22, 1979, the northern portion of the Cannon AFB controlled airspace was designated as a cautionary area between the altitudes of 5,800 feet and 6,300 feet. The remaining southern portion was noted as a cautionary area between the altitudes of 5,800 feet and 7,000 feet. Recommended VFR corridors for entry/exit to the civilian airports, Clovis and Portales, were depicted to the east and south of the cautionary area. A geometric outline appears in the northeast quadrant of the cautionary area. This trapezoidal-like outline originates north of the cautionary area where there is a numerical symbol on the chart intended to denote that the maximum altitude in that airspace is 5,300 feet m.s.l. The symbol is illustrated as a straight line over numerals (5300). Neither the outline nor the symbol is explained in the accompanying legend. It is not known if the Cessna pilot was familiar with the FAA publication "Graphic Notices and Supplemental Data."

The geometric outline in the northeast sector of the 15-nmi cautionary area of the chart, which relates to a VFR corridor but cannot be readily identified as a VFR corridor, does not appear in the legend although there is an unrelated symbol described in the legend as "Recommended VFR corridors". A numerical symbol which appears outside the cautionary area is intended to indicate that the maximum altitude to be flown in that area is 5,300 feet. This symbol, which is used on instrument approach charts, is not described in the legend of the subject graphic notice. The meaning of the geometric outline and the numerical symbols might not be known to a noninstrument rated pilot.

12. The terminal area graphic chart for Clovis-Cannon AFB, which was published in the January 1980 issue of "Graphic Notices and Supplemental Data," contained symbols not depicted in the legend and notations not clearly defined on the chart. The Cessna pilot may not have understood that he was flying at an unsafe altitude even if he had consulted the chart.
