AIRCRAFT ACCIDENT REPORT

**EMPIRE AIRLINES
FLIGHT 141, PIPER PA-31, N546BA
ITHACA, NEW YORK
JANUARY 5, 1982**

NTSB-AAR-82-11

Adopted September 22, 1982

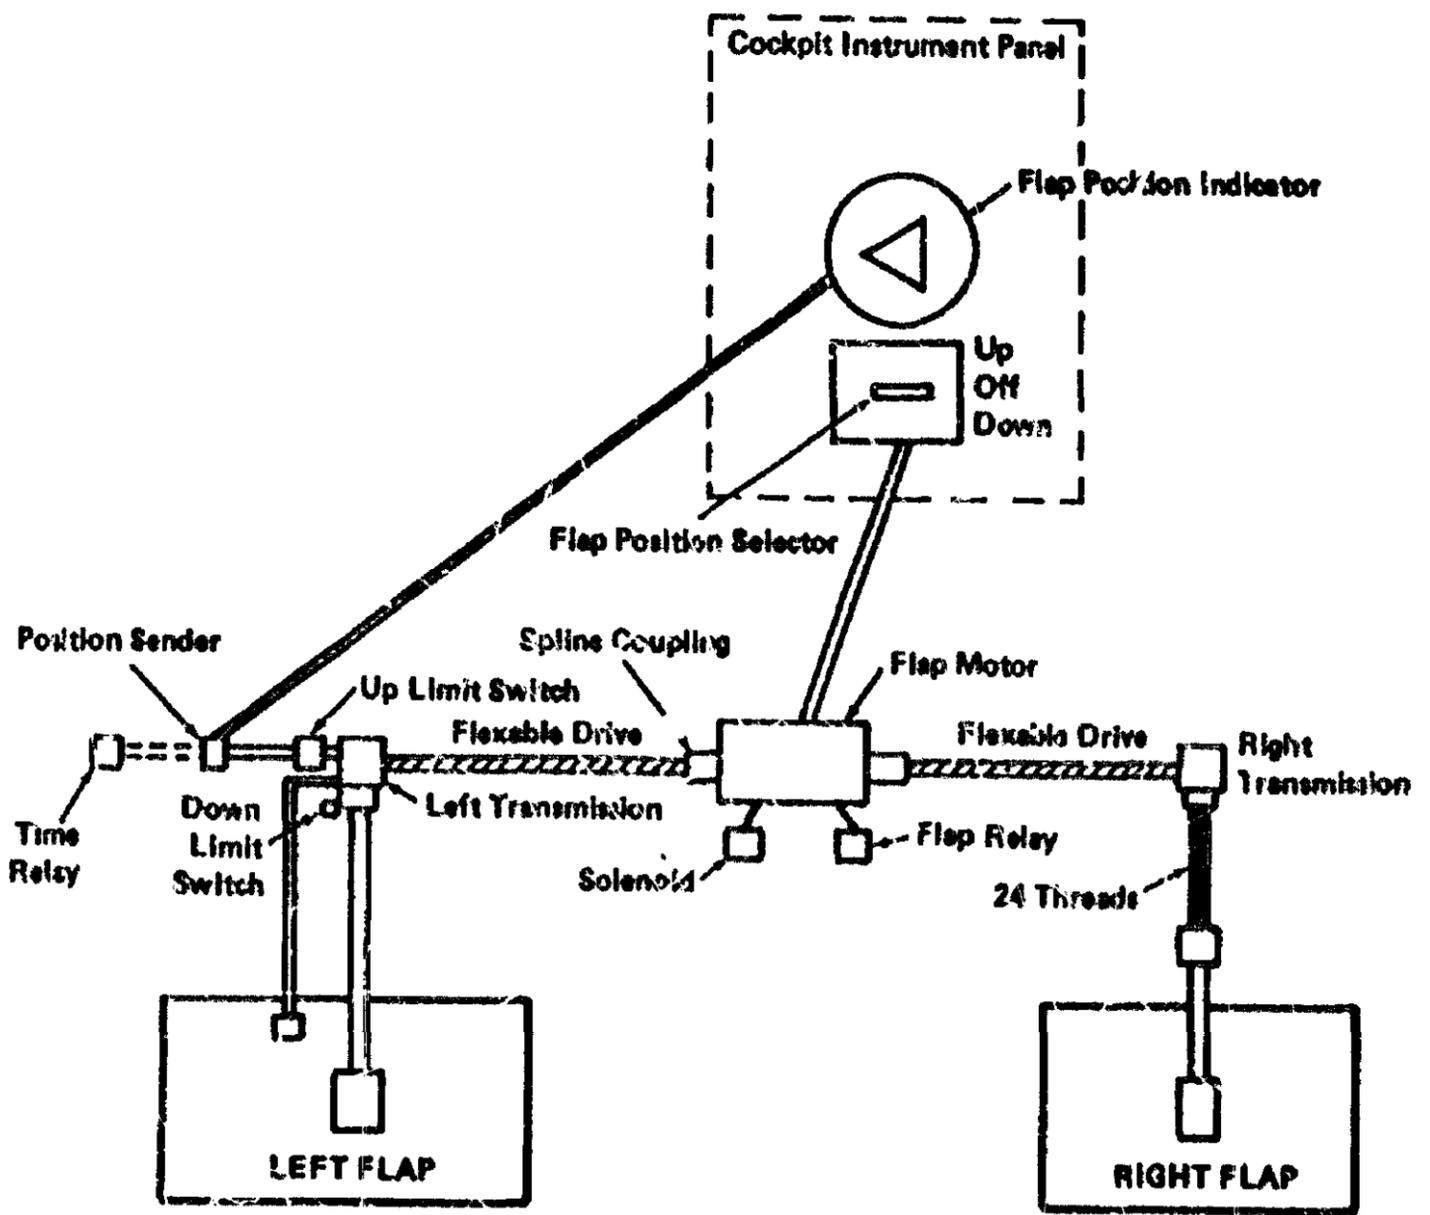
Figure 1.--PA-31-310 (Navajo) flap system.

Microswitches located in the left wing limit flap up and down travel. A rheostat, also located in the left wing, actuates the flap position indicator located above the flap selector switch in the cockpit. A time-delay relay located near the flap motor stops the motor if an asymmetric flap condition occurs when the flaps are selected to the down position. If the flaps do not extend together (the left flap does not leave the up limit switch), the time delay relay will turn the flap motor off within 1 second (about 9° of flap travel), and the flap selector will become inoperative until the time-delay relay is reset. The time-delay relay can be reset by pulling the flap control circuit breaker, located in the cockpit, and resetting it. The time-delay relay does not affect flap motor operation if the left flap is not at the up or down limit.

The time-delay relay does not affect the system if a failure occurs at any point after the left flap has left either the up or down limit switch. If a failure occurs in either flap system (when the left flap

is not in contact with a limit switch) use the flap selector switch to bring the operable flap to a symmetrical configuration with the inoperable flap.

Examination of the wreckage confirmed that the left wing flap was on the up position and the right wing flap was extended to about 34°. The flap system design is such that when the selection for flap extension is initiated a time relay is activated. Should the left flap fail to extend from the full up position, the flap motor will deactivate after 1 second during which the right flap will extend about 2°. Therefore, the Safety Board must conclude that when the crew selected flap extension, both flaps began to extend. However, as the air loads began to oppose flap travel, the worn left spline coupling, which normally transmitted torque from the flap motor to the left flap transmission, began to slip thus slowing or stopping the extension of the left flap at an intermediate position. The right flap continued to extend at its normal rate.

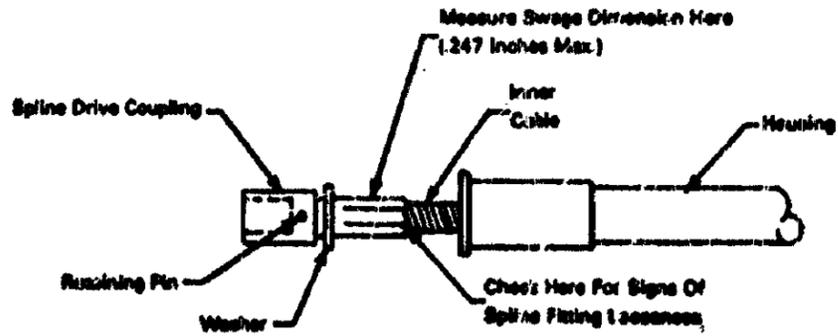
FIGURE 2

4. Visually inspect the flexible shaft splined drive coupling and retaining pin for evidence of looseness on the cable swage fitting. (Ref Sketch D, Figure 2.) If any looseness is apparent, replace the flexible shaft assembly.

5. Inspect the swaged fittings at both ends of the flexible shaft as follows:
 - a. Expose the swaged portion of the inner cable at the motor end by twisting the outer housing two (2) turns clockwise. The swaged portion of the cable should have eight (8) flats clearly visible and free from deep scratches or wear marks. (Ref Sketch D, Figure 2.)

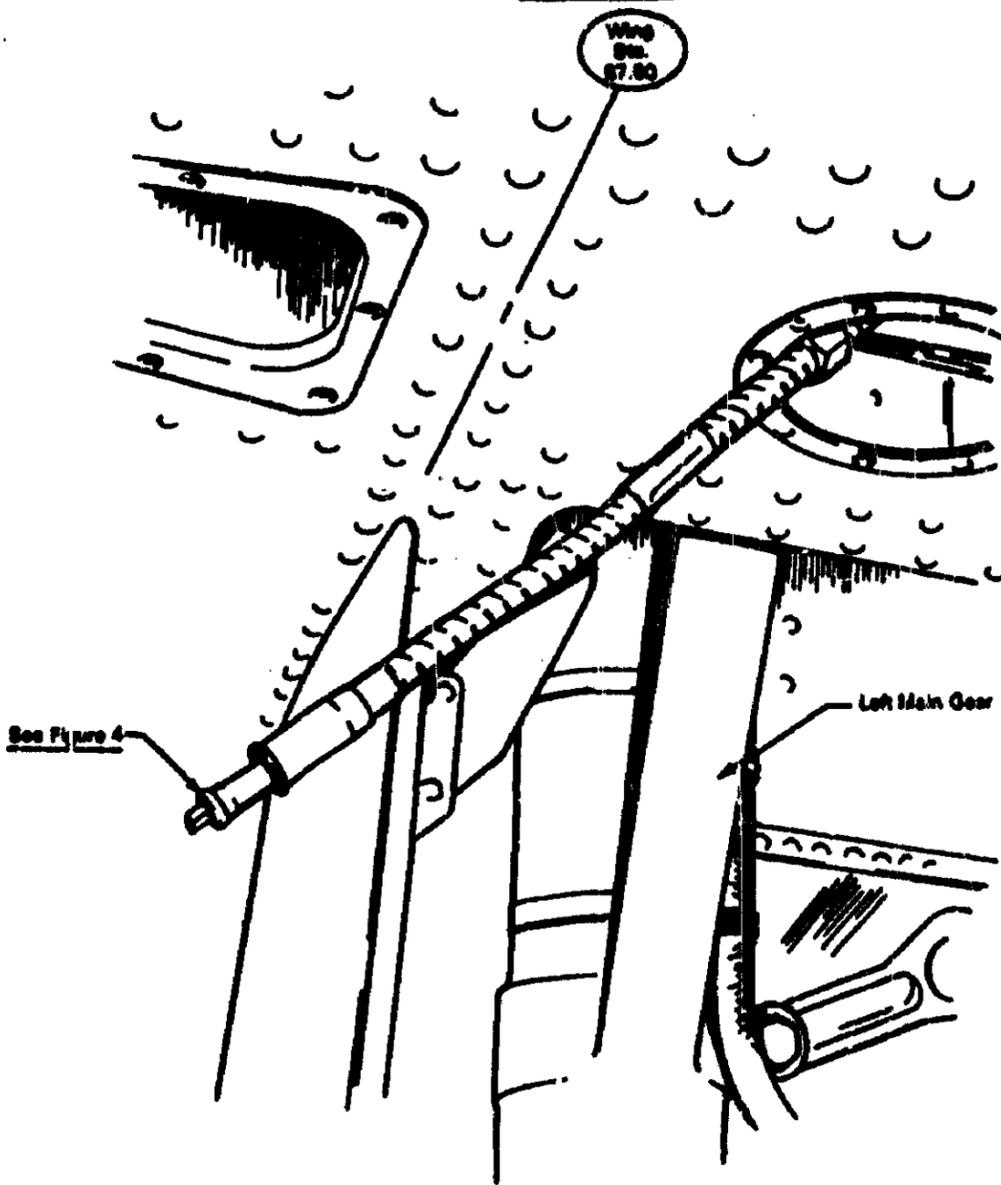
FIGURE 3
Left Wing Shown - Right Wing Opposite

- c. Disconnect drive shaft from the flap transmission. Using caution not to damage the shaft housing, route inboard through the Sta. 87.50 bulkhead. (ref Sketch E.) Inspect the swaged portion of the drive blade fitting end as described in "a" and "b" above.
