AIRCRAFT ACCIDENT REPORT

**ASHLAND PROPERTIES, INC.
CESSNA 414A, N2620L
NEAR HANOVER COUNTY AIRPORT
ASHLAND, VIRGINIA
JANUARY 3, 1982**

NTSB-AAR-82-12

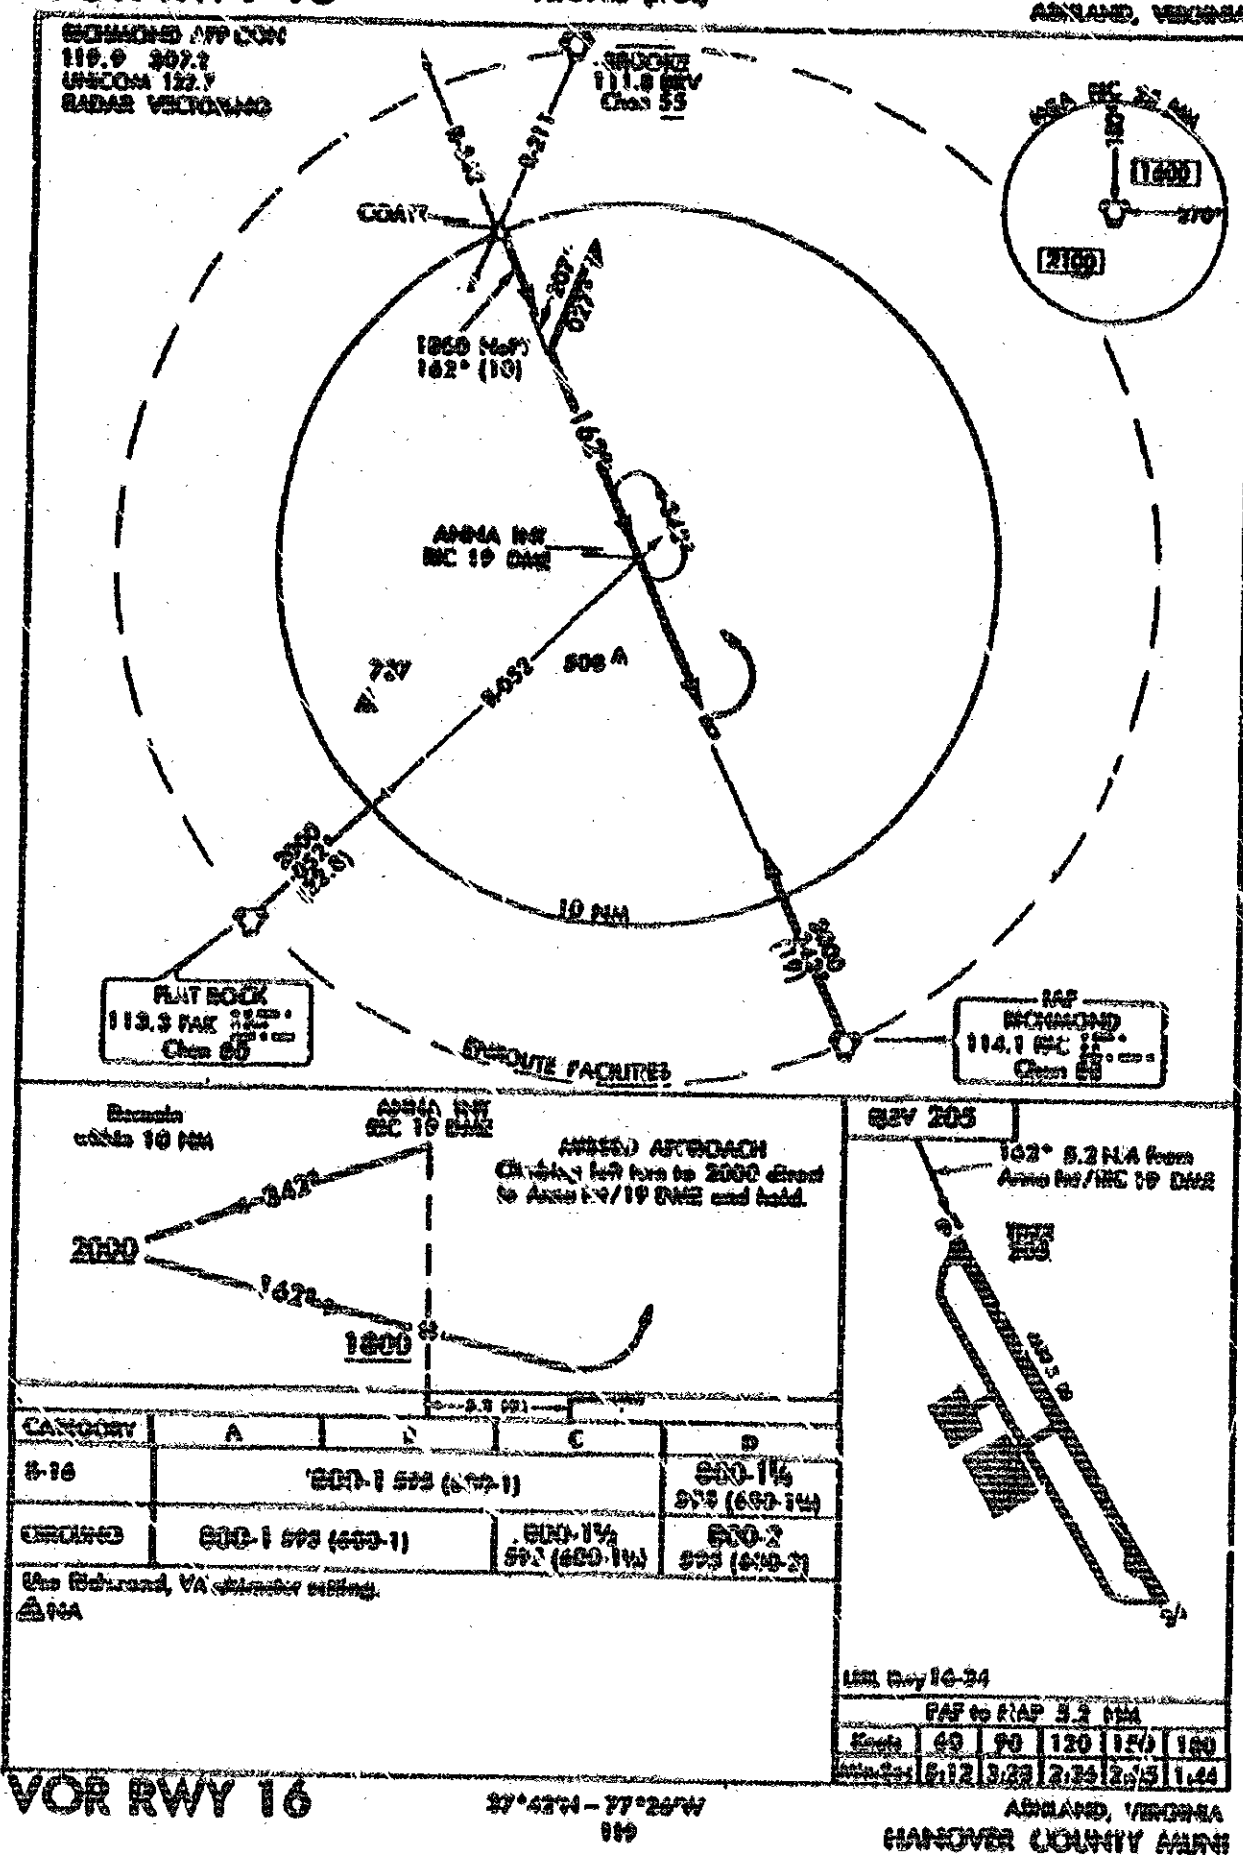
**Figure 1.--Approach chart for Runway 16, Hanover County Municipal Airport,
Ashland, Virginia.**

The field elevation at Hanover County Airport is 205 feet. The approach chart for the nonprecision approach to runway 16 at Hanover County Airport depicts an inbound heading of 162° using the Richmond VOR 342° radial. The final approach fix, ANNA intersection, is defined as the intersection of that inbound track and the 052° radial from the Flat Rock VOR or the 19-mile distance measuring equipment (DME) point from the Richmond VOR. This intersection is 5.2 nmi northwest of the airport and 19 nmi northwest of the Richmond VOR. (See figure 1.) The approach chart specifies a crossing altitude of 1,800 feet at the final approach fix after which the pilot may descend to, but not below, the specified minimum descent altitude of 800 feet (595 feet above ground level). The minimum visibility specified on the approach chart for the approach is 1 mile.
