NATIONAL TRANSPORTATION SAFETY BOARD

AIRCRAFT ACCIDENT REPORT

**PAN AMERICAN WORLD AIRWAYS, INC.,
CLIPPER 759, BOEING 727-235, N4737,
NEW ORLEANS INTERNATIONAL AIRPORT
KENNER, LOUISIANA
JULY 9, 1982**

NTSB/AAR-83/02

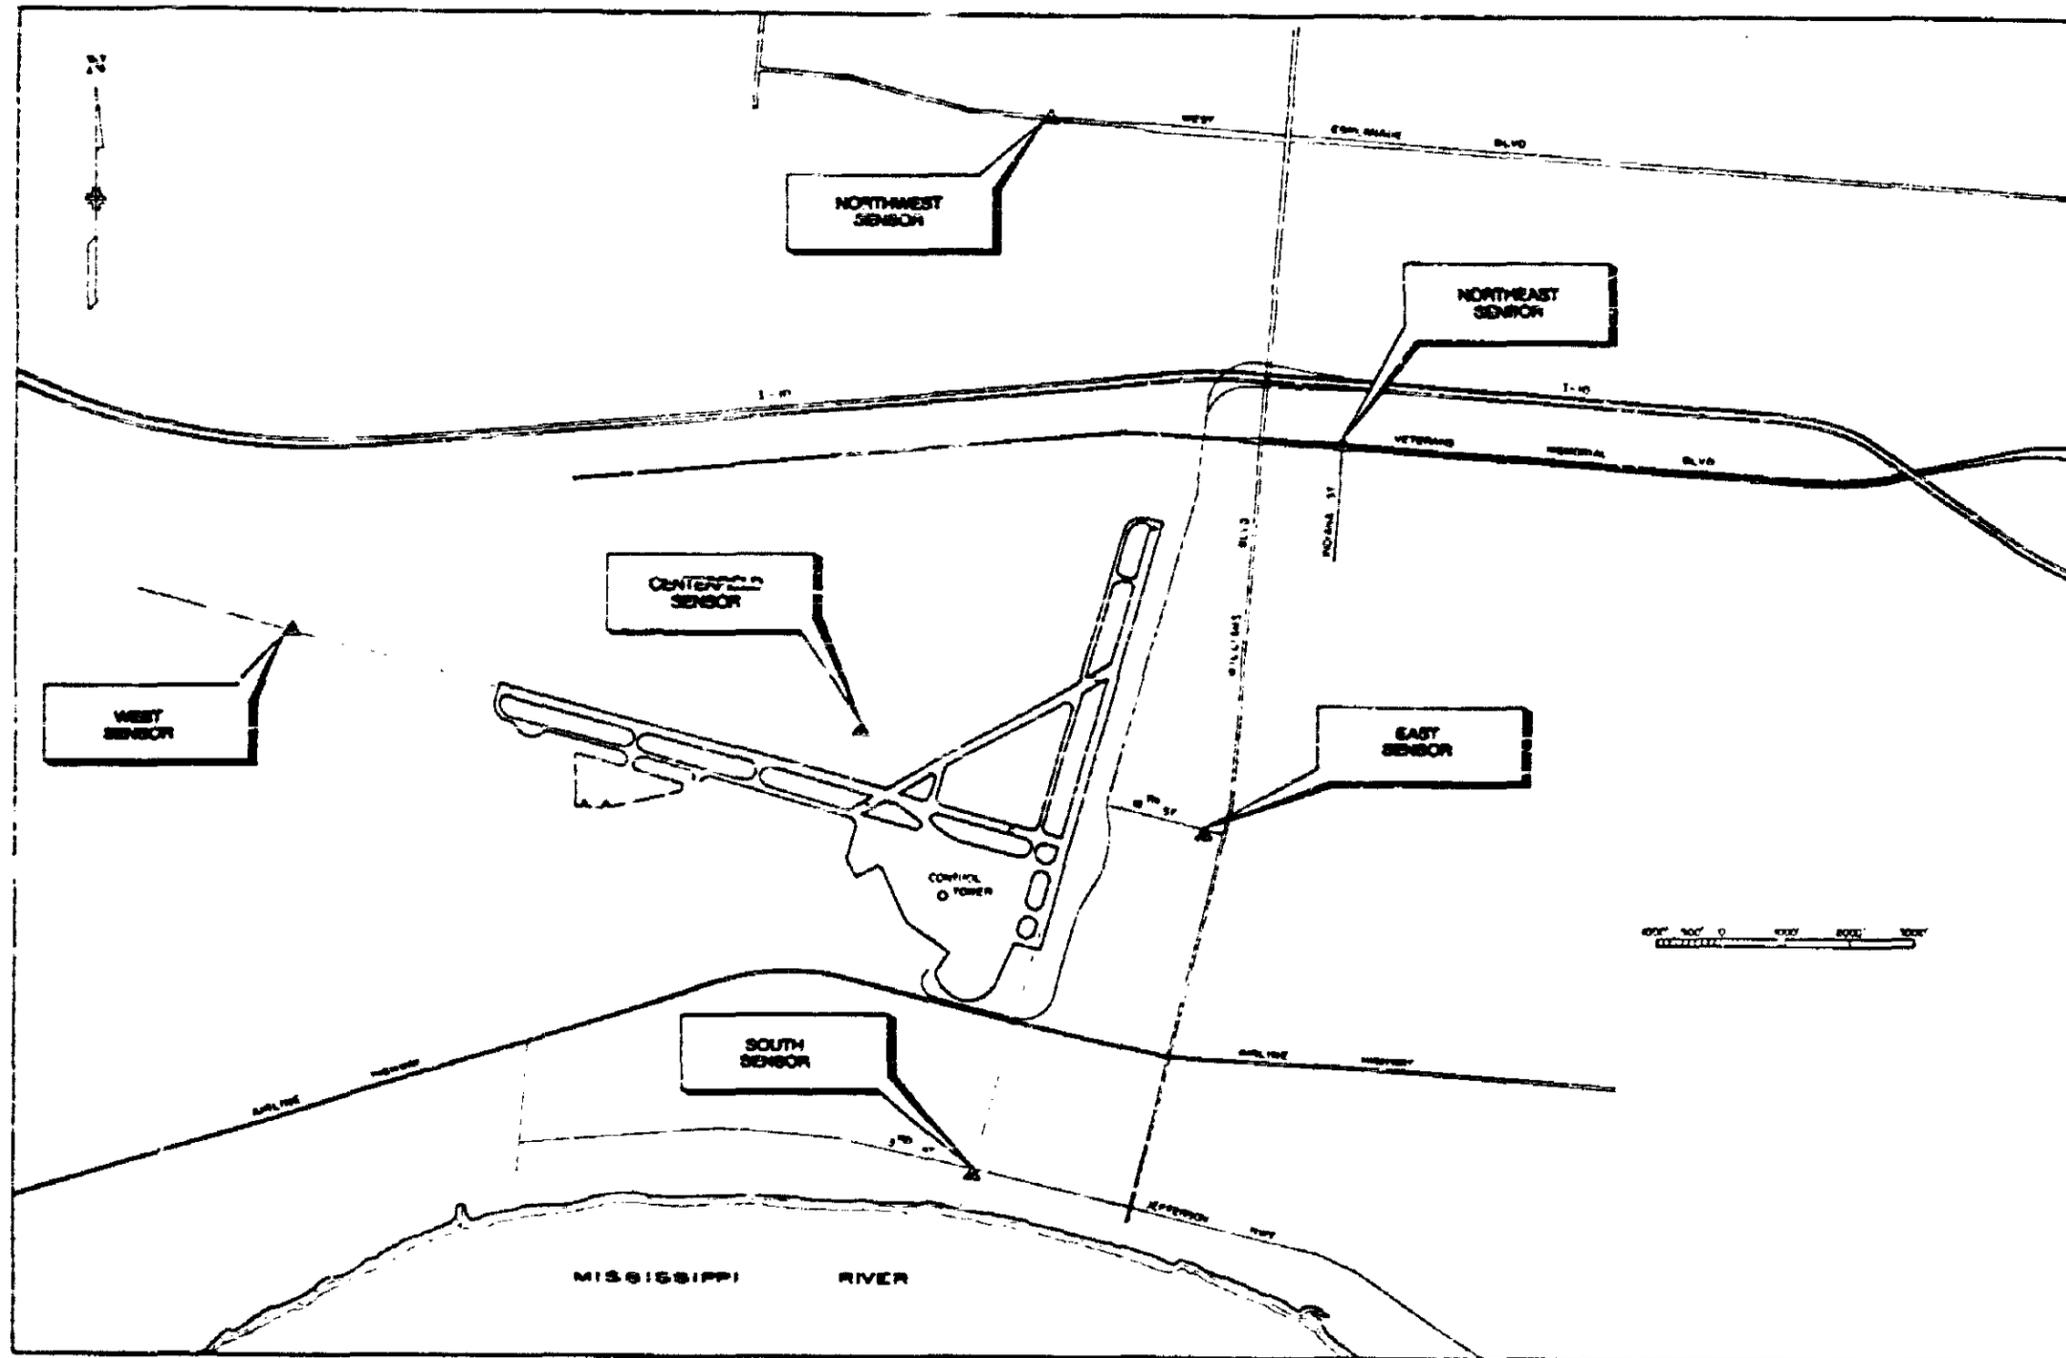
Figure 1.--Low Level Wind Shear Alert System
at New Orleans International Airport.

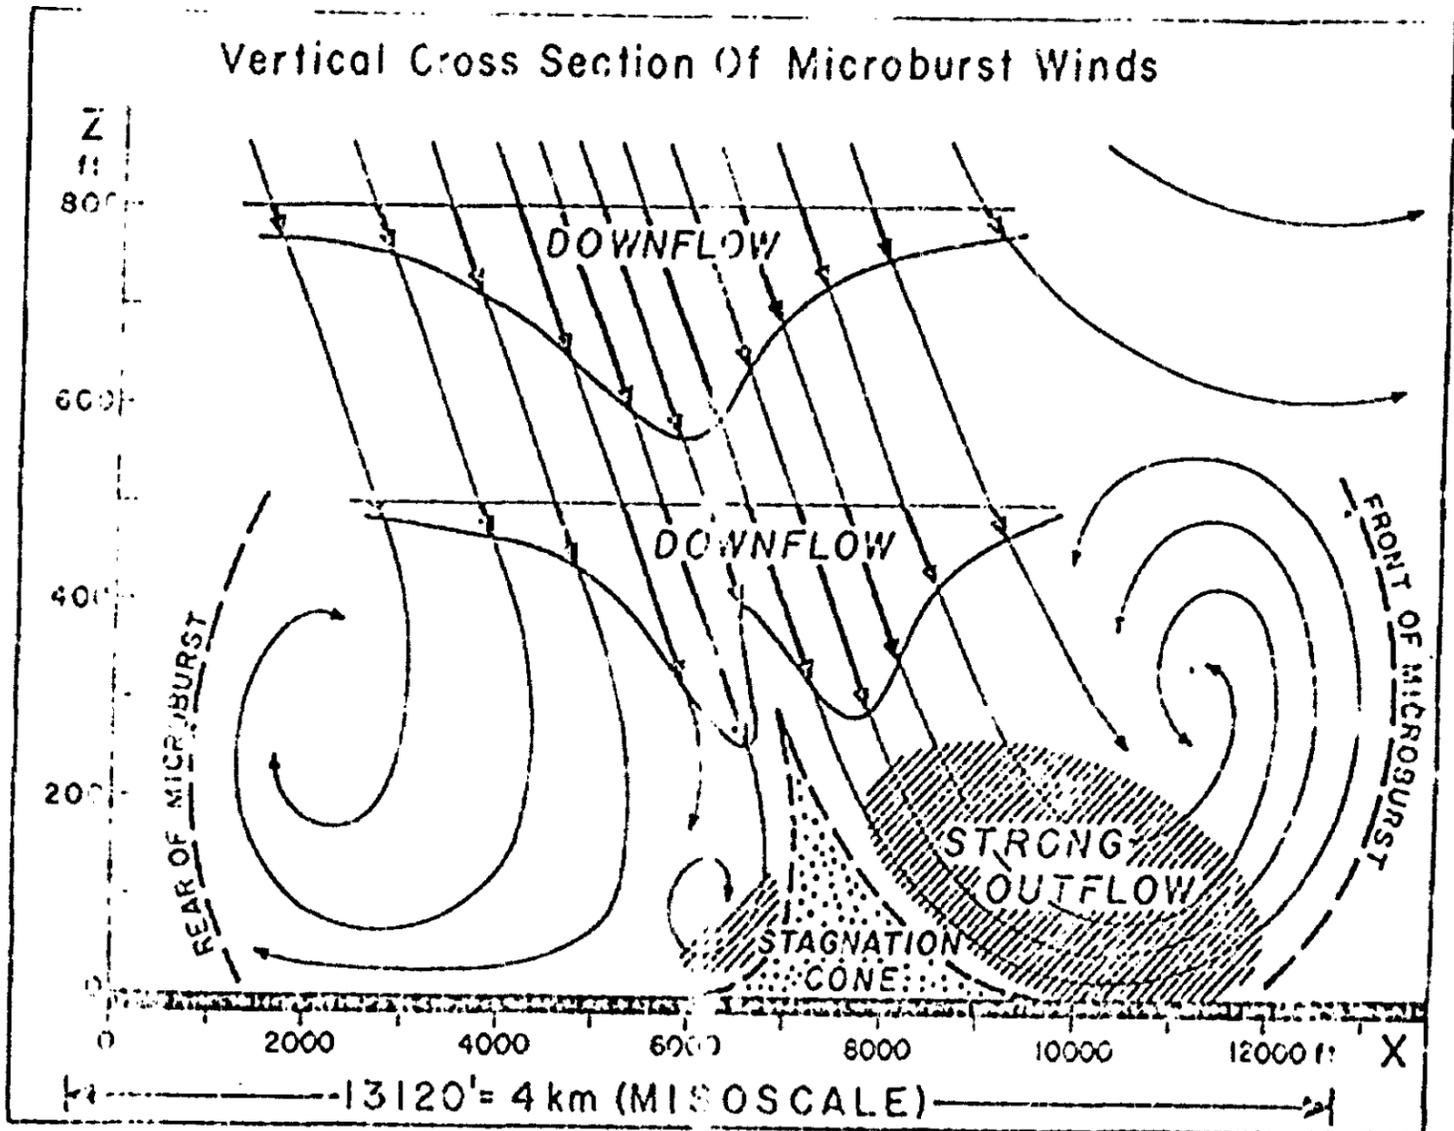
Figure 3.--Vertical cross-section of a microburst.
("Microburst Wind Shear at New Orleans International
Airport, Kenner, Louisiana, on July 9, 1982." p. 30, Dr. T. Theodore Fujita.)

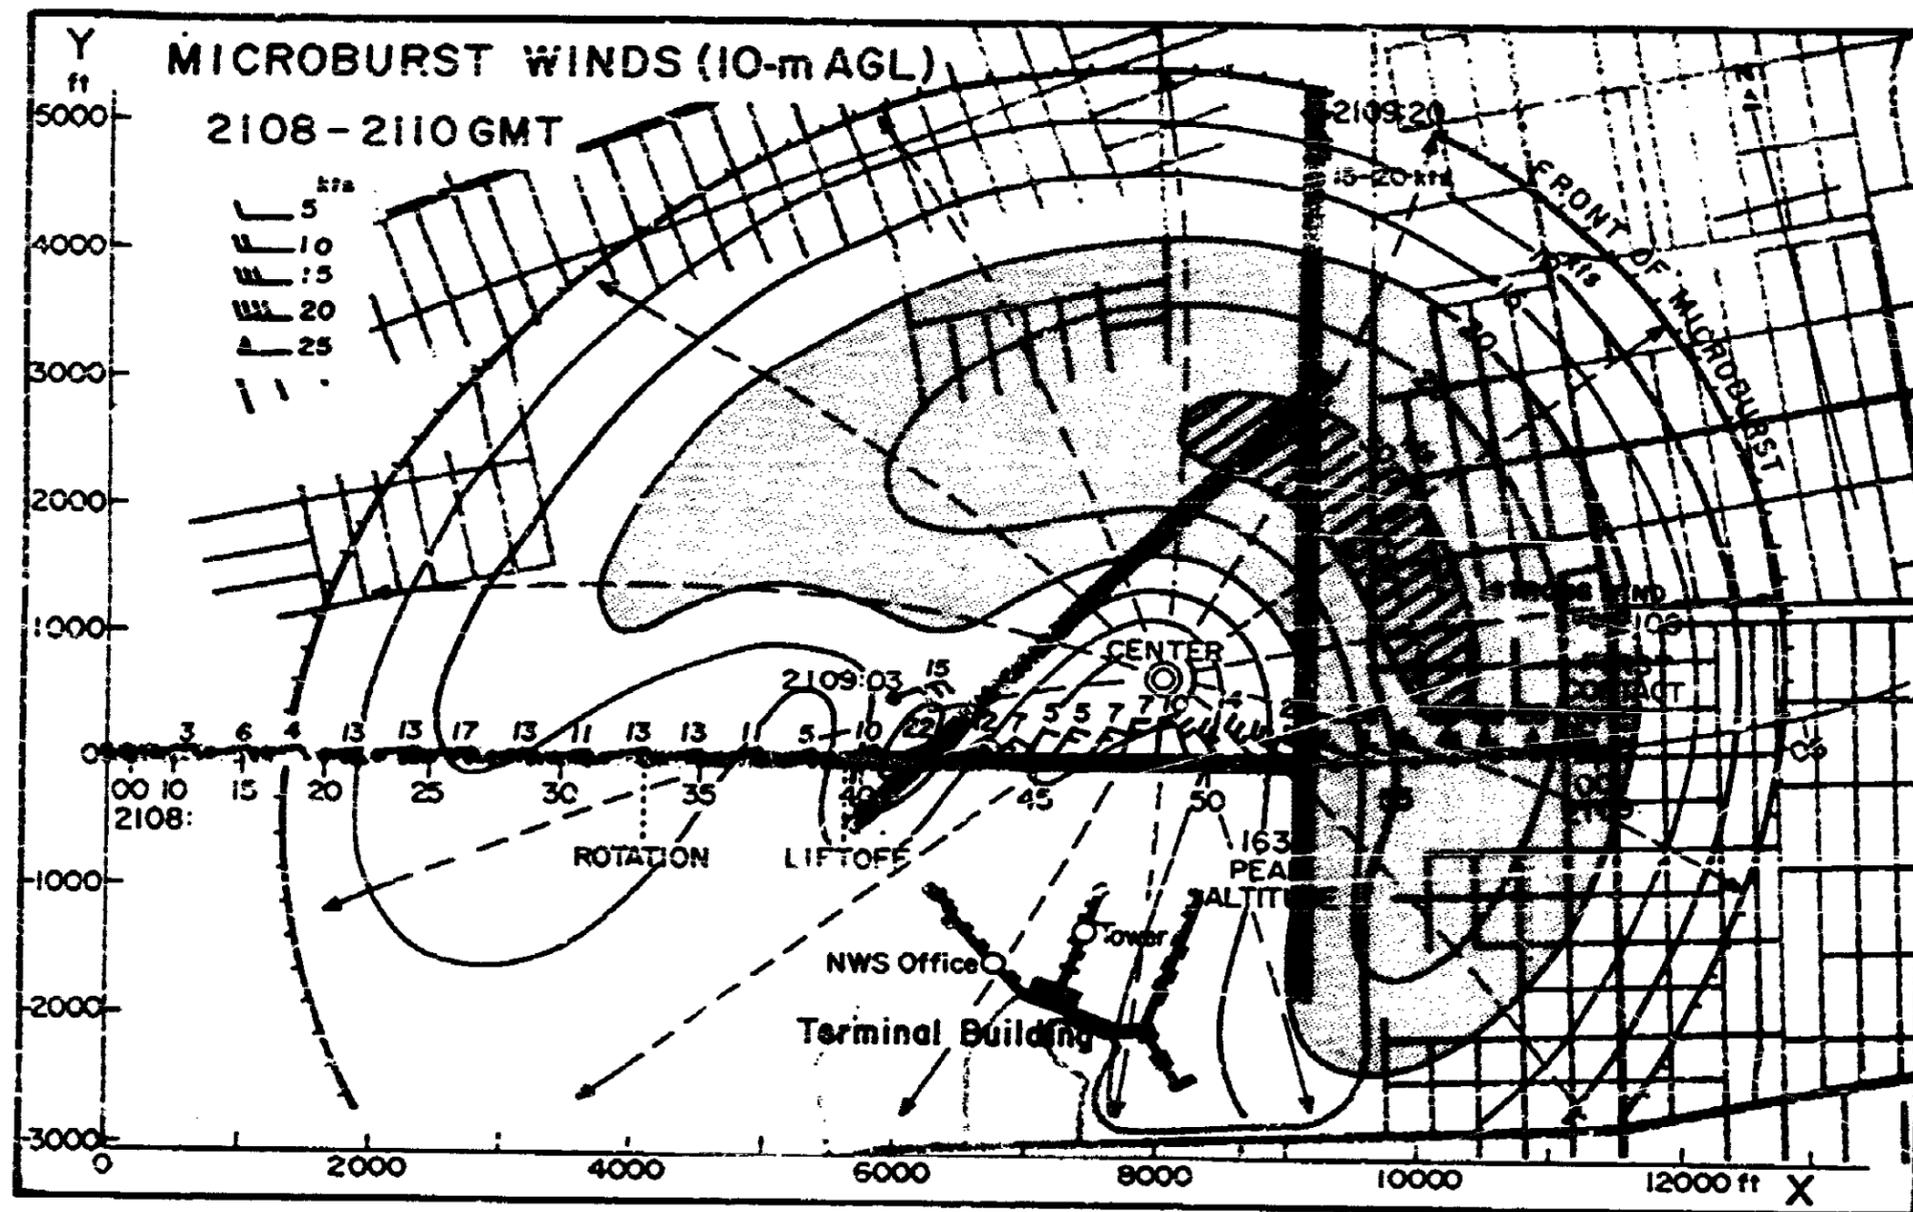
Figure 4.—Windfield of the microburst over the New Orleans International Airport (Moisant Airport) at the time of the accident. All wind speeds with barbs are reduced to the 30 ft (10 m) height above the runway with 0 to +1-ft elevation. Microburst was moving towards the northeast accompanied by strong west winds near the accident site and 15 to 20 knots southerly wind at the departure end of runway 19. (Page 28, "Microburst Wind Shear at New Orleans International Airport, Kenner, Louisiana, on July 9, 1982," Dr. T. Theodore Fujita.)

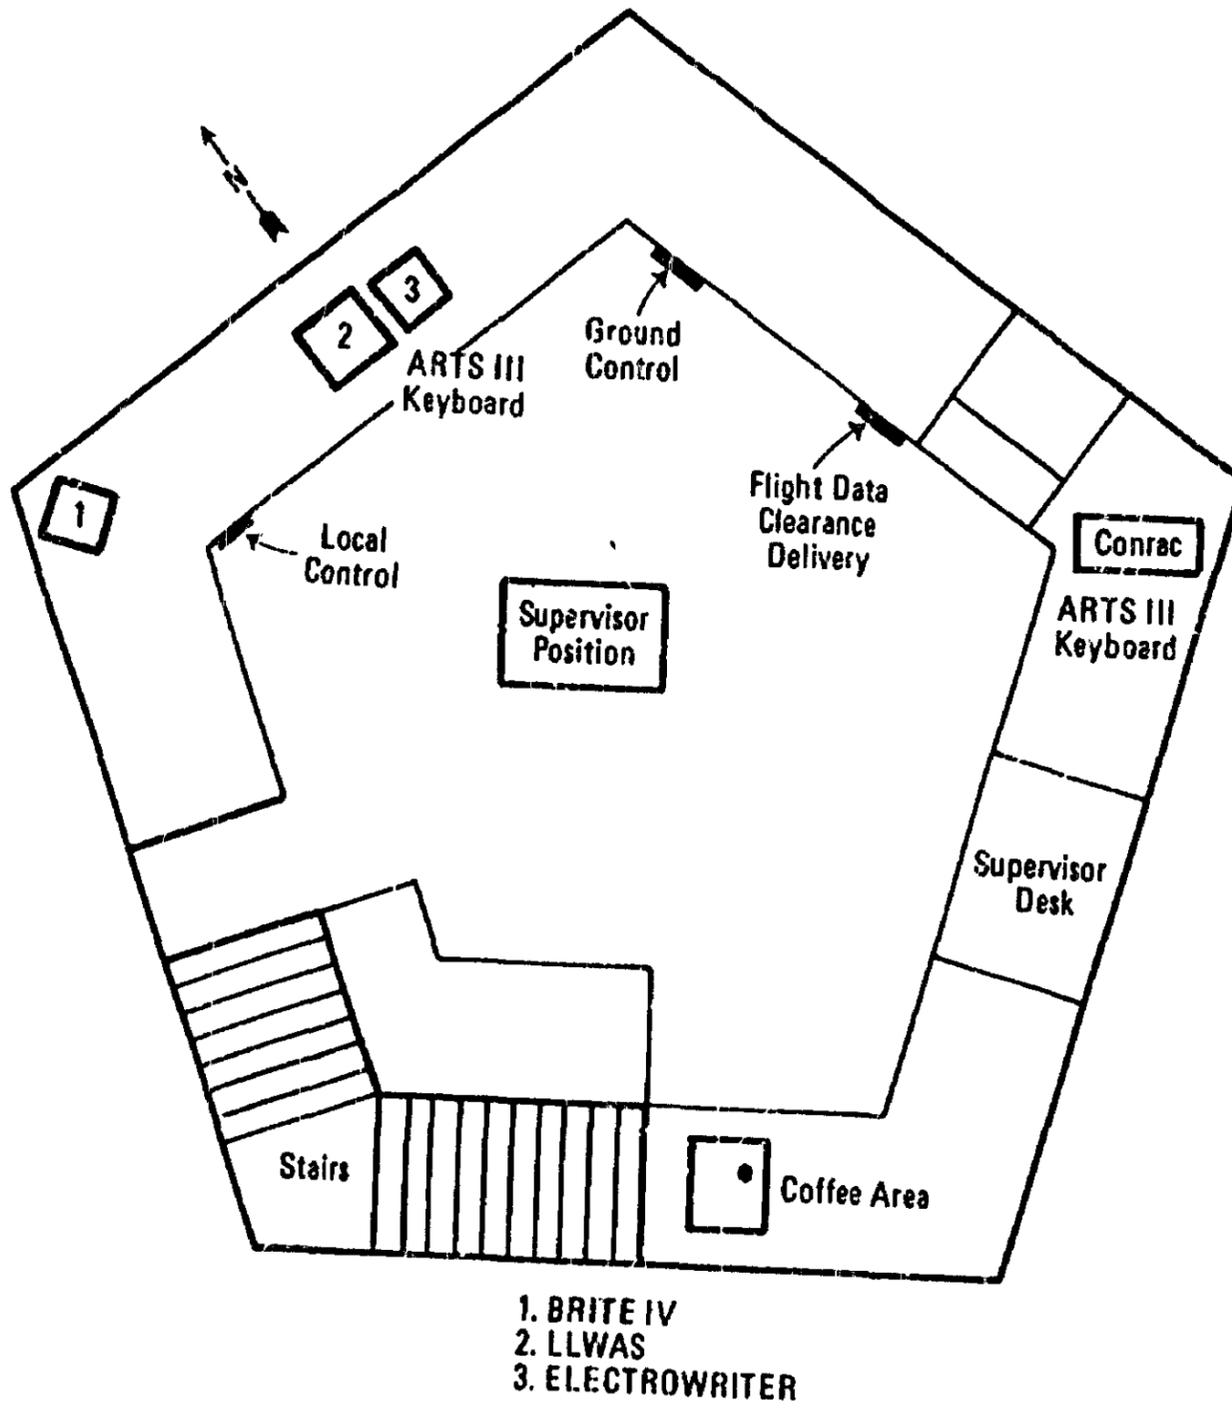
Figure 5.—New Orleans International Airport tower cab layout chart.

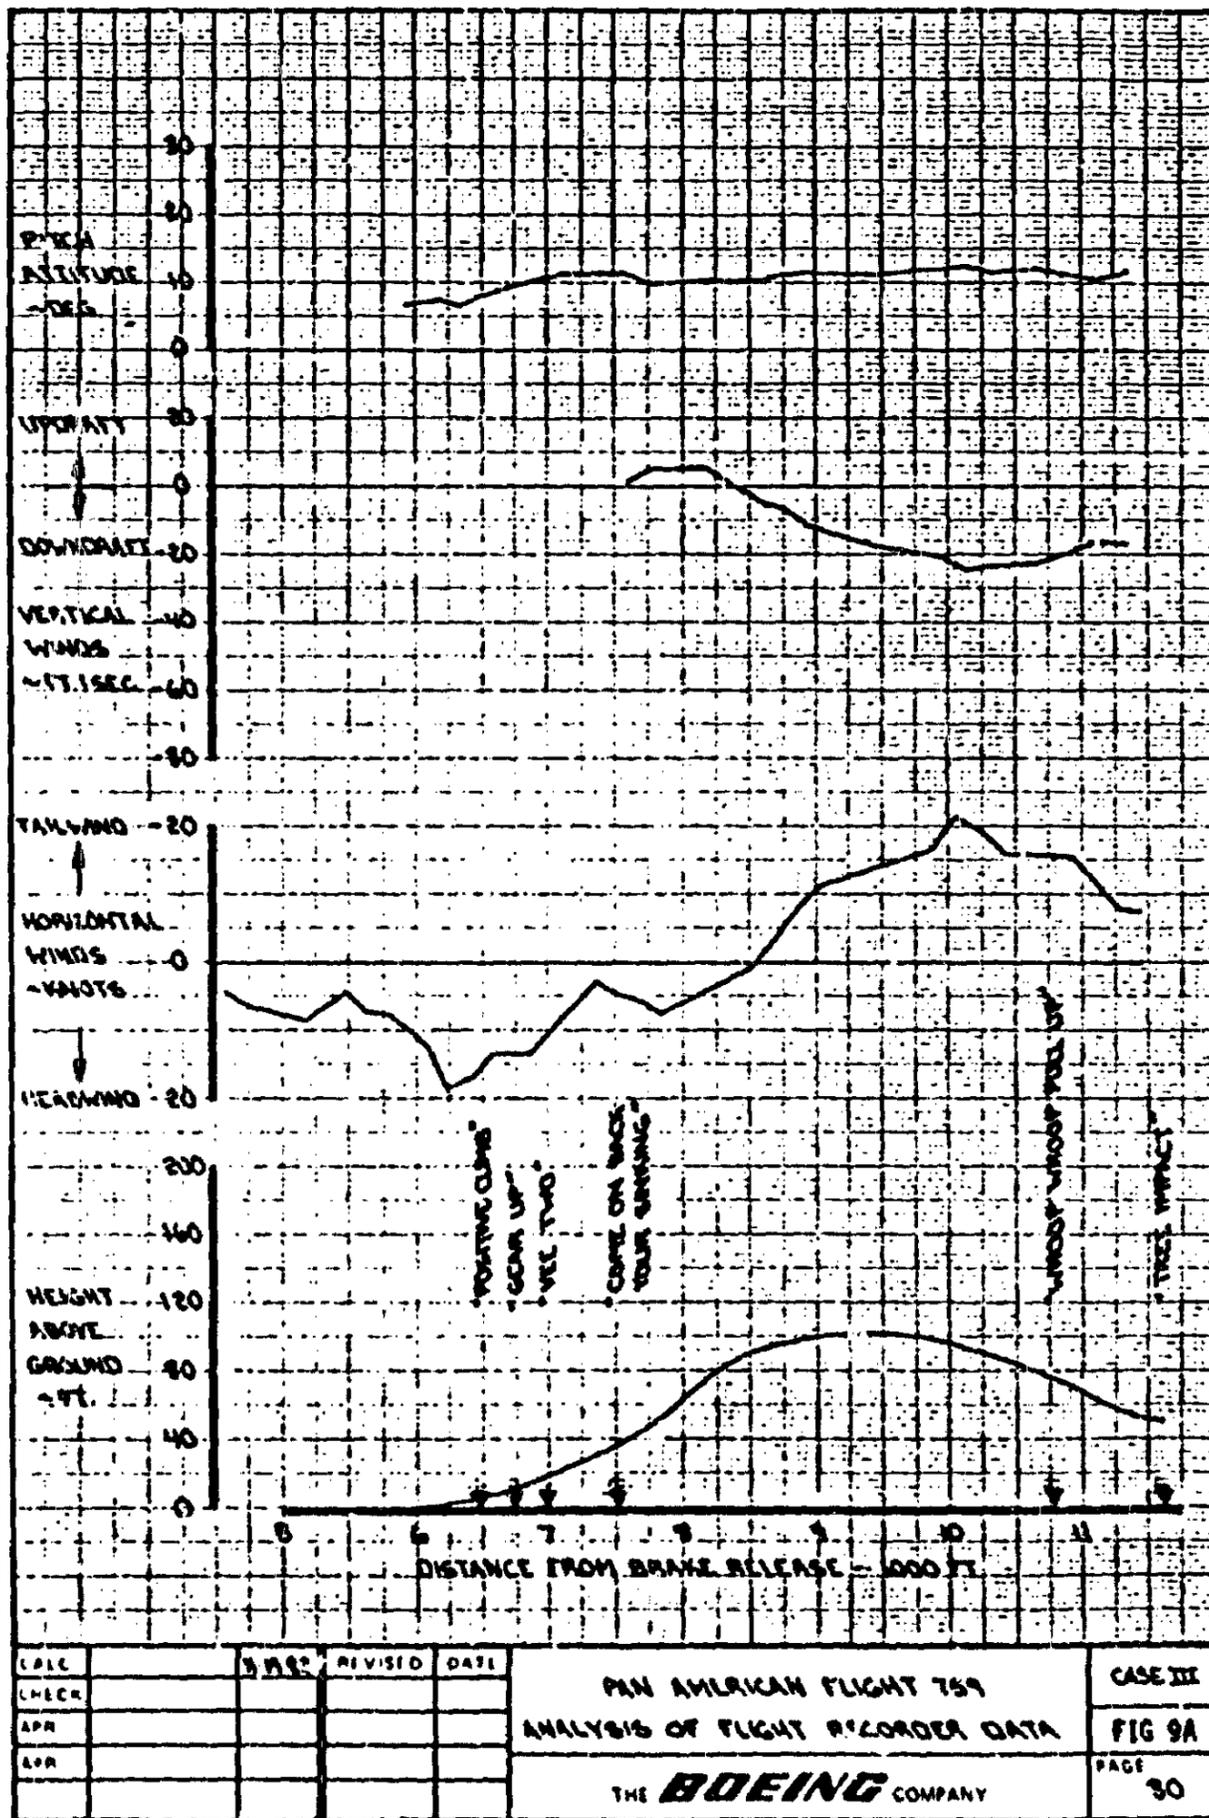
Figure 6.--Boeing's analysis of flight recorder data, case III.

derived from the airplane's measured performance parameters combined with the motion equation results for the assumed groundspeed profiles. No attempt was made to adjust the derived airplane pitch angles to produce a windfield that would fall within reasonable environmental parameters. Consequently, while the horizontal wind shear demonstrated in case III is reasonable, the 25 fps downdraft at 100 feet AGL is not; a 25 fps downdraft at 100 feet AGL would produce a diverging outflow on the order of 100 knots. It was obvious that surface winds of this magnitude did not occur during this accident.
